Post-Test Examination of the WWER Bundle QUENCH-12

13th International QUENCH Workshop, Forschungszentrum Karlsruhe, November 20-22, 2007

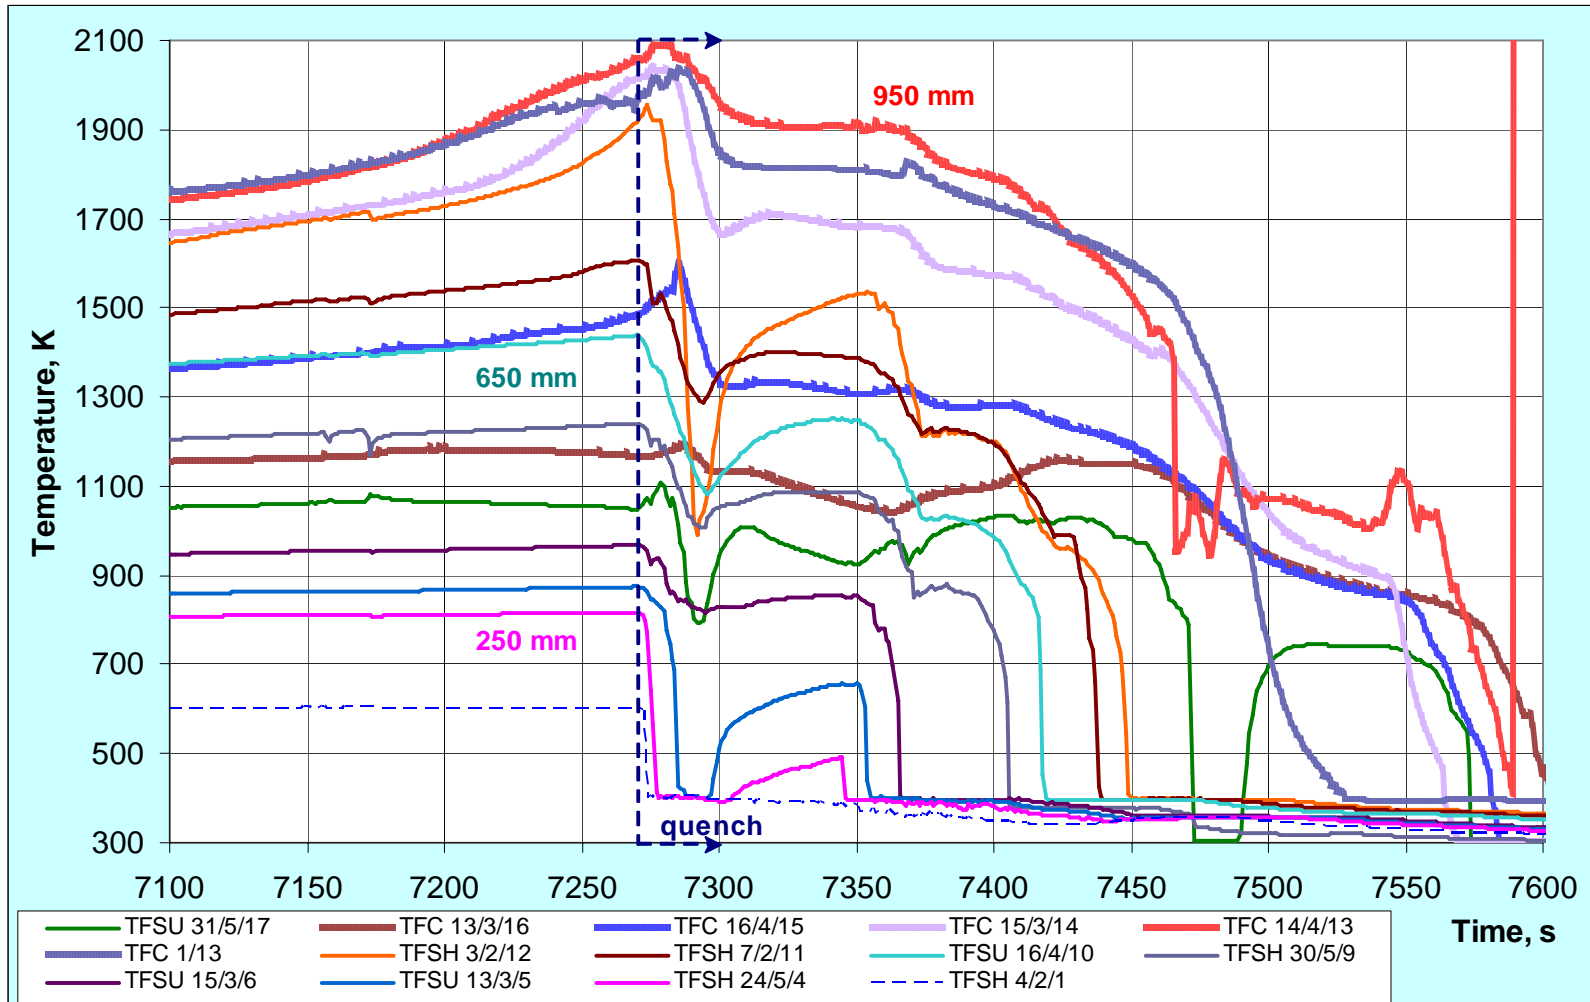
QUENCH-12, quench phase: selected reading of the bundle thermocouples.
Quench front propagation. Cooling of the bundle during ~350 s

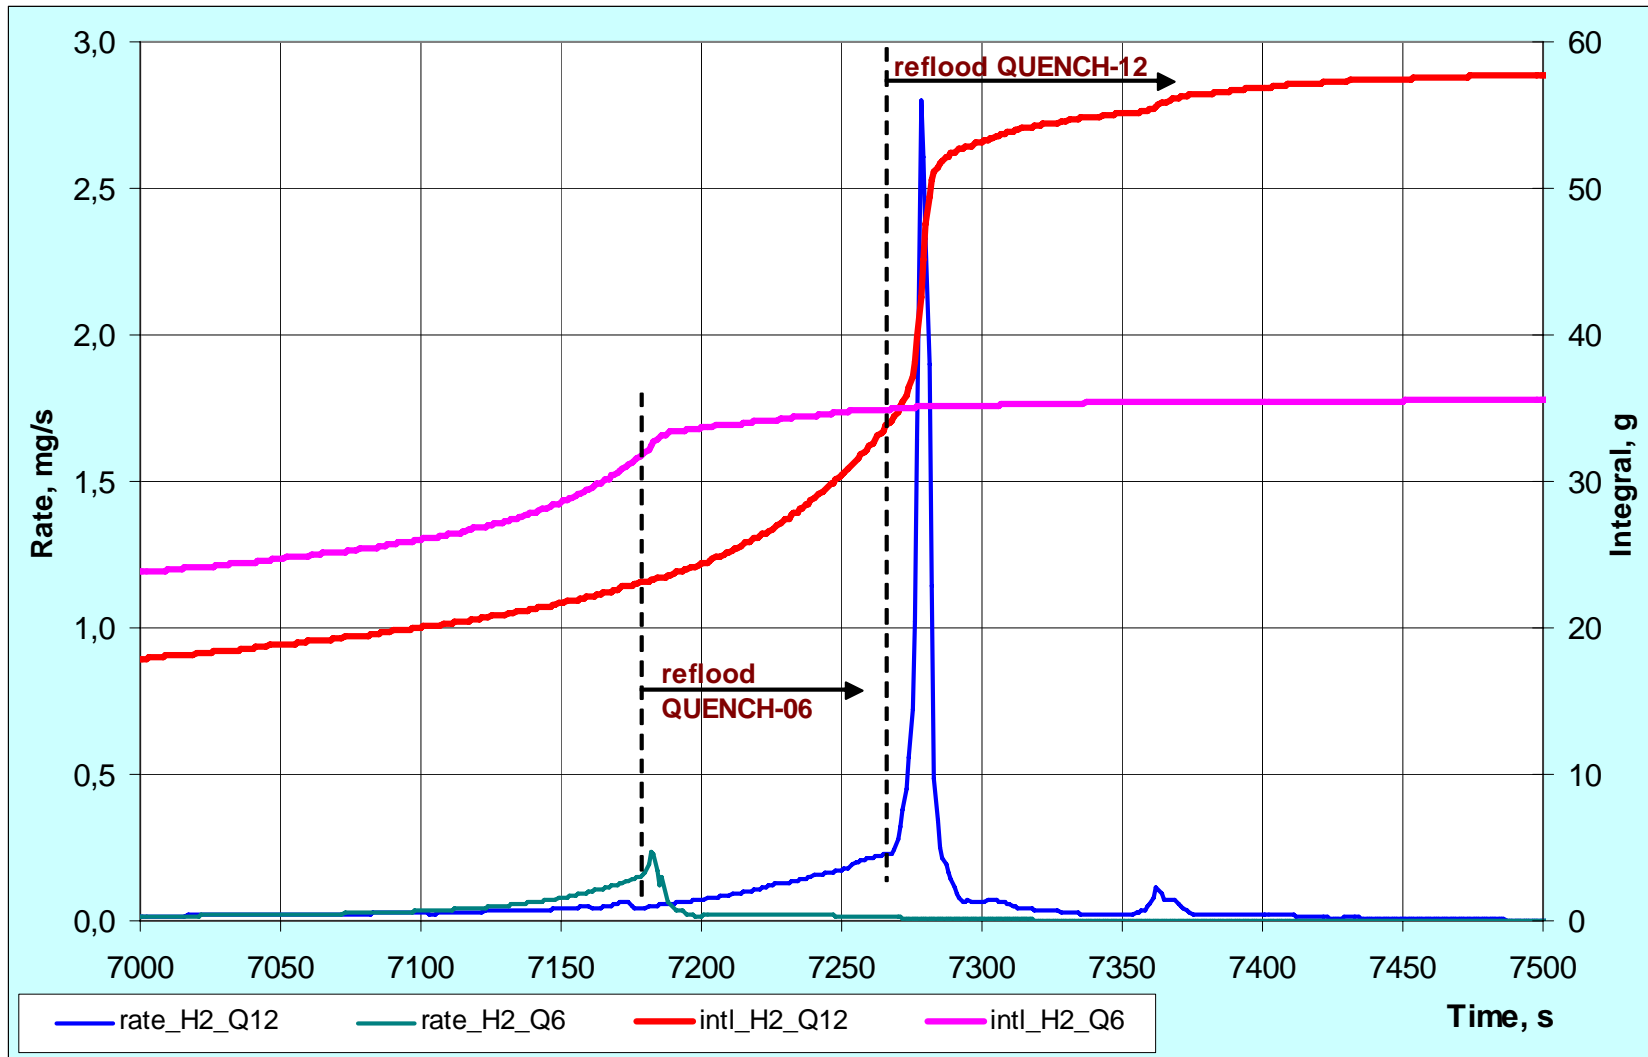
Comparison of hydrogen release during QUENCH-12 and QUENCH-06

- The breakaway typical oxidation in QUENCH-12 must be due to the Zr1%Nb cladding alloy since in QUENCH-06 the Zry-4 cladding was exposed to a very similar test conduct. The much higher hydrogen release during the reflood phase of QUENCH-12 can be the effect of the hydrogen evolution during the quench phase oxidation and a release of previously picked-up hydrogen. Both contributions may have been favored by the presence of post-transition scale with inferior barrier effect.

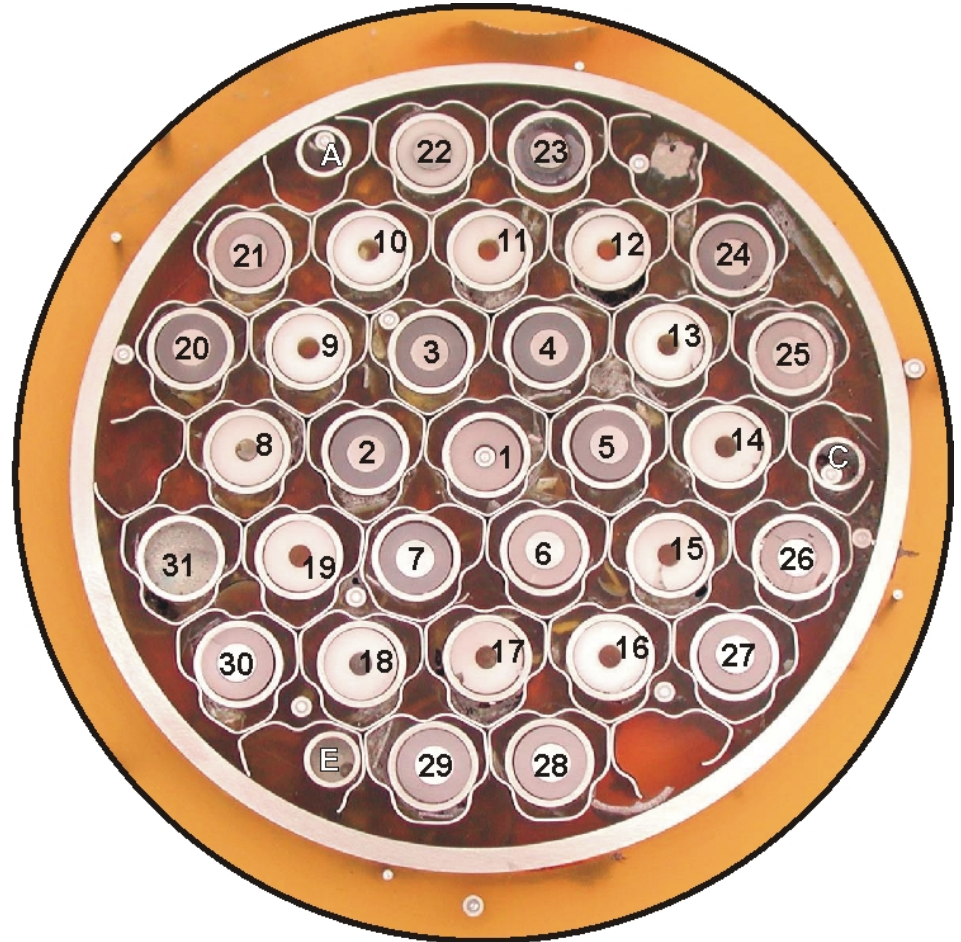
Elevation 550mm, top view

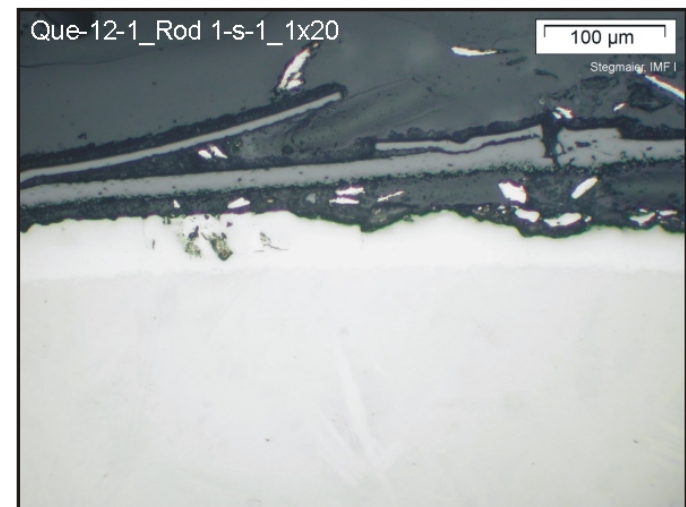
QUENCH-12, level 550 mm; oxidation of the central rod

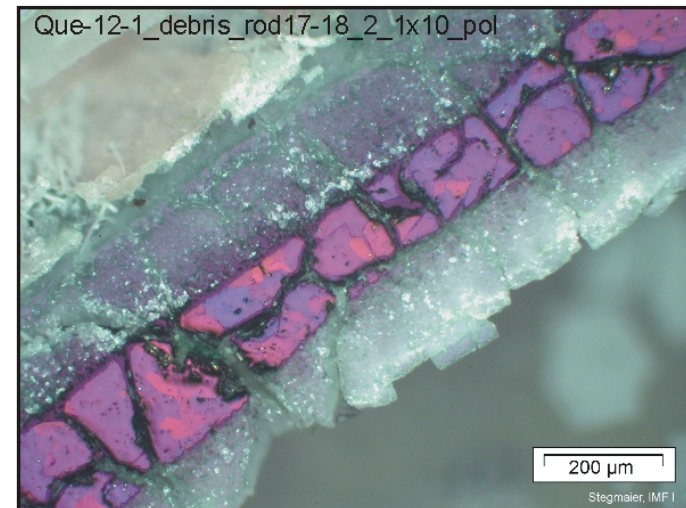
QUENCH-12, level 550 mm; cladding debris showing both-sided oxidation

Debris fragments
between two rods

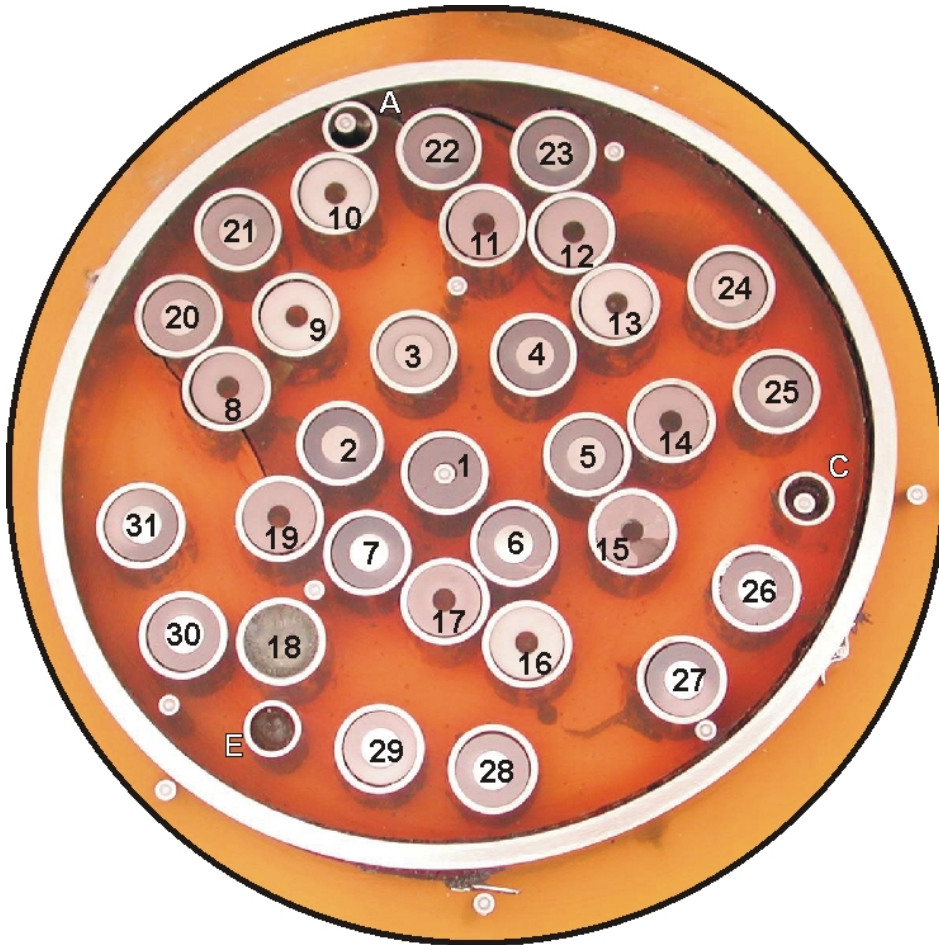
QUENCH-12; cross section overview at 650 mm elevation

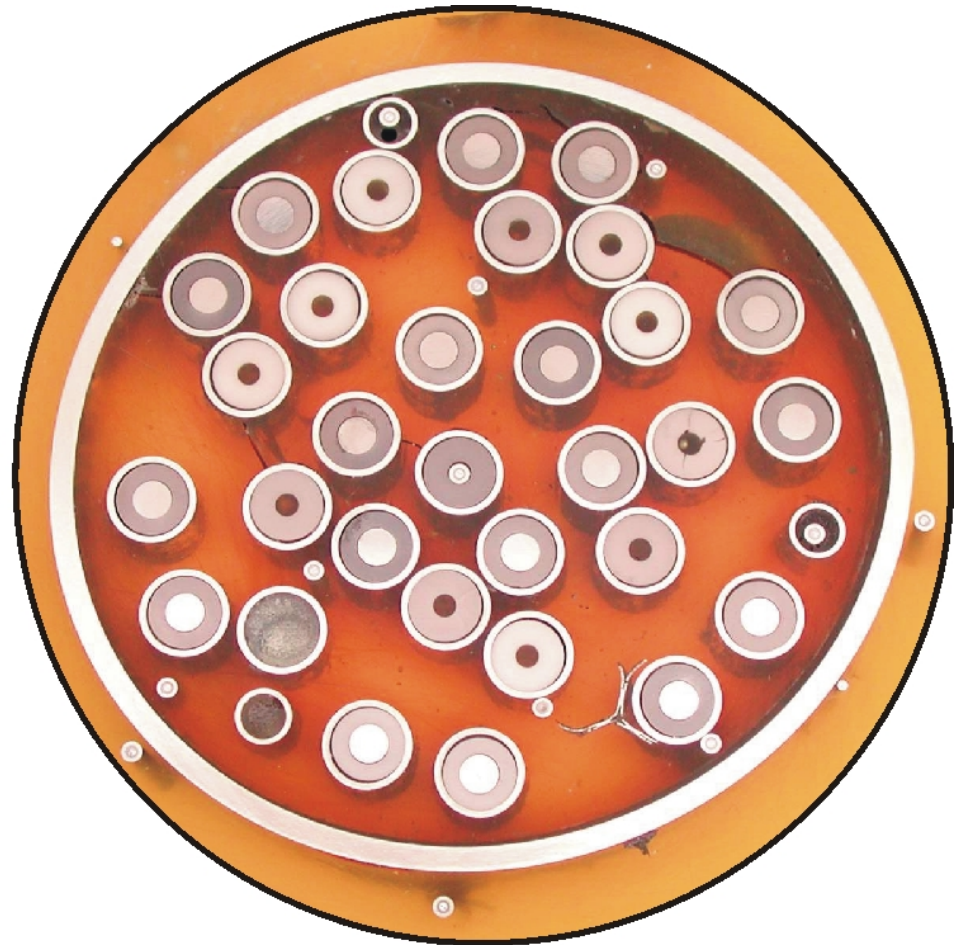
Elevation 650mm, top view

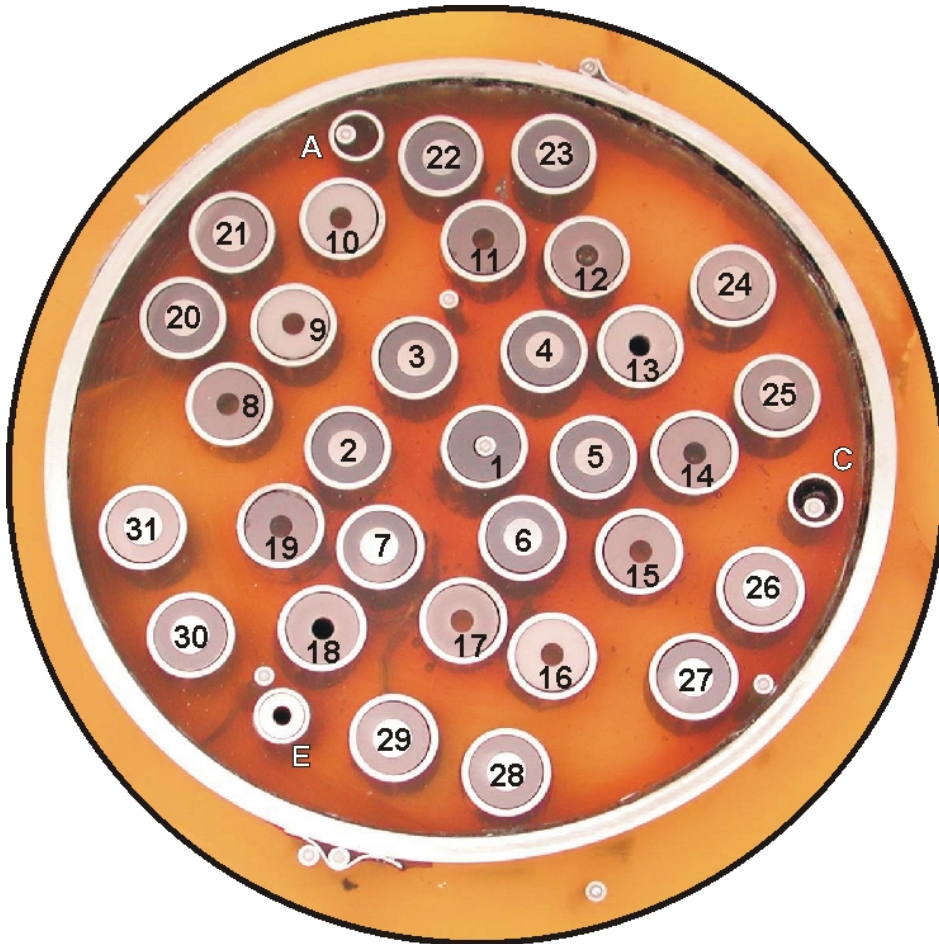
QUENCH-12; cross section overview at 750 mm elevation

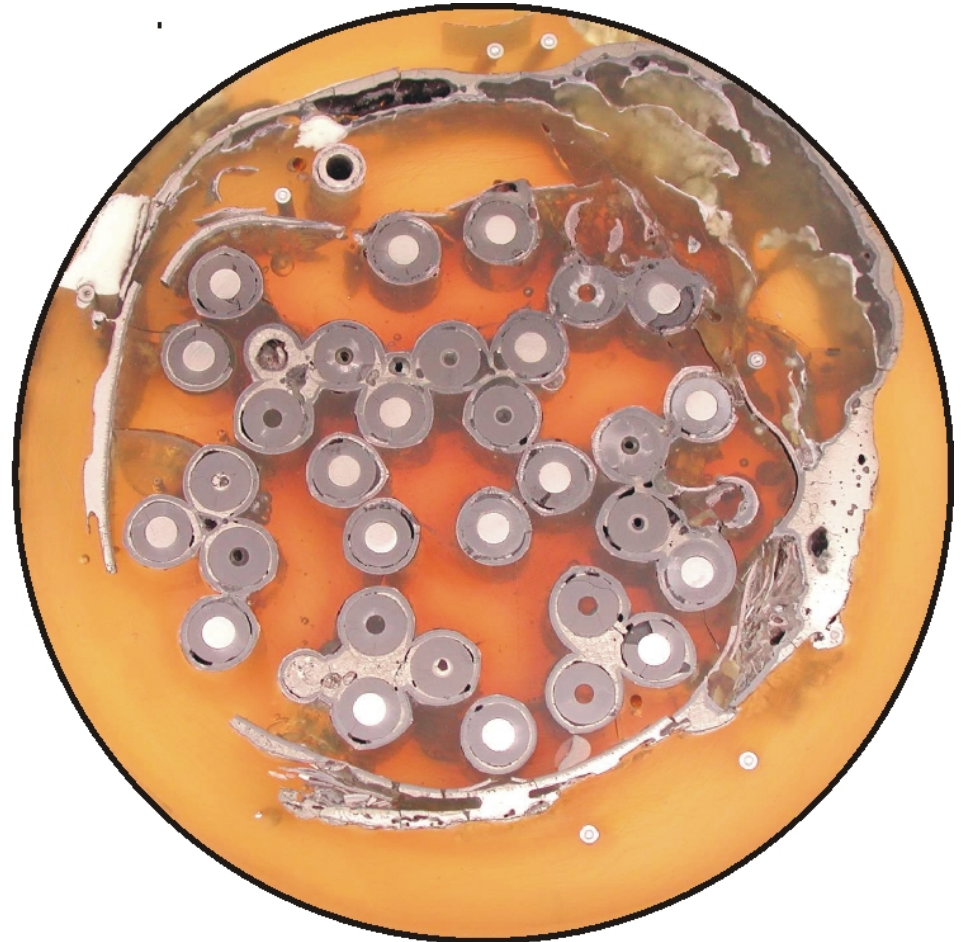
Elevation 950mm, top view

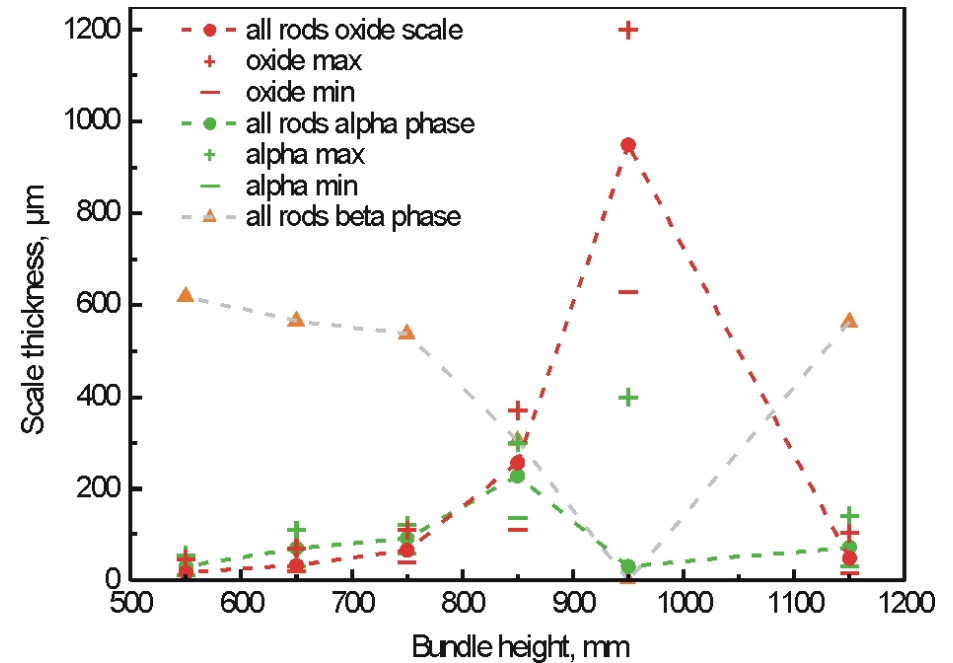
QUENCH-12; axial oxidation profiles, overview (left), details (right)

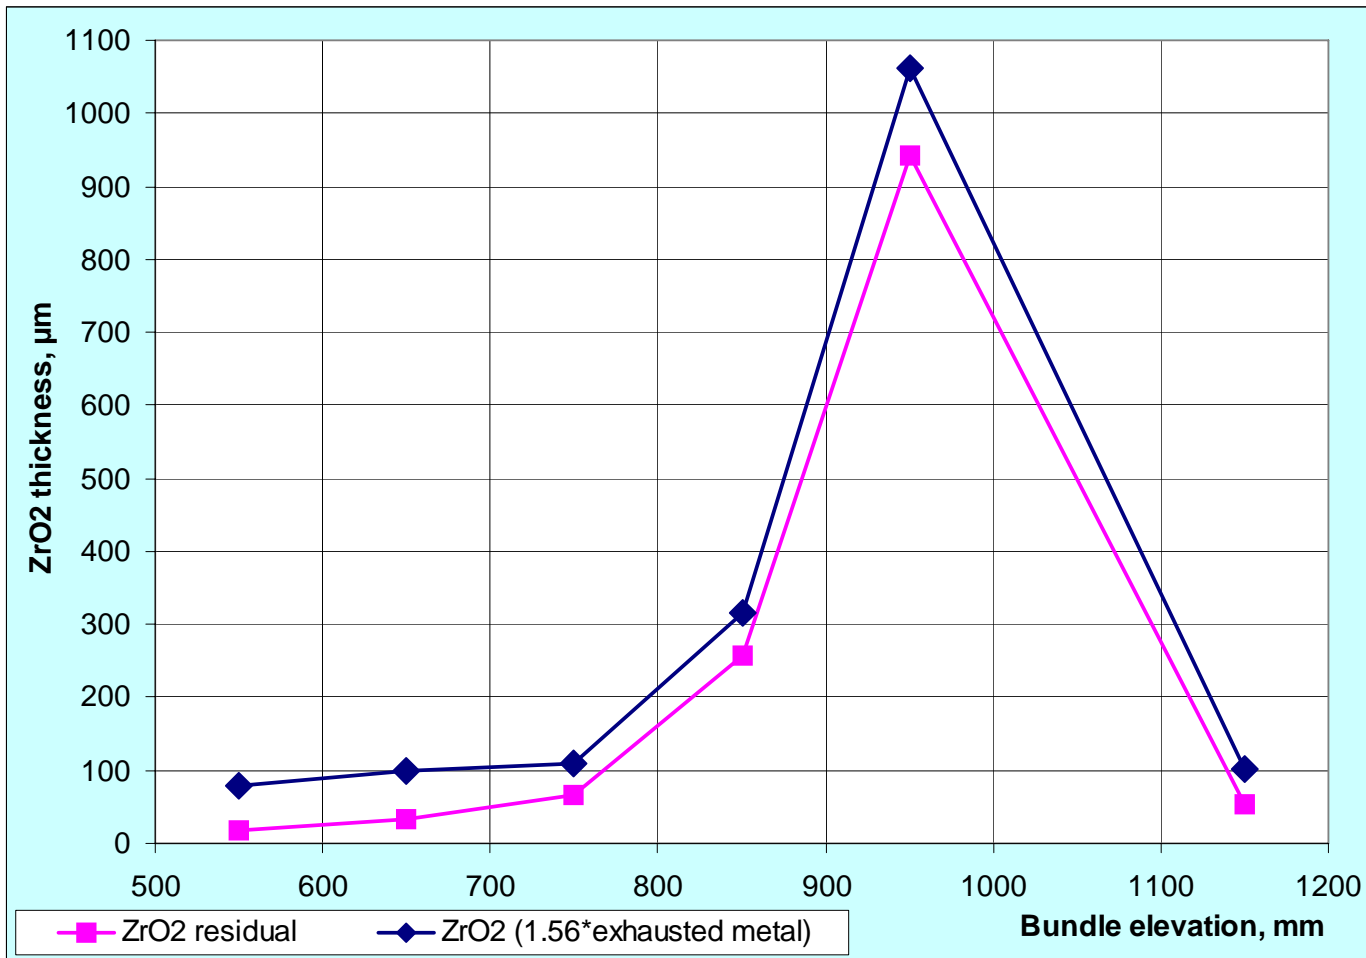
QUENCH-12, post-test analysis:
Axial distribution of the oxide layer on the surface of cladding tubes.
Measured residual oxide and oxide calculated on the base of residual metal
