Experimental and Post-Test Calculation Results of the Integral Reflood Test QUENCH-12 with a VVER-type Bundle

*J. Stuckert, M. Große, M. Steinbrück
Forschungszentrum Karlsruhe*

High-Temperature Materials Behavior and Flooding of an Overheated LWR Core and **Hydrogen Source Term**

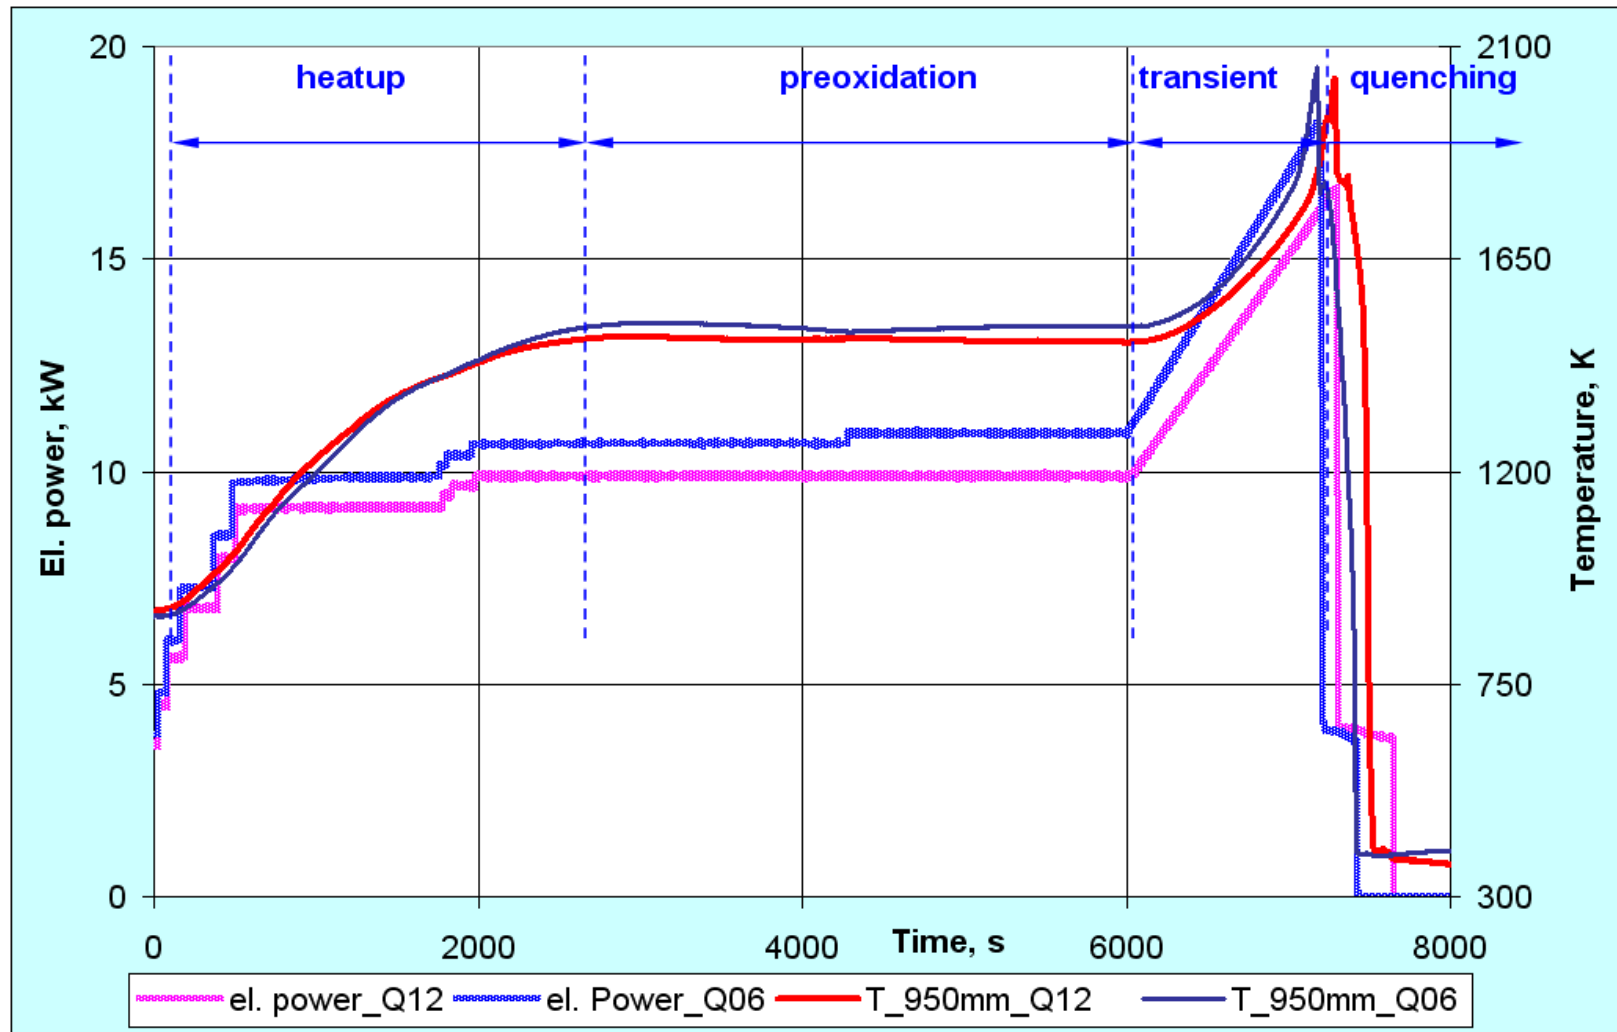
Test performance: el. power profile in accordance to the pre-test calculations provided good reproduction of temperature history in comparison with the reference test QUENCH-06

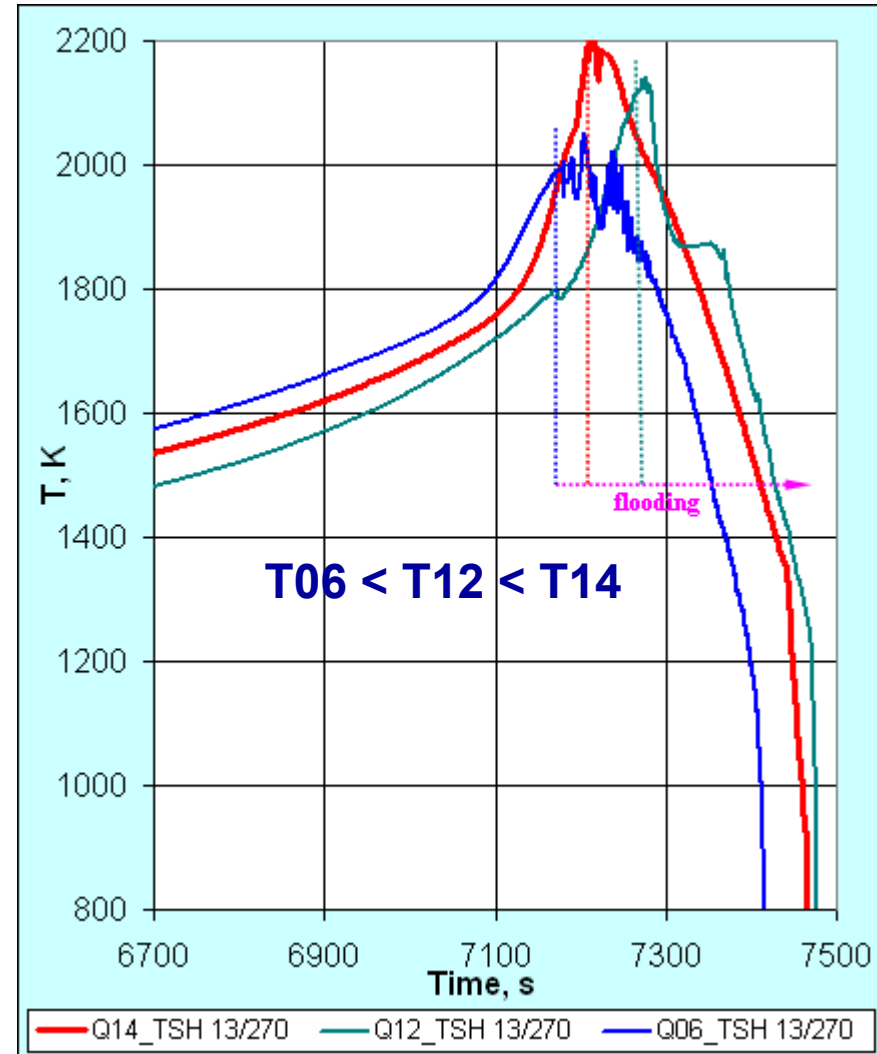
Comparison of transient and reflow phases for
QUENCH-14 (M5), QUENCH-12 (E110), QUENCH-06 (zry-4):
 similar escalation before reflow

shroud temperature at hot elevation of 950 mm

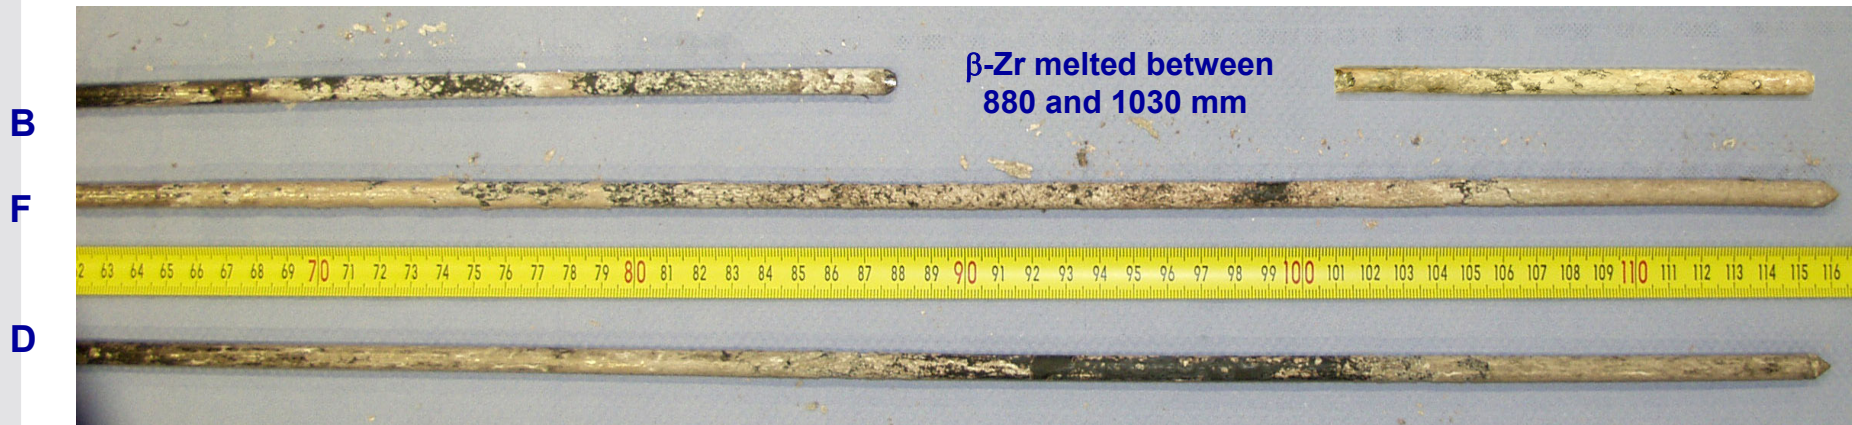
corner rod B after pre-test (800 °C, oxide layer thickness less of 5 µm)

corner rods withdrawn during the test:
spalling of the outer skin of oxide layer due to breakaway oxidation.

D – withdrawn after pre-oxidation,
F – withdrawn before reflood,
B – withdrawn after test.

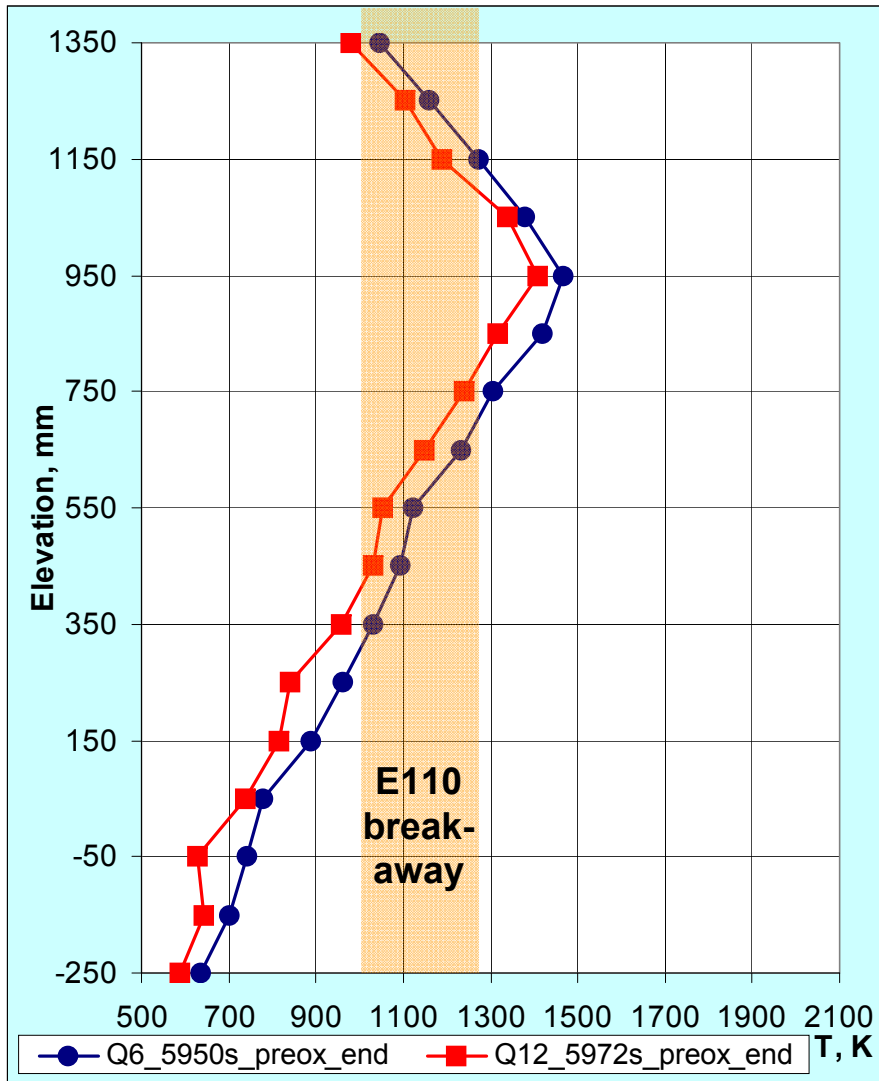
Axial bundle temperature profiles for QUENCH-06 and QUENCH-12 on beginning and end of transient phase

beginning of transient

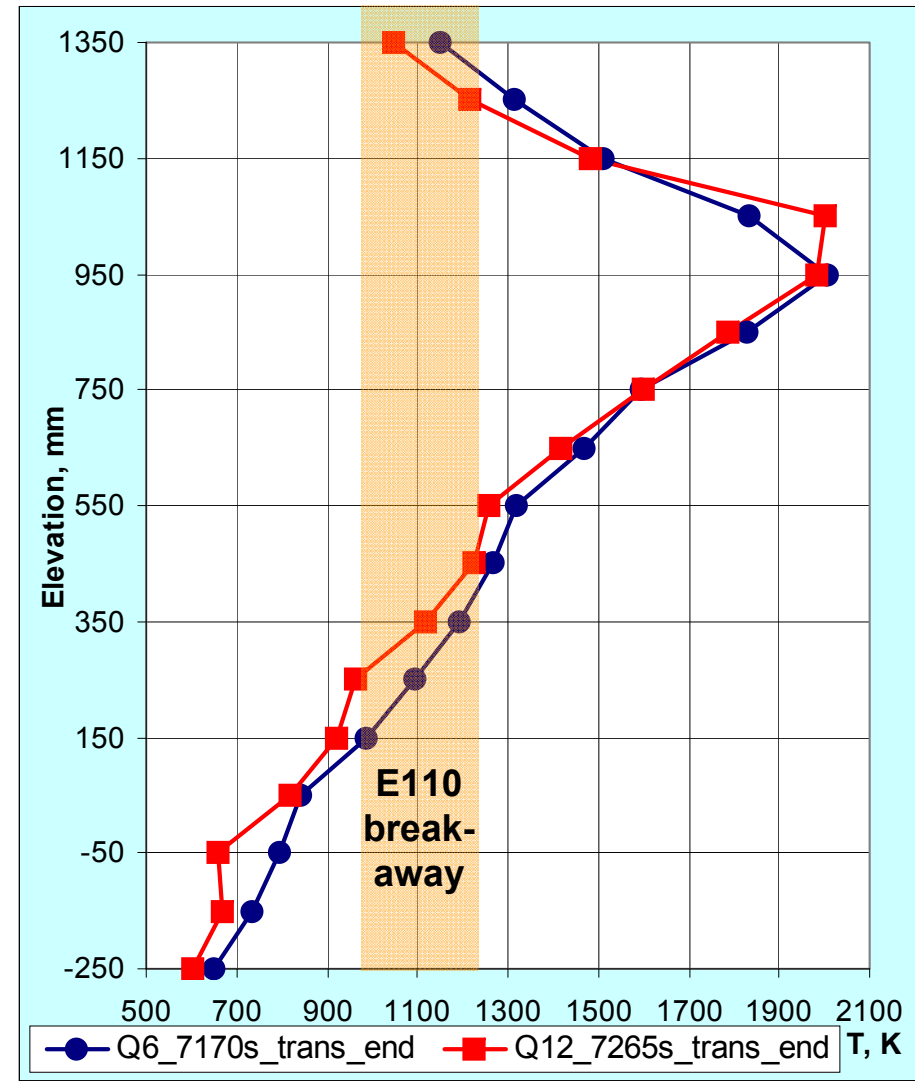
end of transient

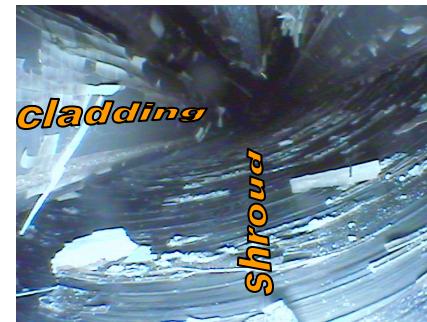
650 mm:
spalled oxide scales
at shroud and cladding

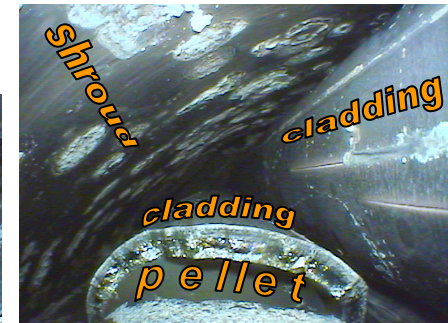
900 mm:
circumferential
and longitudinal cracks
at the cladding;
nodular breakaway
corrosion
at the shroud

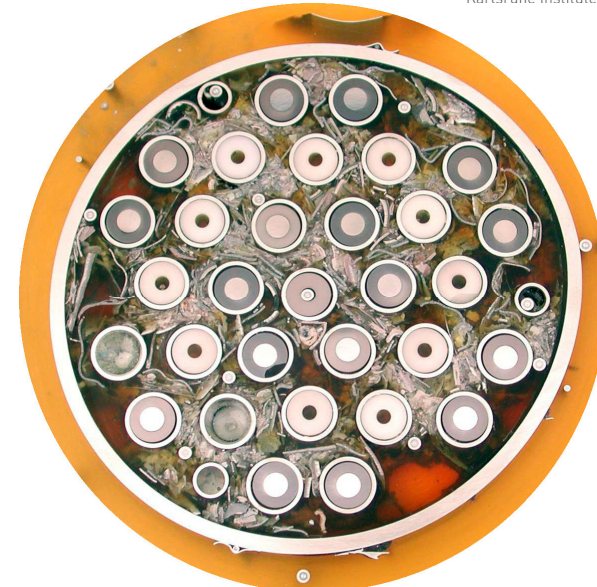
Q12: rubble on spacer grid consists of spalled cladding scales and fragments of partially oxidized cladding

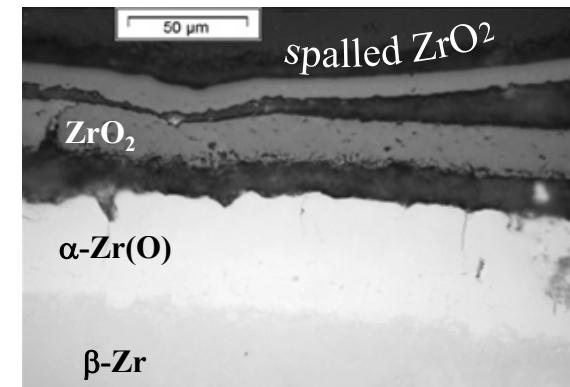
Q12 cladding: spalling of oxide scales due to breakaway effect

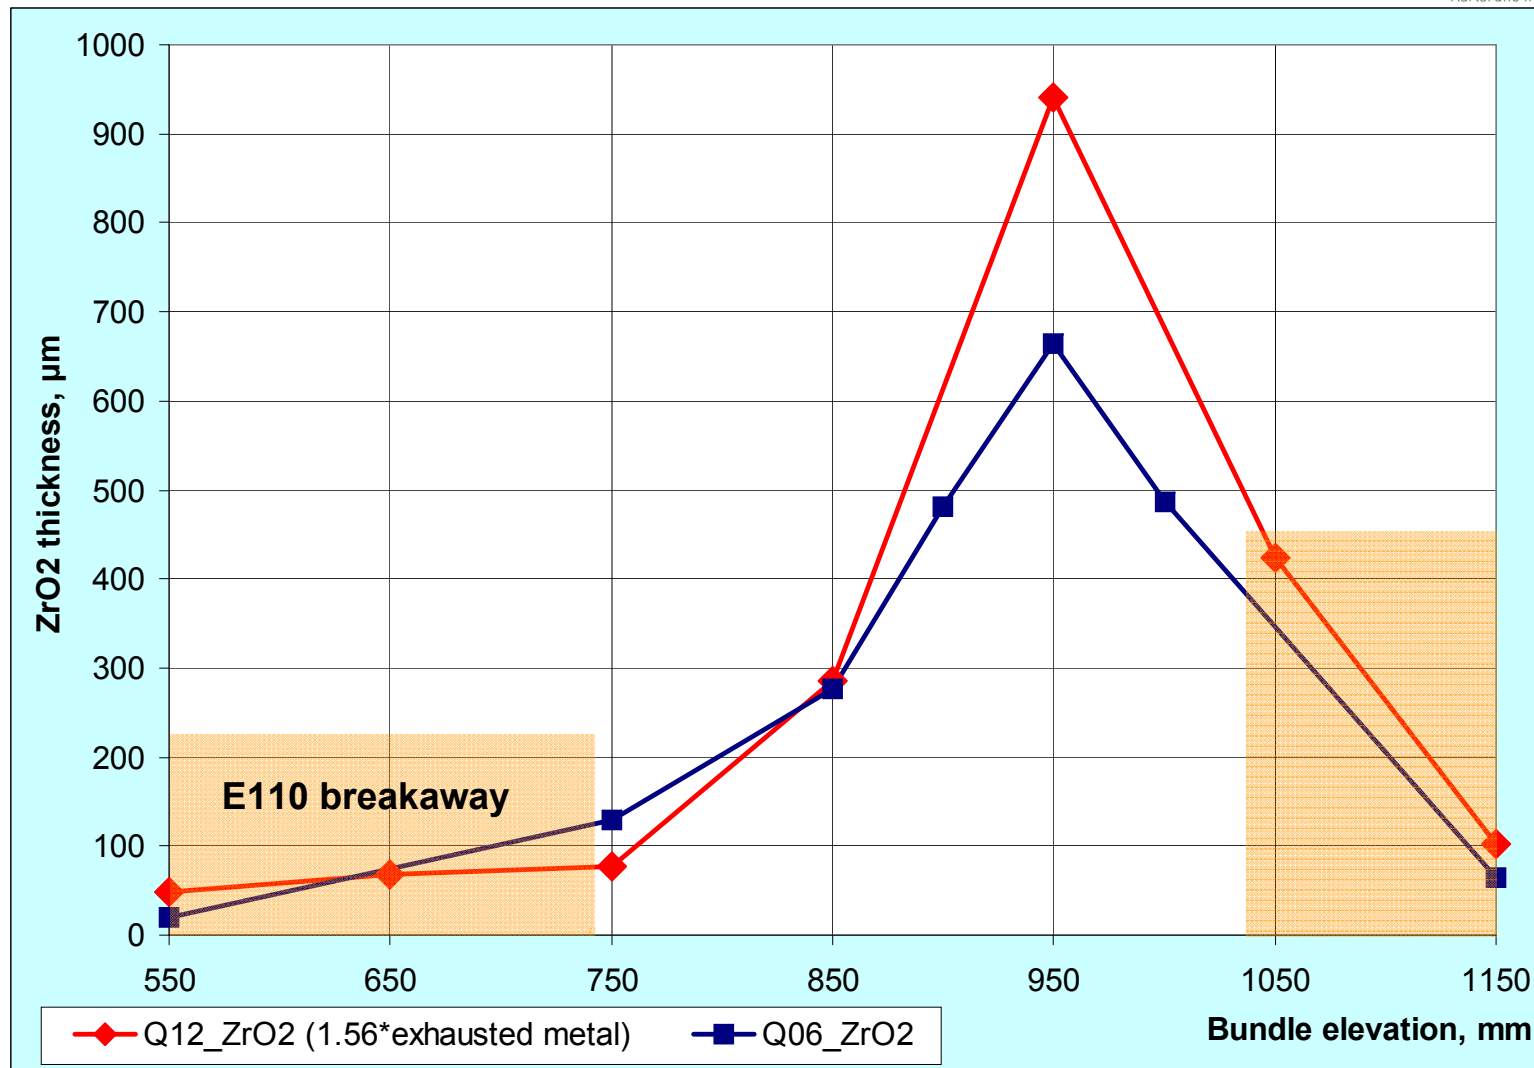
Comparison of averaging oxide cladding thicknesses for QUENCH-06 and QUENCH-12 at all elevations

Degree of cladding oxidation is mostly lower for QUENCH-06 (Zry-4) in comparison to QUENCH-12 (E110)

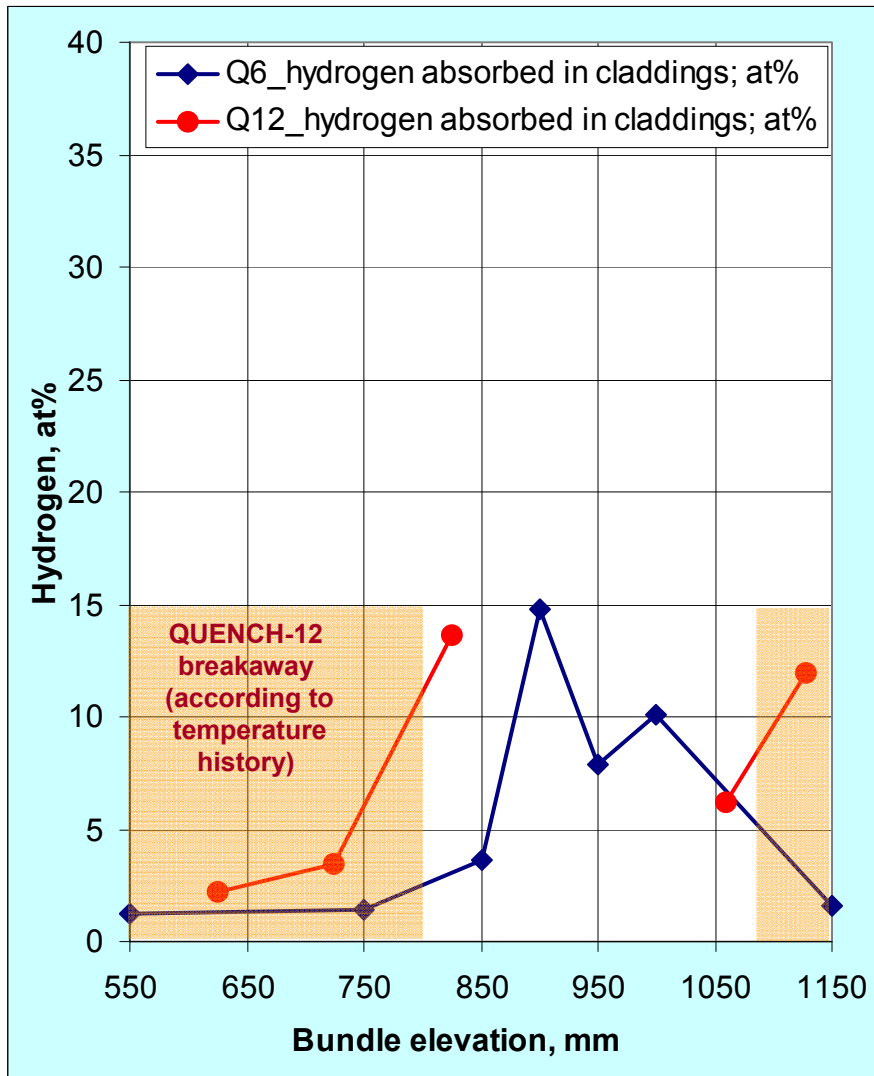
Q-06<->Q-12: H₂ uptake in cladding measured by hot extraction

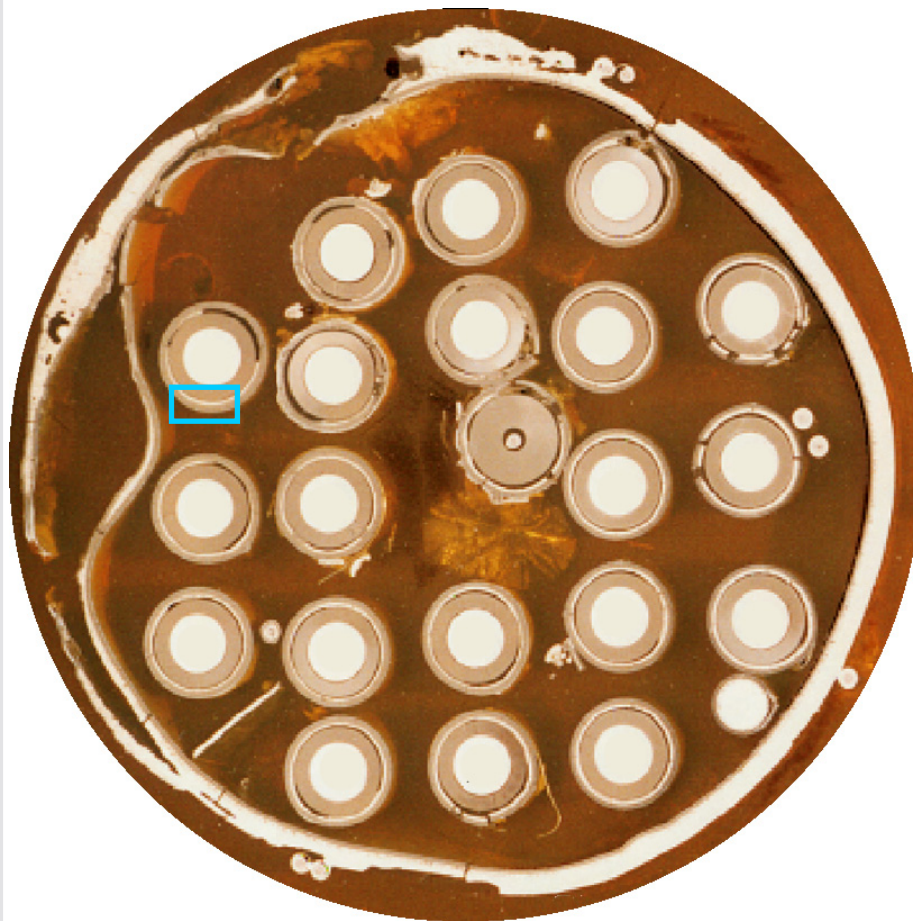
Other important phenomenon: melt formation and oxidation by
QUENCH-06 and QUENCH-12 at elevation 950 mm

**Q06 - bundle geometry intact->
good coolability;
melt localized between pellet and ZrO₂ layer**

- Melting point of claddings and shroud metal layer was reached at the peak temperature elevations of 950 – 1050 mm. Contrary to QUENCH-06, where melt was confined between pellets and the outer cladding oxide layer, the melt in QUENCH-12 has in places dissolved the surrounding oxide layer. As a result, non-coherent melt relocation, melt pool formation, and minor melt oxidation were observed.

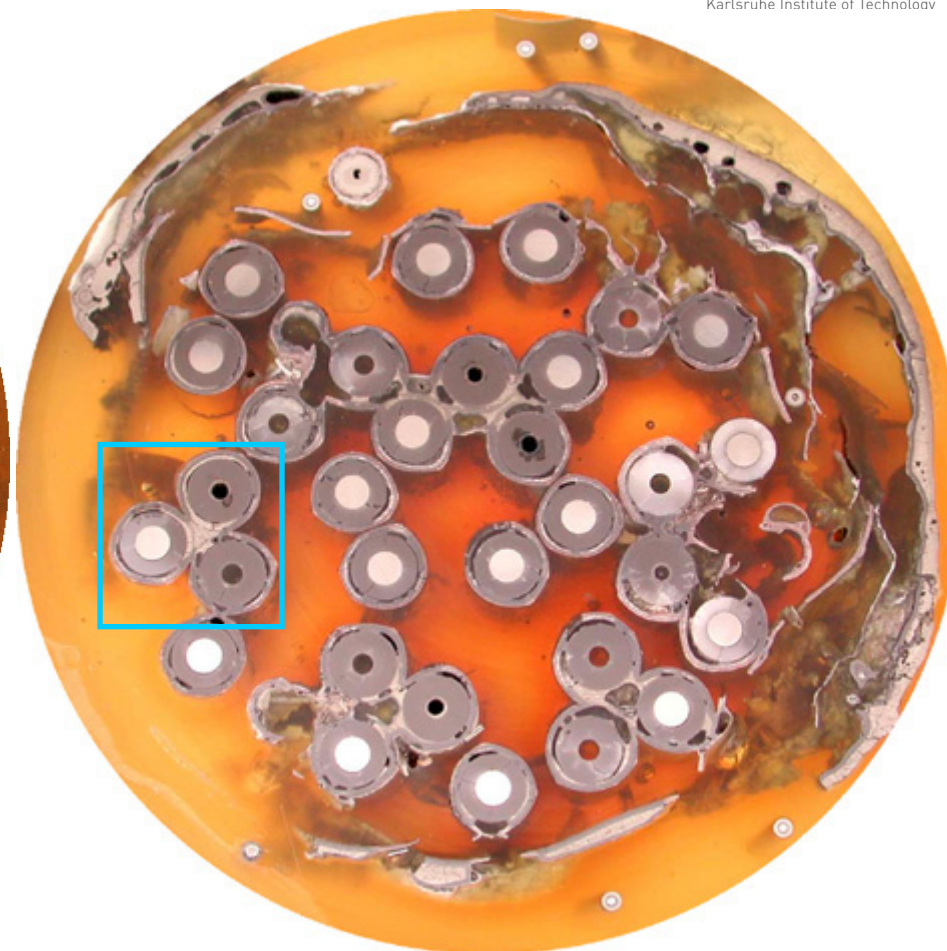
**Q12 - bundle geometry destroyed->
declined coolability;
molten pools formation inside rod clusters**

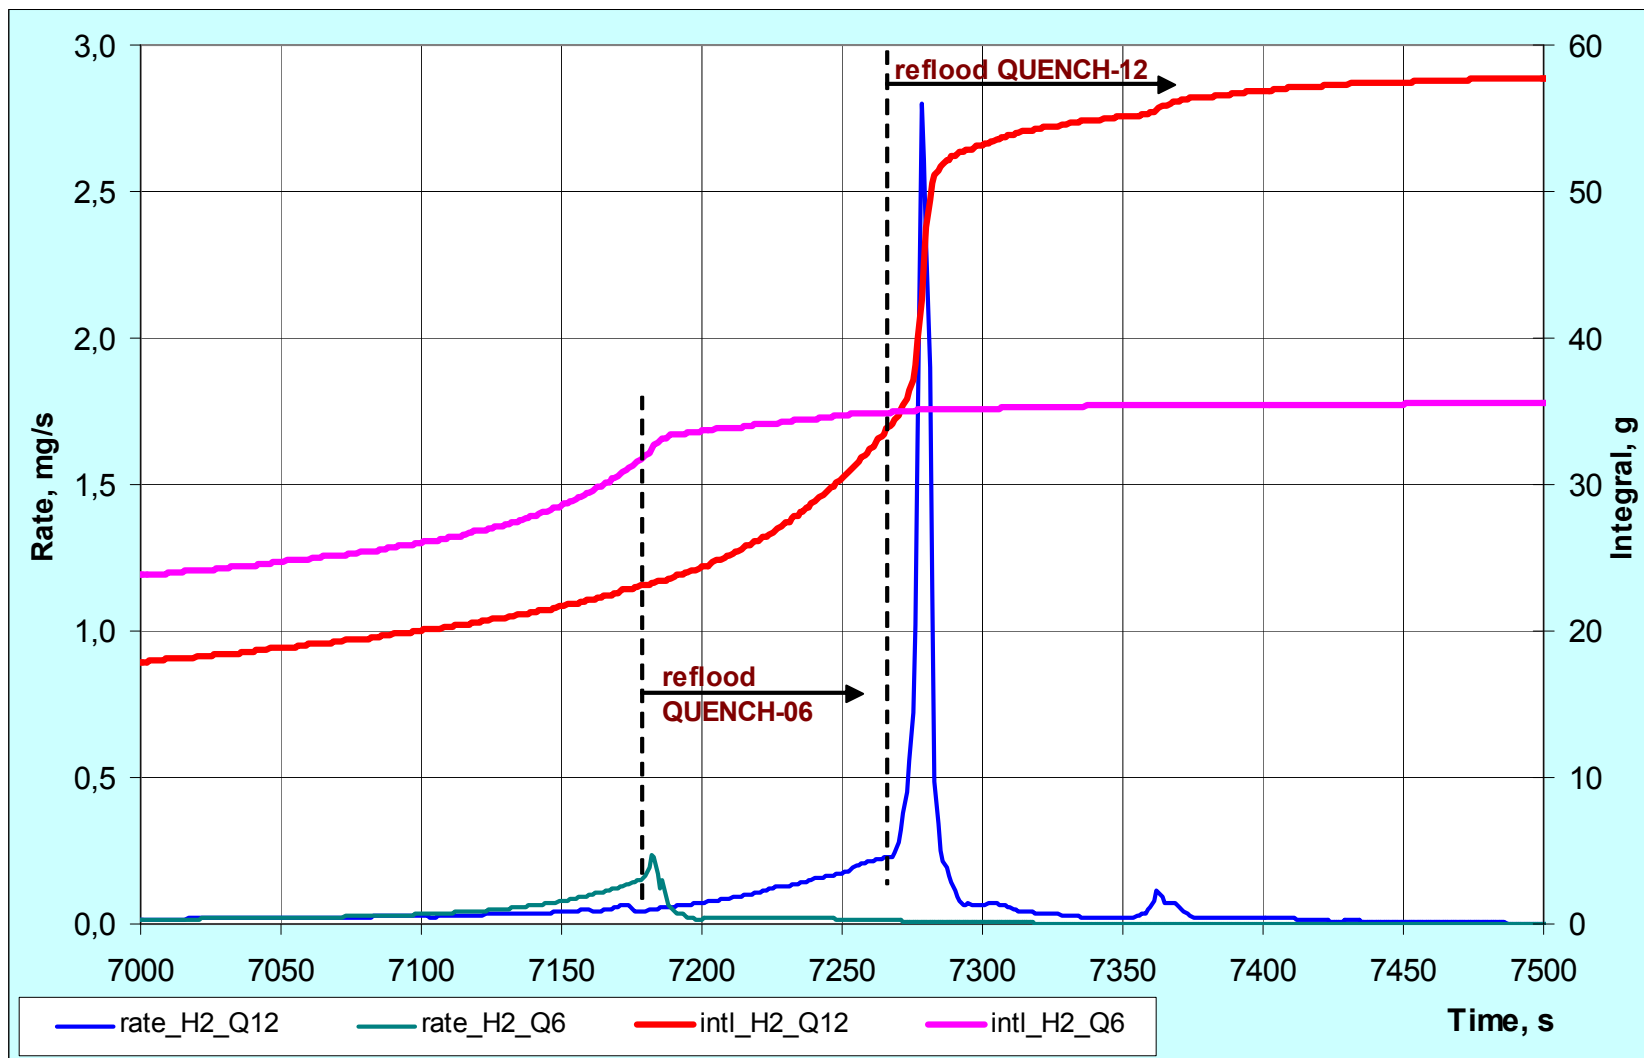
Comparison of hydrogen release during **QUENCH-12** and **QUENCH-06**

- The total hydrogen production was 58 g (QUENCH-06: 36 g), 24 g of which were released during reflood (QUENCH-06: 4 g). Three possible sources of increased hydrogen production during reflood: 1) interaction of steam with new metal surfaces developed by spalling of oxide scales damaged during pre-oxidation phase because breakaway effect; 2) release of hydrogen absorbed in metal by breakaway during pre-oxidation and transient phases; 3) moderate melt oxidation released into space between rods.

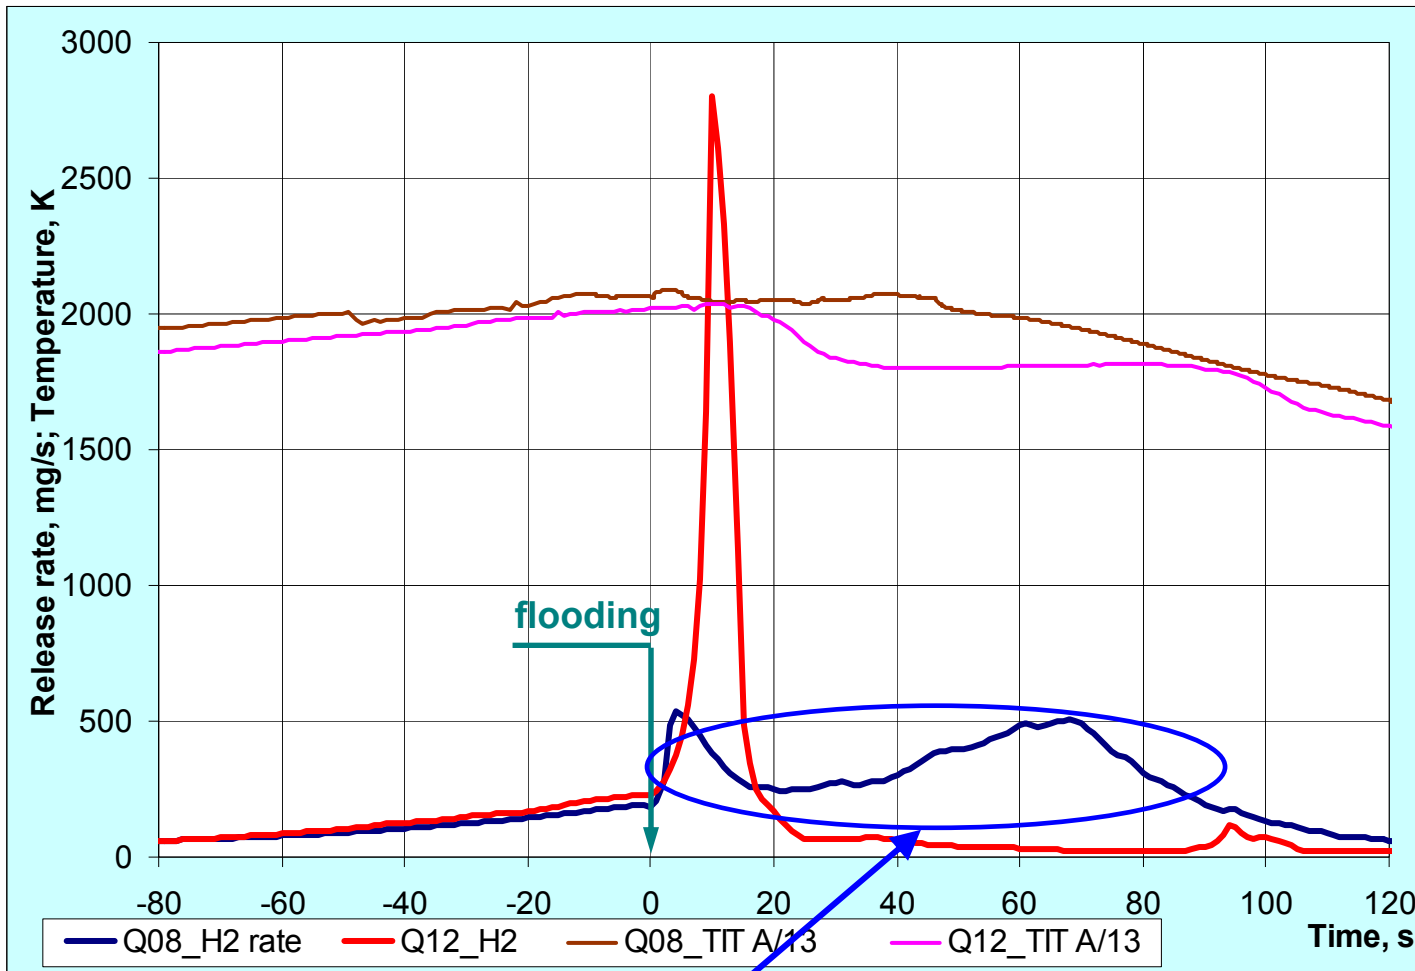
Comparison of hydrogen release during reflood
 for Q-08 test (oxidation before transient 270 μm ; significant melt oxidation)
 and Q-12 test (oxidation before transient 160 μm ; minor melt oxidation)

Long duration of hydrogen production during the quench phase in case of significant melt oxidation (Q-08)
