Experimental and Post-Test Calculation Results of the Integral Reflood Test QUENCH-12 with a VVER-type Bundle

Abstract – The QUENCH-12 experiment was carried out to investigate the effects of VVER materials (niobium-bearing alloys) and bundle geometry on core reflood, in comparison with test QUENCH-06 using western PWR materials (Zircaloy-4) and bundle geometry. While the PWR bundle uses a single unheated rod, 20 heated rods, and 4 corner rods arranged on a square lattice, with a heated length of 1000 mm, the VVER bundle uses 13 unheated rods, 18 heated rods and 6 corner rods, arranged on a hexagonal lattice. The test was conducted at the Forschungszentrum Karlsruhe on 27 September 2006 with largely the same protocol as QUENCH-06, in order to demonstrate the effects on the VVER characteristics more readily. The test protocol involved pre-oxidation to a maximum of about 200 µm oxide thickness at a temperature of about 1200 °C, followed by a power ramp until a temperature of 1800 °C was reached, then reflood with water at room temperature was initiated. The total hydrogen production was 58 g (QUENCH-06: 36 g), 24 g of which were released during reflood (QUENCH-06: 4 g). Reasons for

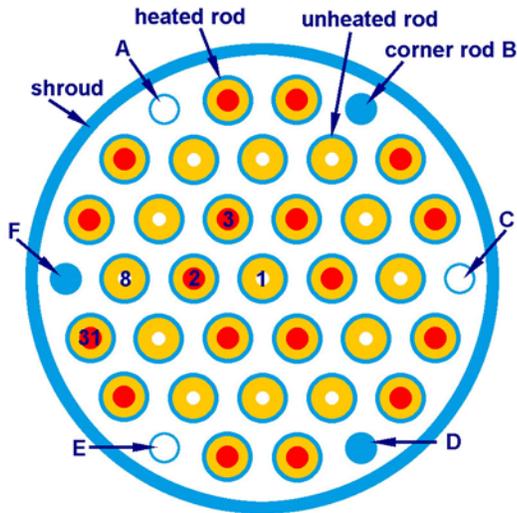
Fig. 2. Bundle cross-section with marked rods.

The test bundle is approximately 2.5 m long and is made up of 18 heated and 13 unheated fuel rod simulators (Fig. 2). Heating is electric by 4 mm diameter tungsten heaters installed in the rod center, and the heated length is 1.024 m.

Electrodes of molybdenum/copper are connected to the tungsten heaters at one end and to the cable leading to the DC electrical power supply at the other end. The distribution of the electric power within the two groups is as follows: 33 % of the power is released in the six inner fuel rod simulators, 67 % in the twelve outer fuel rod simulators.

The tungsten heaters of heated rods are surrounded by annular ZrO_2 pellets. The center hole of the unheated rods was used for installation of centerline thermocouples.

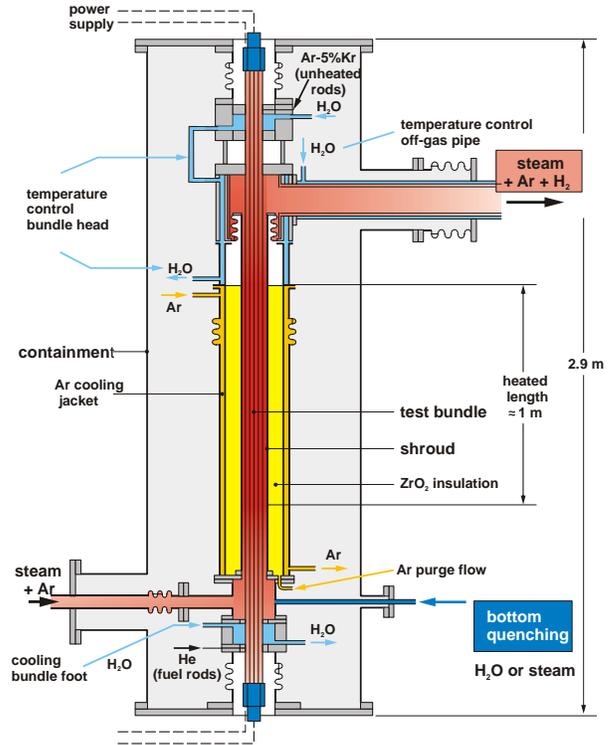
Fig. 1. QUENCH test section with test bundle and fluid lines.

In the forced-convection mode of the test facility, superheated steam from a steam generator and superheater together with argon as a carrier gas for gas measurements enter the test bundle at the bottom (Fig. 1). The argon, the steam not consumed, and the hydrogen produced in the zirconium-steam reaction flow from the bundle outlet at the top through a water-cooled off-gas pipe to the condenser where the steam is separated from the non-condensable gases. The system pressure in the test section is around 0.2 MPa. The test section has a separate inlet at the bottom to inject water for reflood.

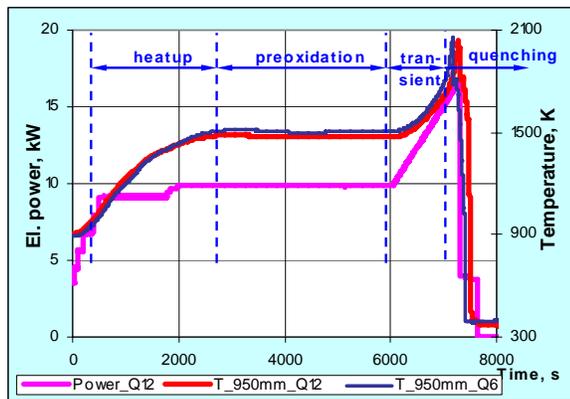
Fig.3. Temperature at the 0.95 m level (Q12: TFC 1/13; Q6: TIT A/13) and electric power vs. time together with an indication of the QUENCH-12 test phases.

The main test phases of the QUENCH-12 experiment are shown in Fig. 3 and summarized below.

- Phase I Stabilization at ~620 °C. Facility checks.
- Phase II Heatup by ~0.3-0.7 K/s to ~1200 °C for ~48 min (first transient).
- Phase III **Pre-oxidation** in a flow of 3.3 g/s of superheated steam and 3.3 g/s argon for ~53 min at a relatively constant temperature of ~1200 °C.
- Phase IV **Transient** heatup from ~1200 to 1800 °C with a heating rate of ~0.3-2.5 K/s for 20.5 min.
- Phase V **Quenching** of the bundle from the bottom by a water flow of 48 g/s.

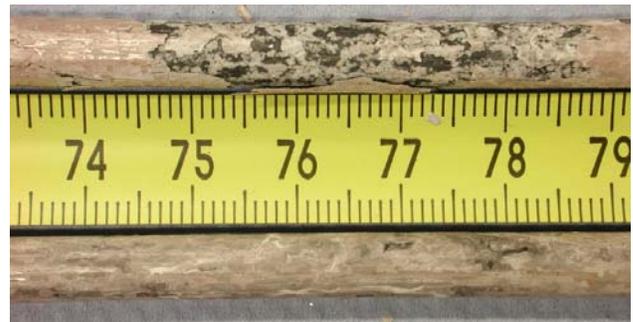
Fig. 4. The withdrawn corner rods D (lower) and F (upper) revealed breakaway oxidation with intensive spalling of oxide scales.

Pre-oxidation of the bundle was carried out to achieve the target cladding oxidation of around 200 μm at the upper end of the heated zone. The first corner rod D, which was withdrawn at the end of the pre-oxidation phase, revealed an extensive breakaway oxidation along the complete hot zone. It was not possible to measure the oxide layer thickness due to spalling of the oxide scales (Fig. 4). The second corner rod F was withdrawn during the transient phase before starting the moderate temperature escalation. This rod also exhibited an extensive spalling of oxide scales.

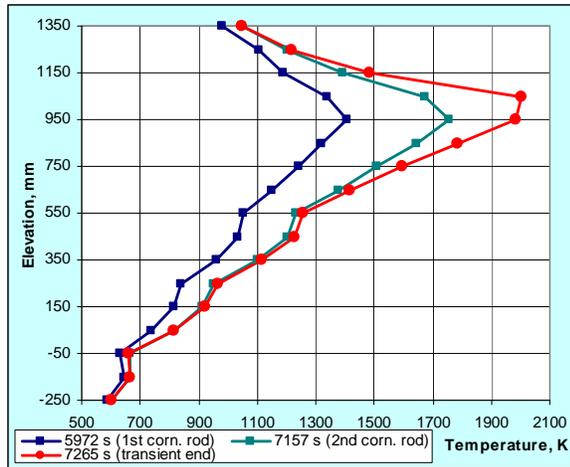
Fig. 5. Axial temperature profiles during pre-oxidation and transient phases.

The power was ramped after pre-oxidation at a rate of 5.1 W/s in order to increase the temperature until the desired maximum temperature of 1800 °C before quench was reached. The axial temperature distributions given in Fig. 5 for three different times before reflood show that the hottest bundle zone was located between 0.85 and 1.05 m.

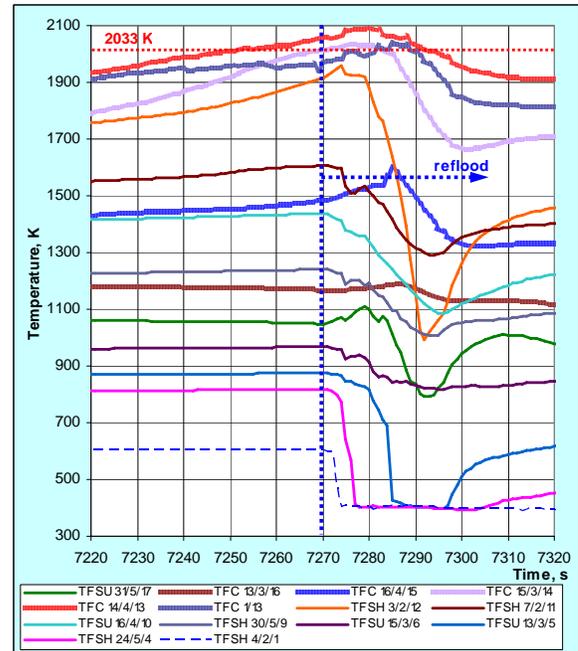
Fig. 6. Selected readings of bundle thermocouples between elevations 1 (-0.25 m) and 17 (1.35 m). Marking of thermocouples: rod number/rod group/elevation.

Then, reflood with 48 g/s of water at room temperature was initiated starting with a rapid filling of the lower plenum of the test section. The electrical power was reduced to 4 kW during the reflood phase, thus approximating effective decay heat levels. Following the initiation of reflood, a moderate temperature excursion of about 50 K was observed for 15 s, i. e. over a longer period than in QUENCH-06. Some temperatures exceeded for a short period the melting point of the β -Zr before reflood (2033 K, Fig. 6).

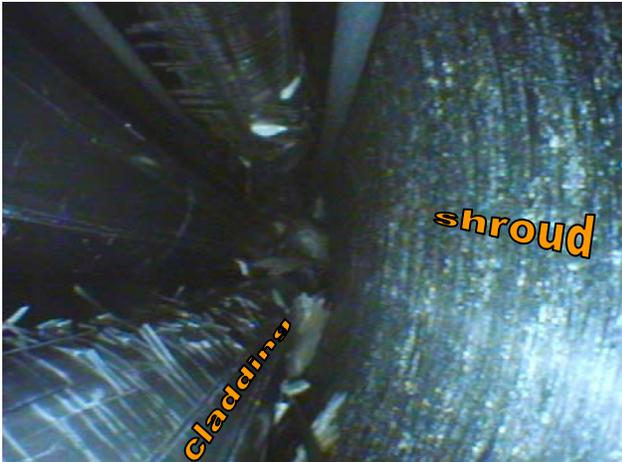
Fig. 7. Videoscope observation at bundle elevation 0.40 m at the empty position of corner rod F: circumferential spalling of the oxide layer on the surface of fuel rod simulator cladding.

The QUENCH-12 bundle was investigated in detail by videoscope before filling with epoxy resin. As the metallographic investigation of the epoxy filled bundle is a selective 2-D method, the videoscope allows continuous 3-D observations. Scanning by the videoscope camera at the positions of withdrawn corner rods revealed differences in the surface morphology. The lowest elevation where breakaway oxidation of cladding surface took place was at 0.40 m (Fig. 7). The maximum temperature at this bundle position was about 850 $^{\circ}\text{C}$.

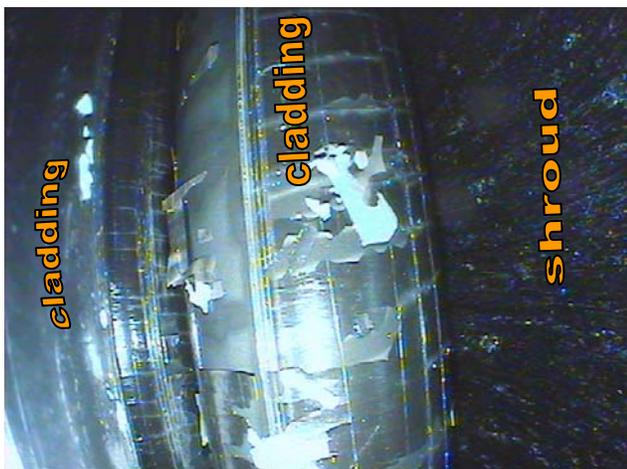
Fig. 8. Videoscope photograph with a side-view lens at elevation 0.40 m: dark inner oxide sub-layer at cladding surface.

The spalled oxide scales were partially removed by pull-out of the videoscope from the bundle. The videoscope was re-inserted with a side view camera lens at the same axial position of corner rod channel D showing formation of regular dark oxide layer under the spalled oxide scales (Fig. 8).

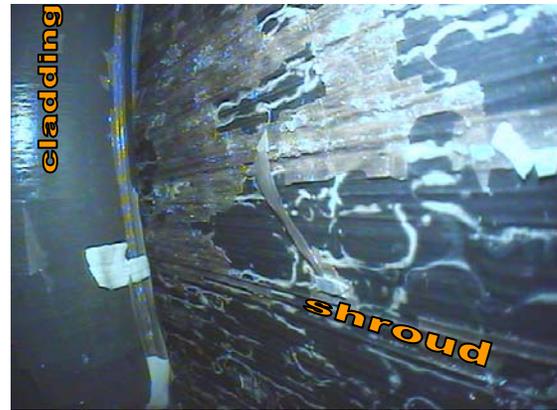
Fig. 9. Videoscope photograph with a side-view lens at elevation of 0.70 m: intensive oxide scale spalling on the coarse shroud surface.

The formation of typical breakaway oxidation at the relatively cooler shroud took place at higher elevations. The initially coarse shroud surface revealed thicker spalled oxide scales, but the oxide sub-layer showed also the regular dark structure (Fig. 9). The inner shroud surface showed at the higher hottest elevations a nodular kind of breakaway oxidation, whereas there is no evidence of breakaway on the cladding surface at these elevations (Fig. 10). However the formation of longitudinal and circumferential cladding cracks in the hot bundle zone (0.70-1.00 m) is typical for Zircaloy-4 cladding as well.

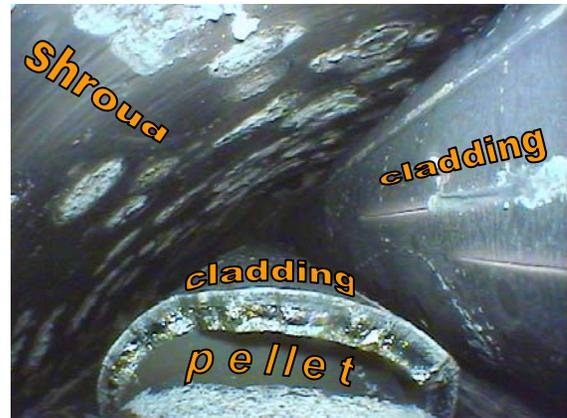
Fig. 10. Videoscope photograph at elevation of 0.90 m: circumferential and longitudinal cracks at the cladding; nodular breakaway corrosion at the shroud.

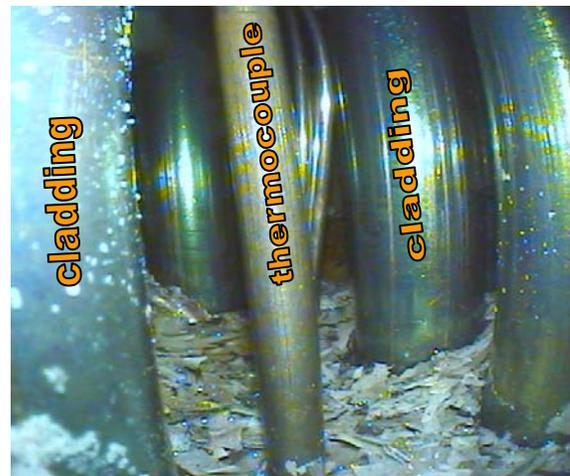
Fig. 11. Spalled oxide scales as debris at the bundle bottom.

Most of the debris due to oxide scale spalling accumulated at the bottom of the bundle (Fig. 11) and at the upper edge of spacers.

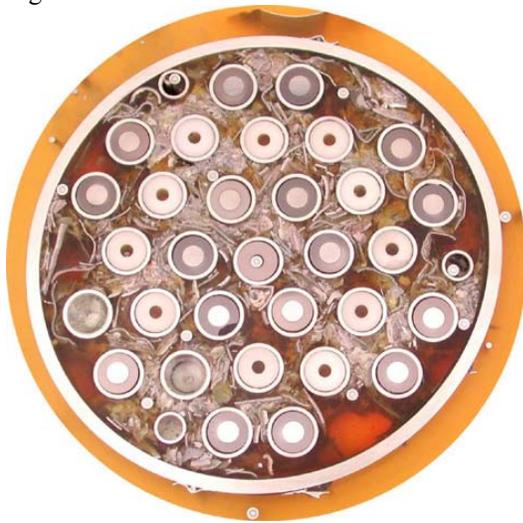
Fig. 12. Cross section overview at 0.55 m elevation.

Overview of top side of the cross-section from elevation 0.55 m is depicted in Fig. 12. This surface corresponds to upper edge of the third grid spacer. Very many rubble fragments can be distinguished, obviously collected on top of the spacer grid. The relocated rubble consists of partial cladding scale shells and fragments of partially oxidized cladding.

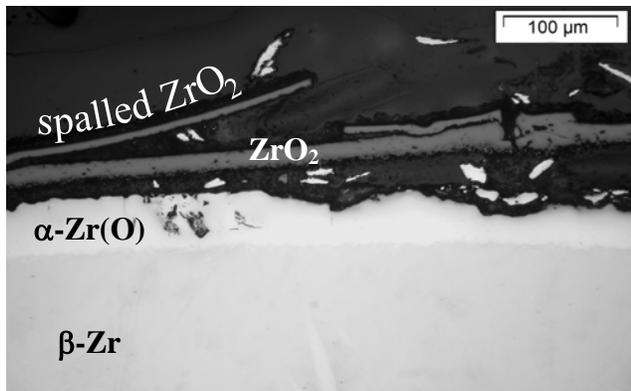
Fig. 13. Oxidation of the central rod at elevation 0.55 m: spalling of oxide scales due to breakaway effect

Fig. 13 illustrates the cladding oxidation of the central rod. An earlier grown partial layer of the scale tends to spall from a thicker next one which is found split from the α -Zr(O) layer.

At the given elevation (0.55 m) the temperatures during the pre-oxidation period were about 1050 K, which is the lowest value of the breakaway range for the E110 alloy⁴. But the temperature rise from 1050 K to 1200 K during the transient test phase was not sufficient to leave the breakaway regime later on. For the other upper elevations the typical breakaway temperatures were experienced mainly during the pre-oxidation period.

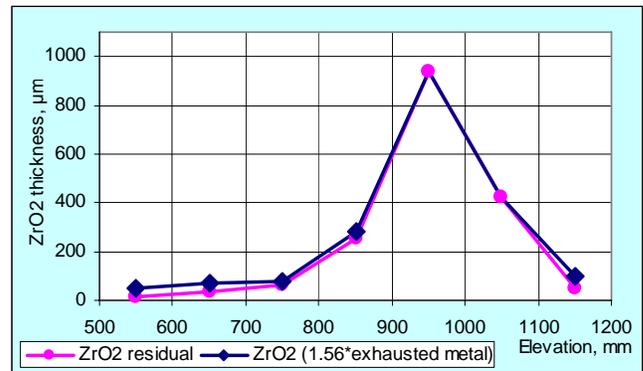
Fig. 14. Cladding oxidation: measured residual oxide and oxide calculated on the base of residual metal.

In order to take into account the breakaway loss of scales for the elevations 0.55, 0.65, 0.75, 0.85 and 0.115 m, an evaluation of thickness measurement results for the simulator rods was performed. A calculated average oxide layer thickness for the respective elevations was gained as follows. Subtraction of the measured average remaining metal thickness value from the original tube wall thickness, nominally 700 μm , gives the consumed metal thickness. Multiplication of this by the Pilling-Bedworth factor 1.56 gives the corresponding calculated oxide layer thickness, used as basis for quantification of the lost partial scale thickness in addition to that of the measured remaining scale (Fig. 14).

The pronounced breakaway effect at elevations 0.55 m, 0.65 m, 0.105 m provoked much more intensive original bundle oxidation in comparison to reference test QUENCH-06. Indeed the estimated total oxide layer thickness at elevations 0.55 m was about $80 \pm 11 \mu\text{m}$ for QUENCH-12 and only $20 \pm 1 \mu\text{m}$ for QUENCH-06. The high scatter in QUENCH-12 was due to the relatively large lateral temperature differences in this test.

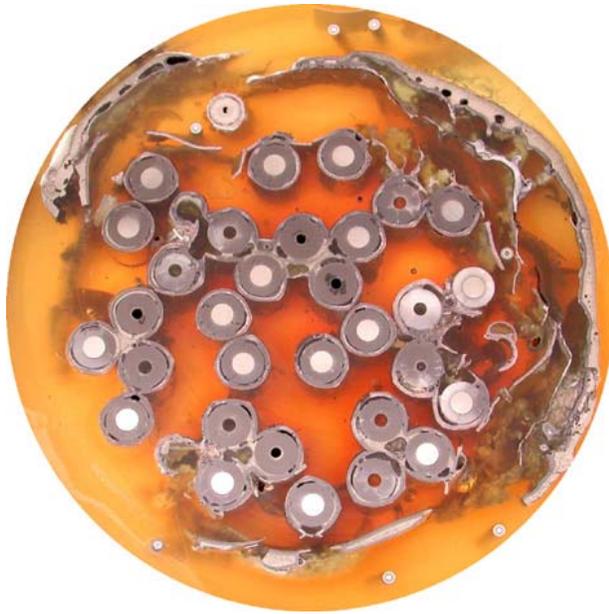
Fig. 15. Cross section overview at 0.95 m elevation.

The melting temperature of the cladding alloy matrix ($> 1900 \text{ K}$) was exceeded at elevation 0.95 m. Fig. 15 gives an impression of the bundle degradation state at this elevation. On the one hand the cladding oxidation and the cladding brittleness are much more advanced than at the adjacent elevations. On the other hand there are several rod groups, which are bound together in clusters due to formation of common melt pools. Neck formation between rods and parts of the inner shroud structure took place.

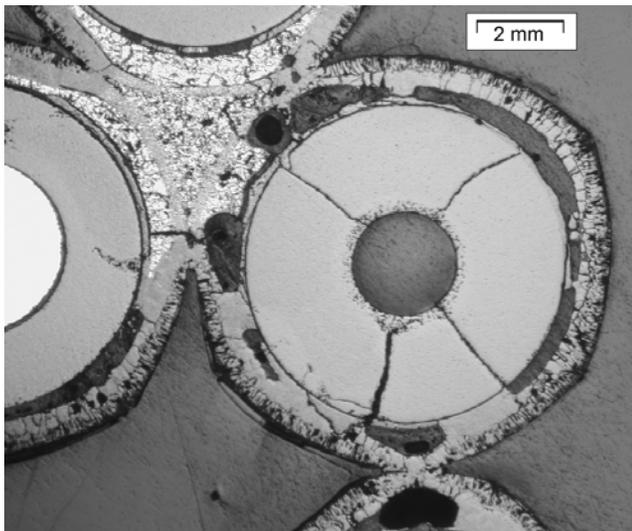
Fig. 16. Melt pool formation via necking mechanism

An example of such a melt pool is depicted in Fig. 16. Some metallic melt remains at rods 8 and 31, whereas most of the cladding of rod 19 rod is fully oxidized. The rounded shape of voids indicates loss of melt by downward relocation. The other part of released metallic melt, enclosed by rods 8, 31, and 19, is captured within the triangular space between the claddings. The embedded oxide scale segments have been thinned by oxygen transfer to the melt from outer and inner side.

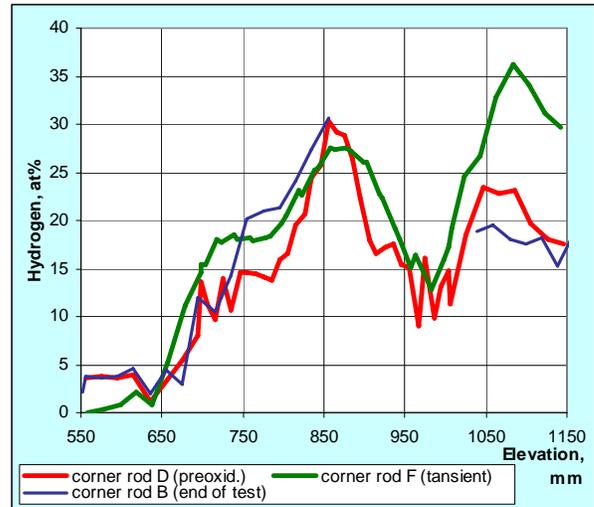
Fig. 17. Hydrogen uptake by the corner rods obtained by neutron radiography.

Hydrogen uptake by the corner rods was measured by neutron radiography at PSI. The hydrogen content in the corner rods reached a maximum of 35 at% at the bundle elevation of about 1.10 m (Fig. 17).

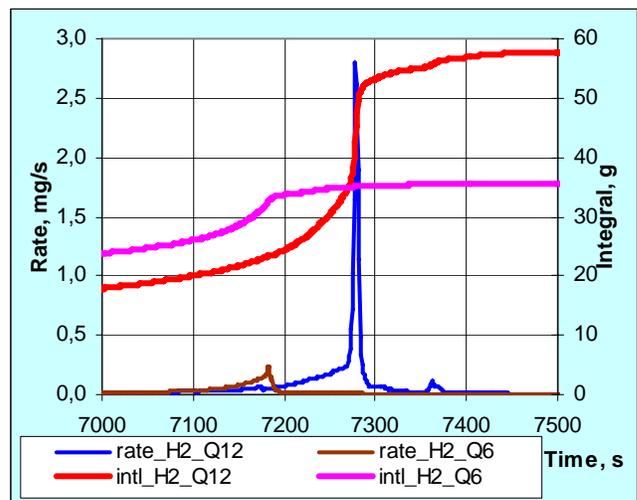
Fig. 18. Comparison of hydrogen release during QUENCH-12 and QUENCH-06.

Measurements of hydrogen production are as follows: 34 g were released during the pre-oxidation and transient phases and about 24 g in the quench phase. The amount released in the quench phase is six times higher than in QUENCH-06 with ~4 g (Fig. 18). The reasons for the increased hydrogen production may be extensive damaging of the cladding surfaces due to the breakaway oxidation, local melt formation with subsequent melt oxidation, and a release of previously picked-up hydrogen.

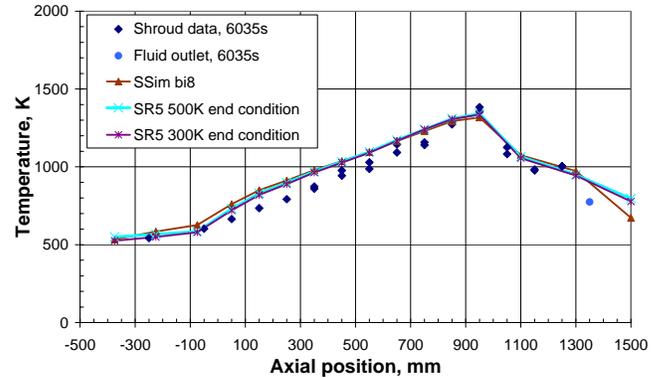
Fig. 19. Axial temperature profile on shroud.

As a preliminary, supporting calculations were also performed with various slightly adjusted end conditions and using SCDAPSIM, all with the E110 correlation. Fig. 19 compares the axial temperature profiles from those complementary calculations at a time shortly before quench initiation, with the measured data. In fact the cases are rather similar, the main difference occurring towards to top and bottom of the bundle. The agreement is excellent at 0.95 m but with some distortion of the profile.

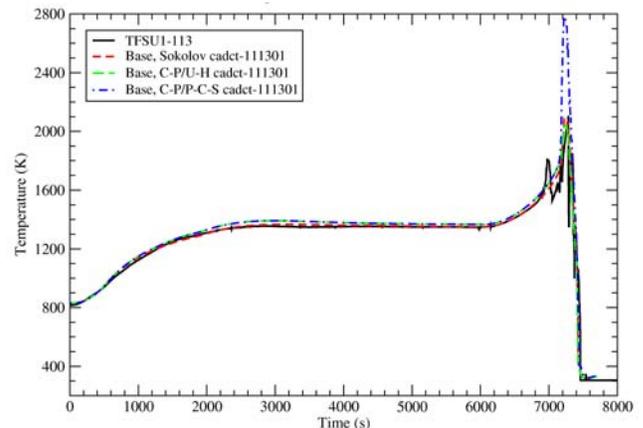
Fig. 20. Temperature at 0.95 m elevation on central rod.

Figs. 20 and 21 compare the results using the three correlations with the measured temperatures at the hottest elevation (0.95 m) of the central rod and shroud, respectively. All of the cases are close to the data during the plateau, with almost perfect agreement with the E110 correlation and only a very slightly higher temperature with Cathcart-Pawel. The E110 correlation leads to a sharper increase than U-H during the transient phase just before quench initiation, but with little impact on the temperature at that time. P-C gives a large overestimate in temperature just prior to quench. However, all three cases exhibit rapid cooling and quenching at almost the same time. The results for bundle refilling and quench progression for the E110 case are compared with the data in Fig. 22, while the other cases are somewhat similar. The time offset is due to the 50 s earlier quench initiation adopted in the calculation. The observed water ingress during the fast refill phase is typical of QUENCH experiments but is not calculated. The slow-down of the refill and quenching above 0.95 m is explained by the breach in the shroud which had occurred already at that elevation.

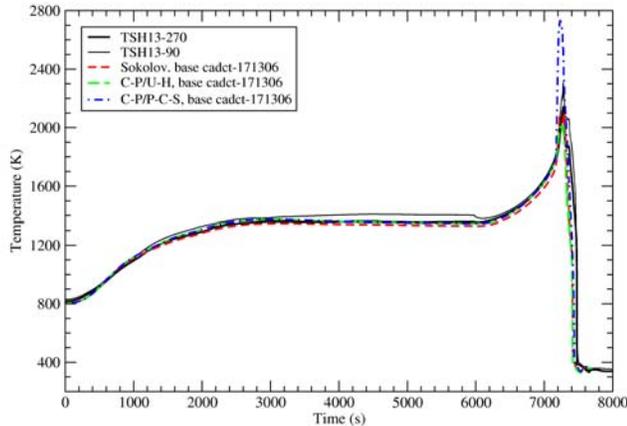
Fig. 21 Temperature at 0.95 m elevation on shroud.

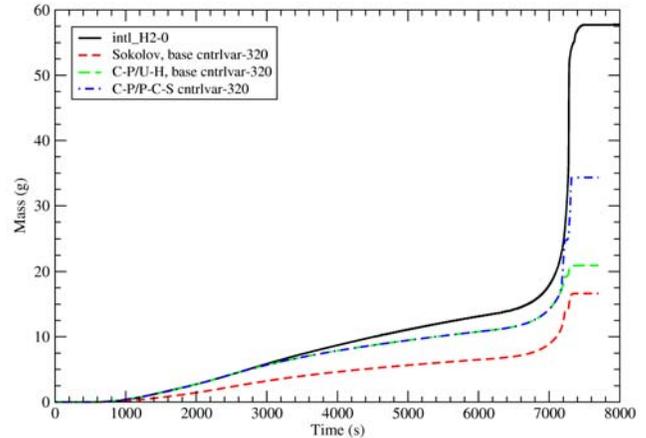
Fig. 23. Calculated and measured hydrogen generation.

Despite the similar thermal response through almost the entire sequence, all of the calculations underestimated the oxidation, as can be seen in Fig. 23. The E110 correlation gives a much lower hydrogen generation during the plateau phase of the experiment, although the final mass is similar to the C-P/U-H case due to greater oxidation just before and during quench. The C-P/P-C correlation gives the closest agreement for hydrogen mass, including a significant oxidation during quench, but the rate is overestimated in the period just before while the total mass is still underestimated overall.

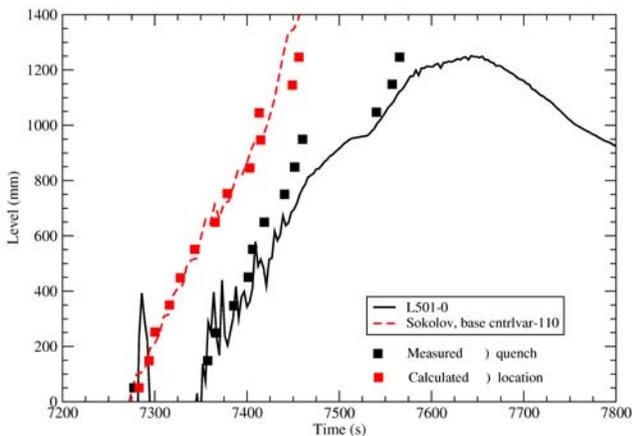
Fig. 22. Calculated and measured liquid level and quench progression.

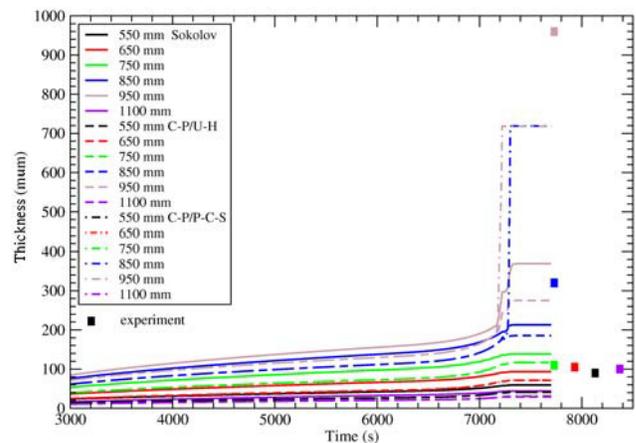
Fig. 24. Calculated and measured oxide scale thickness.

Although the E110 correlation gives a lower oxidation rate than C-P/U-H, the oxide thickness is greater. In fact the correlations for oxidation rate and oxide thickness are derived separately from weight gain and scale thickness measurements. The thicker oxide scale calculated by the E110 correlation suggests an inconsistency with the oxidised mass, or else evidence of a very low oxide density. Even so, Fig. 24 shows an underestimate over most of the oxidised length.
