RESULTS OF THE QUENCH-12 REFLOOD EXPERIMENT WITH A VVER-TYPE BUNDLE

Keywords: severe accident, core reflow, niobium-bearing cladding, breakaway oxidation, hydrogen source term.

ABSTRACT

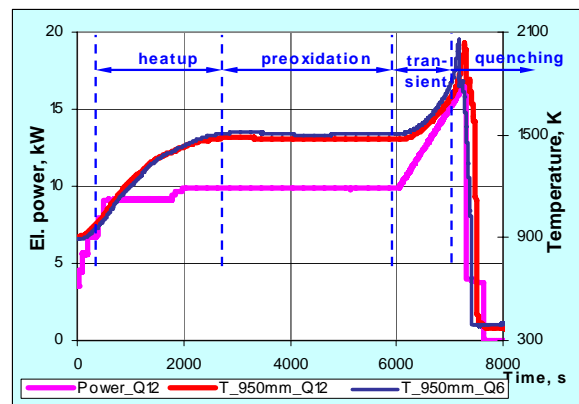
Fig.3. Temperature at the 0.95 m level (Q12: TFC 1/13; Q6: TIT A/13) and electric power vs. time together with an indication of the QUENCH-12 test phases.

The main test phases of the QUENCH-12 experiment are shown in Fig.3 and summarized below.

- Phase I Stabilization at ~620 °C. Facility checks.
- Phase II Heatup by ~0.3-0.7 K/s to ~1200 °C for ~48 min (first transient).
- Phase III **Pre-oxidation** in a flow of 3.3 g/s of superheated steam and 3.3 g/s argon for ~53 min at a relatively constant temperature of ~1200 °C.
- Phase IV **Transient** heatup from ~1200 to 1790 °C with a heating rate of ~0.3-2.5 K/s for 20.5 min.
- Phase V **Quenching** of the bundle from the bottom by a water flow of 48 g/s.

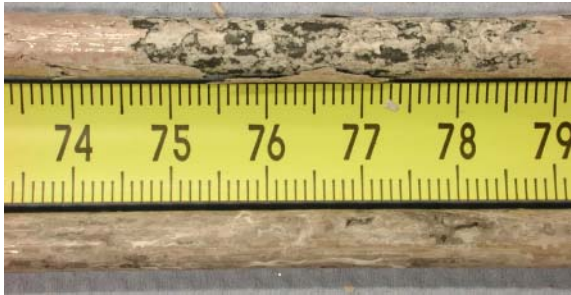
Fig. 4. The withdrawn corner rods D (lower) and F (upper) revealed a breakaway oxidation with intensive spalling of oxide scales.

Pre-oxidation of the bundle was carried out to achieve the target cladding oxidation of around 200 μm at the upper end of the heated zone. The first corner rod D, which was withdrawn at the end of the pre-oxidation phase, revealed an extensive breakaway oxidation along the complete hot zone. It was not possible to measure the oxide layer thickness due to spalling of the oxide scales (Fig.4). The second corner rod F was withdrawn during the

transient phase before starting the moderate temperature escalation. This rod also exhibited an extensive spalling of oxide scales.

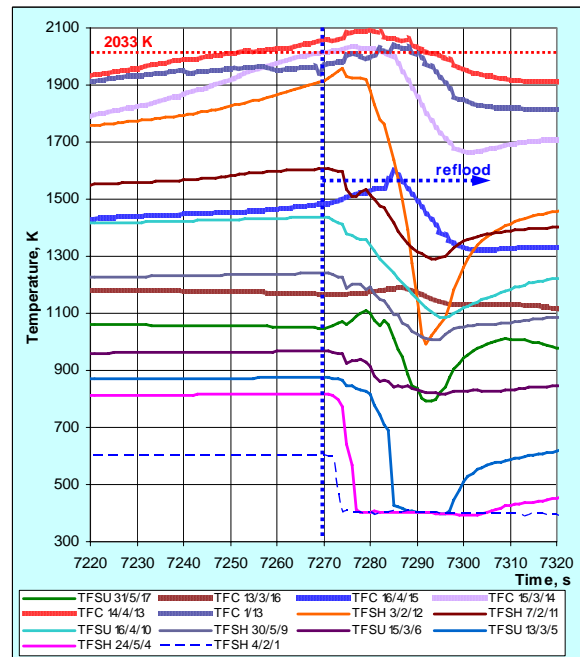
Fig. 6. Selected readings of bundle thermocouples between elevations 1 (-0.25 m) and 17 (1.35 m). Marking of thermocouples: rod number/rod group/elevation.

Then, reflow with 48 g/s of water at room temperature was initiated together with a rapid filling of the lower plenum of the test section. The electrical power was reduced to 4 kW during the reflow phase, thus approximating effective decay heat levels. Following the initiation of reflow, a moderate temperature excursion of about 50 K was observed for 15 s, i. e. over a longer period than in QUENCH-06. Some temperatures exceeded for a short period the melting point of the β -Zr before reflow (2033 K, Fig. 6).

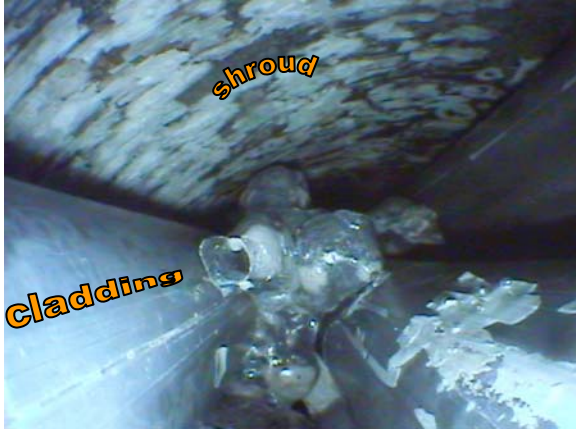
Fig. 8. Videoscope photograph at bundle elevation of 0.88 m: solidified melt of β -Zr part of corner rod B.

Only the lower and upper part of the corner rod B could be withdrawn. At the positions of rod rupture, i. e. at the bundle elevations of 0.88 and 1.01 m, melting of the rod inner β -Zr structure was observed. Fig. 8 demonstrates solidified melt which stems from the missing part of the corner rod B.

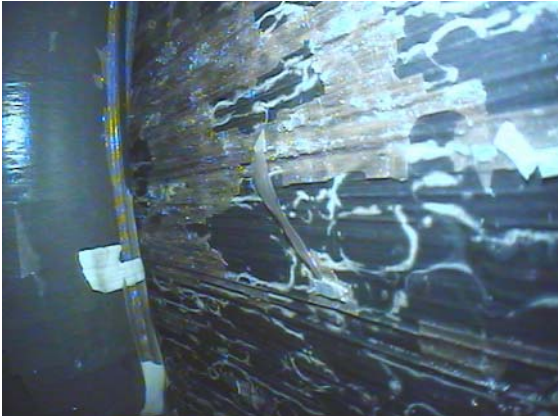
Fig. 12. Videoscope photograph with a side-view lens at elevation of 0.70 m: intensive oxide scale spalling on the coarse shroud surface.

The spalled oxide scales were partially removed by pull-out of the videoscope from the bundle. The videoscope was re-inserted with a side view camera lens at the same axial position of corner rod channel D showing a formation of regular dark oxide layer under spalled oxide scales (Fig. 11). The formation of typical breakaway oxidation at the relatively cooler shroud took place at higher elevations. The initially coarse shroud surface revealed thicker spalled oxide scales, but the oxide sub-layer showed also the regular dark structure (Fig. 12). The inner shroud surface showed at the higher hottest elevations a nodular kind of breakaway oxidation, whereas there is no evidence of breakaway on the cladding surface at these elevations (Fig. 13).

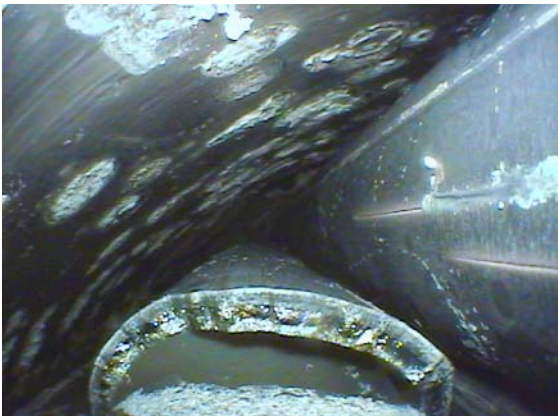
Fig. 13. Videoscope photograph at elevation of 0.90 m: circumferential and longitudinal cracks at the cladding; nodular breakaway corrosion at the shroud.

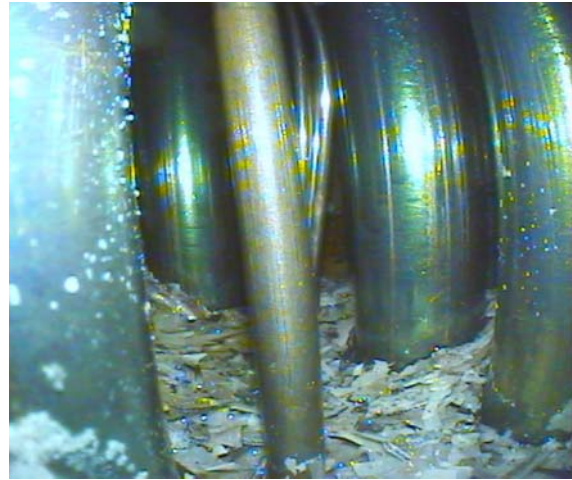
Fig. 14. Spalled oxide scales as debris at the bundle bottom.

Most of the debris due to oxide scale spalling accumulated at the bottom of the bundle (Fig. 14) and at the upper edge of spacers.

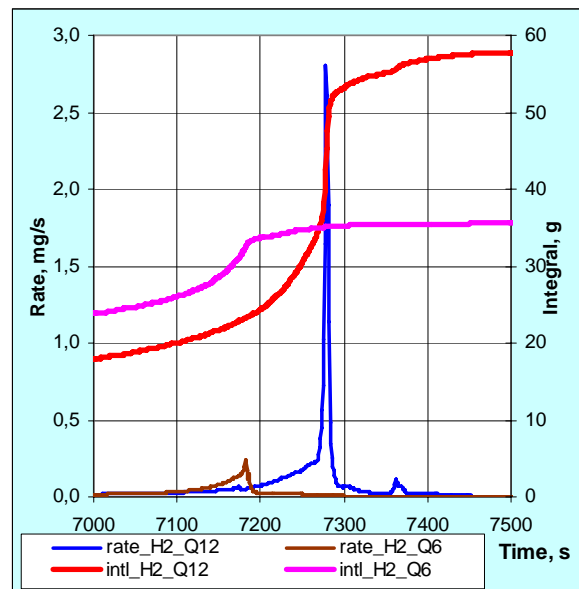
Fig. 15. Comparison of hydrogen release during QUENCH-12 and QUENCH-06.

Preliminary figures for hydrogen production are 34 g in the pre-oxidation and transient phases and about 24 g in the quench phase; the amount released in the quench phase is six times higher than in QUENCH-06 with ~4 g (Fig. 15). This may be attributed partly to the longer excursion time in QUENCH-12. Other reasons for the increased hydrogen production may be extensive damaging of the cladding surfaces due to the breakaway oxidation and local melt formation with subsequent melt oxidation.

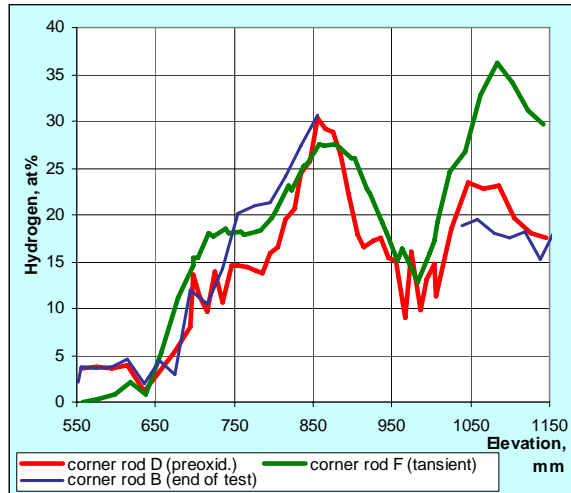
Fig. 16. Hydrogen uptake by the corner rods obtained by neutron radiography.

Hydrogen uptake by the corner rods was measured by neutron radiography at the Paul Scherrer Institute. The hydrogen content in the corner rods reached a maximum of 35 at% at the bundle elevation of about 1.10 m (Fig. 16).
