Experimental Results of Reflood Bundle Test QUENCH-15 with ZIRLO™ Cladding Tubes

*J. Stuckert, M. Große, L. Sepold, M. Steinbrück
Karlsruher Institut für Technologie / Institut für Materialforschung*

Objectives of the QUENCH-15 test

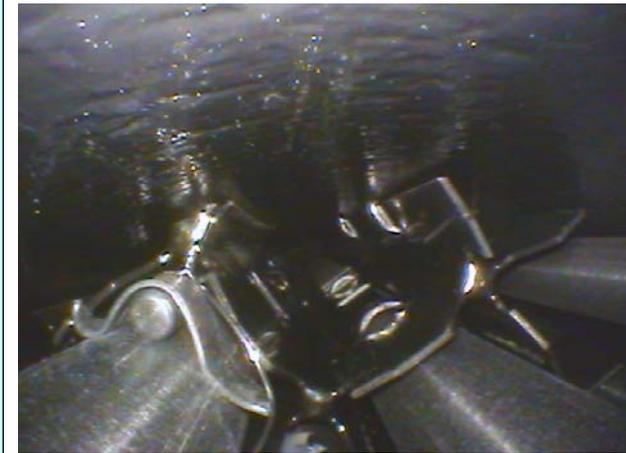
elev. 1150 mm

Pretest to adjusting of calculation parameters

post-pretest videoscope inspection: intact rods, spacer grids and thermocouples

ZrO₂ layer thickness after pretest: 2 μm

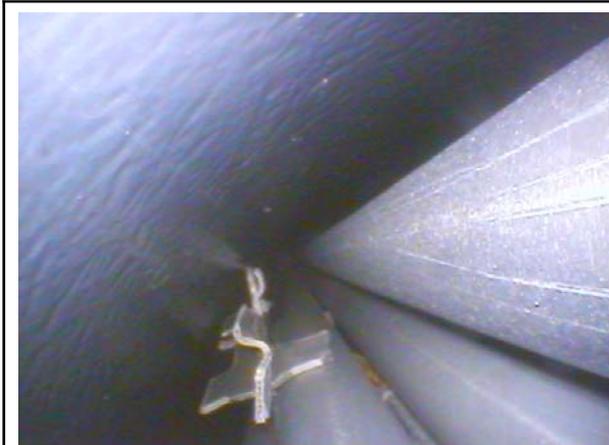
QUENCH-15: Videoscope photos at the location of withdrawn corner rod A: 1) cladding failures, 2) no melt observation

700 mm, relocated part of grid spacer 4

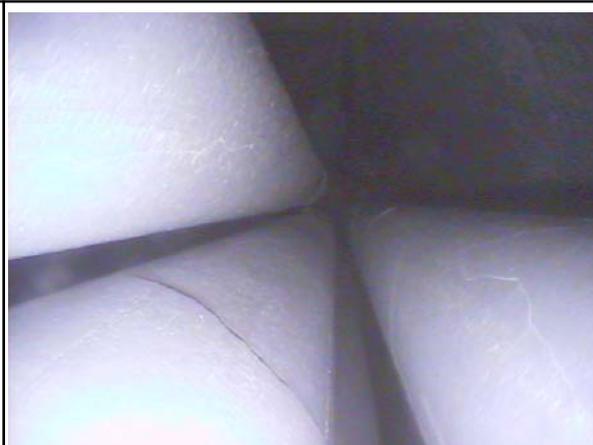
900 mm, circumferential and longitudinal cracks of the fuel rod cladding

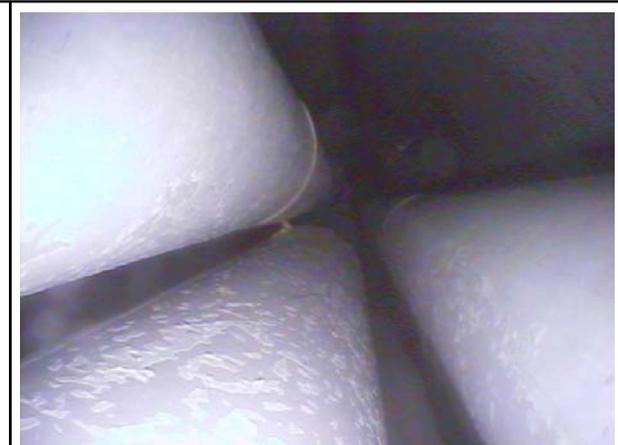
930 mm, spalling of thin oxide scales

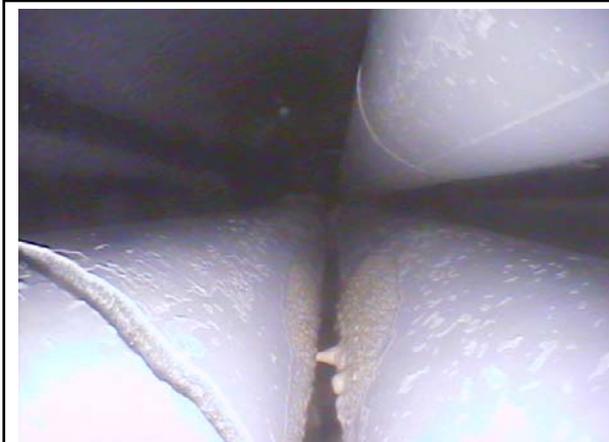
950 mm, circumferential cracks and negligible oxide spalling;
spot from destroyed thermocouple

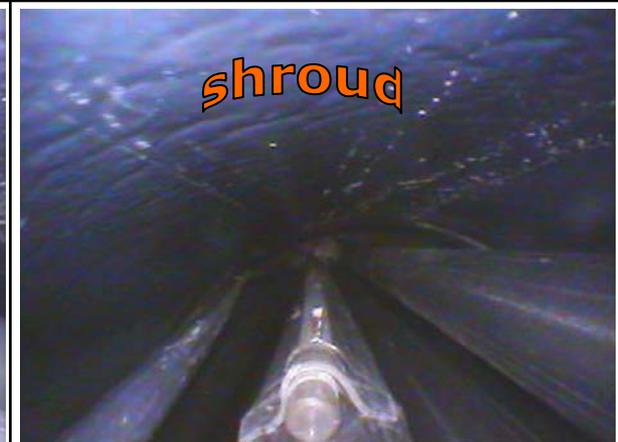
1150 mm,
W/Re thermocouple TFS 12/15

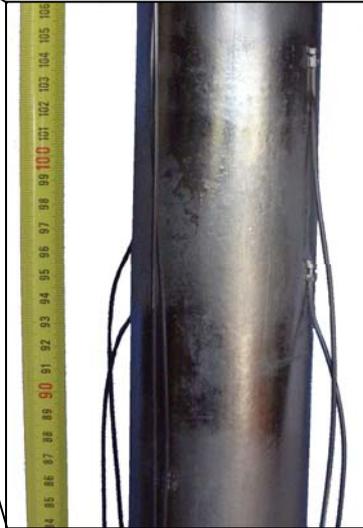
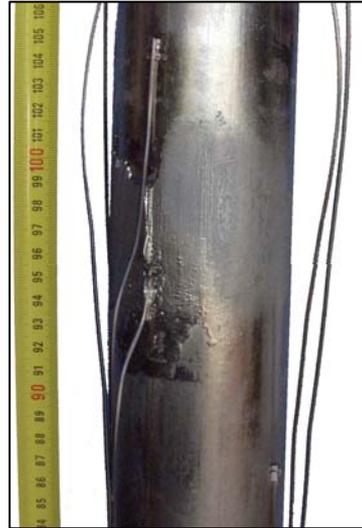
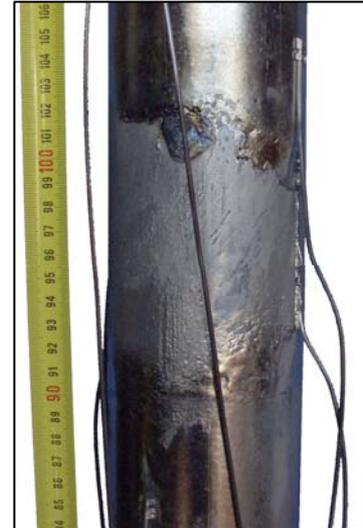
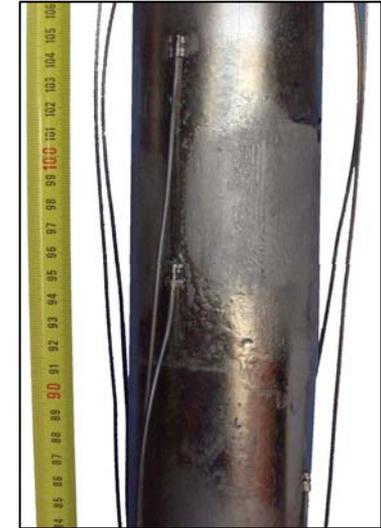
QUENCH-15 shroud appearance

no cracks; negligible melt formation

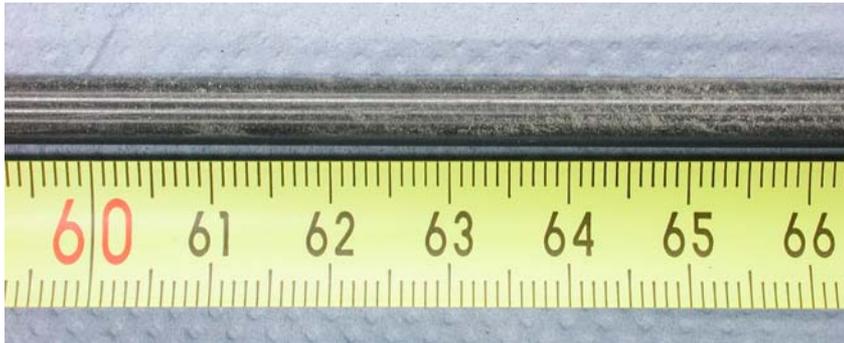
Tube appearance

corner rod A, Zry-4: negligible breakaway, no oxide spalling

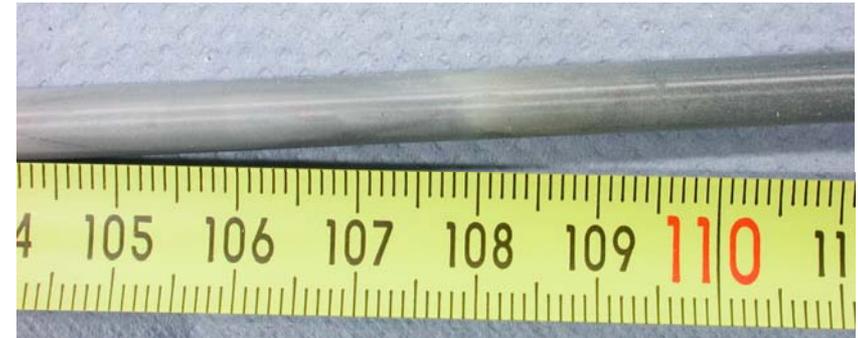
Solid rod appearance

corner rod D, Zry-4: no breakaway, no oxide spalling

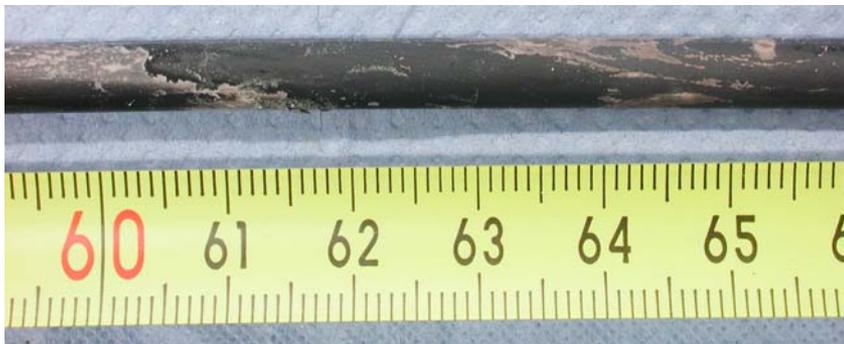
corner rod E, E110: breakaway, intensive spalling of oxide scales

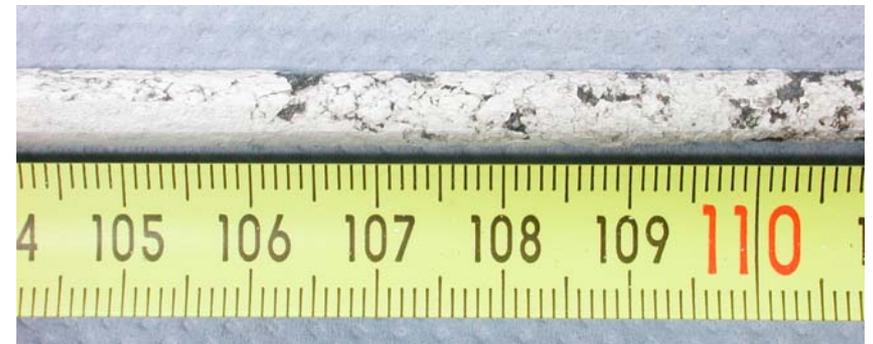
corner rod E, E110: breakaway, intensive spalling of spongy oxide scales

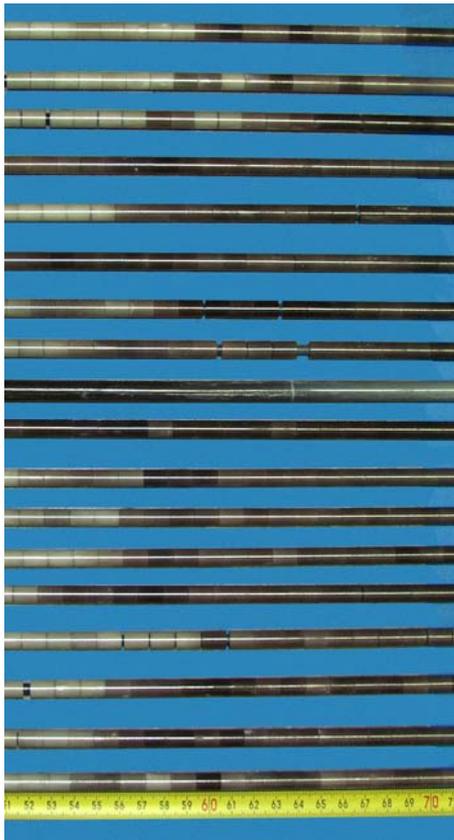
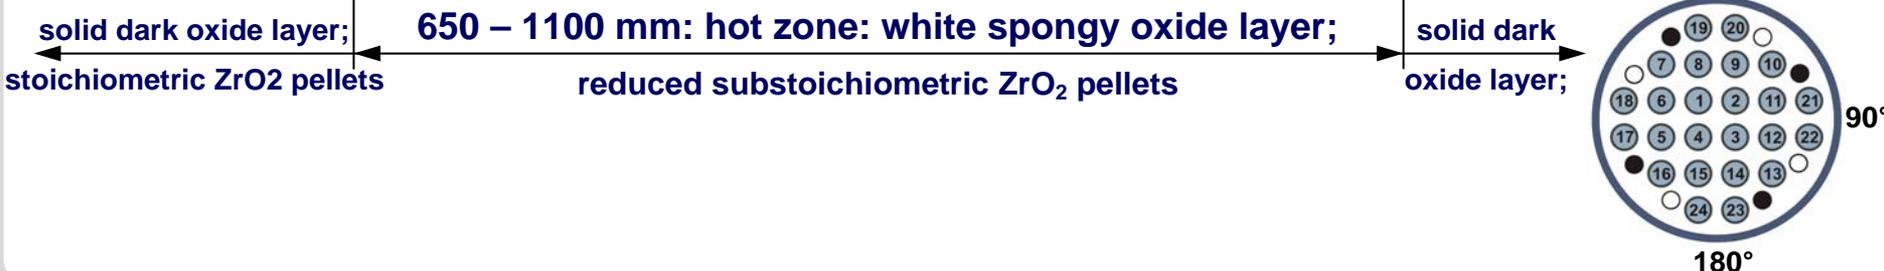
QUENCH-15: fuel rod simulators (18 rods) upward withdrawn from bundle after the test

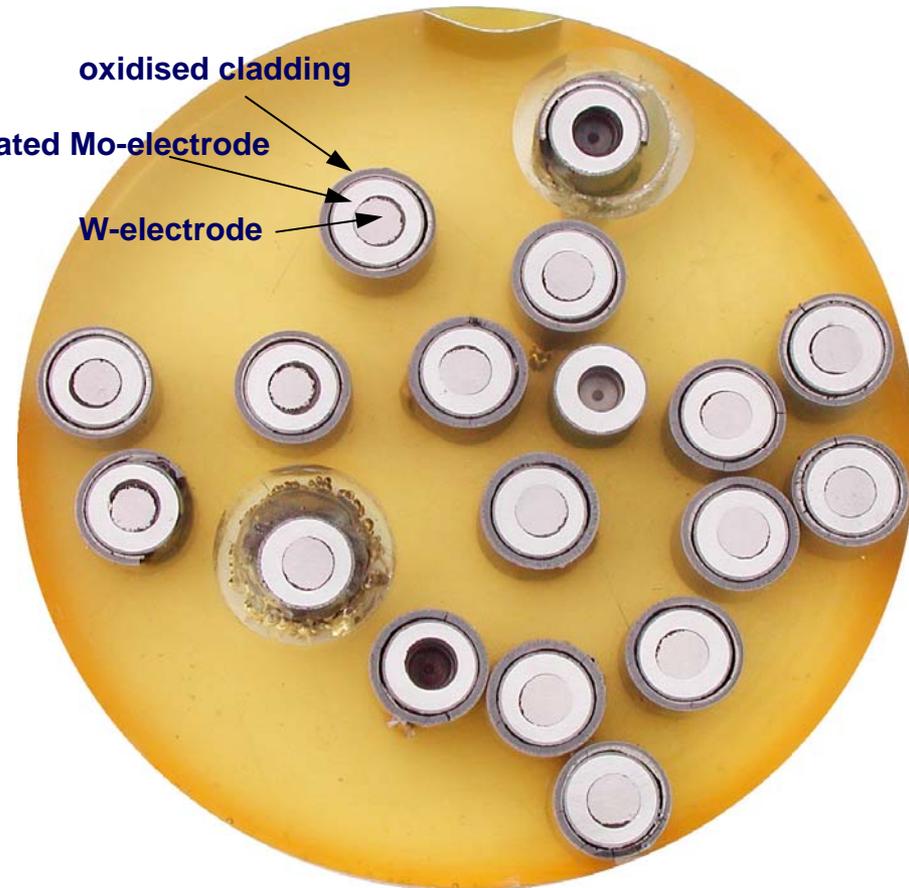
elevation 1034 mm
(junction W-heater to Mo-electrode)
top view

oxidised cladding
coated Mo-electrode
W-electrode

no melt indication

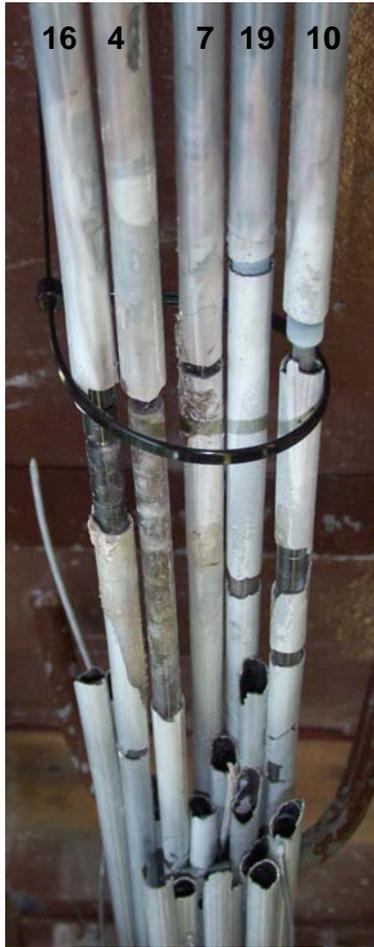
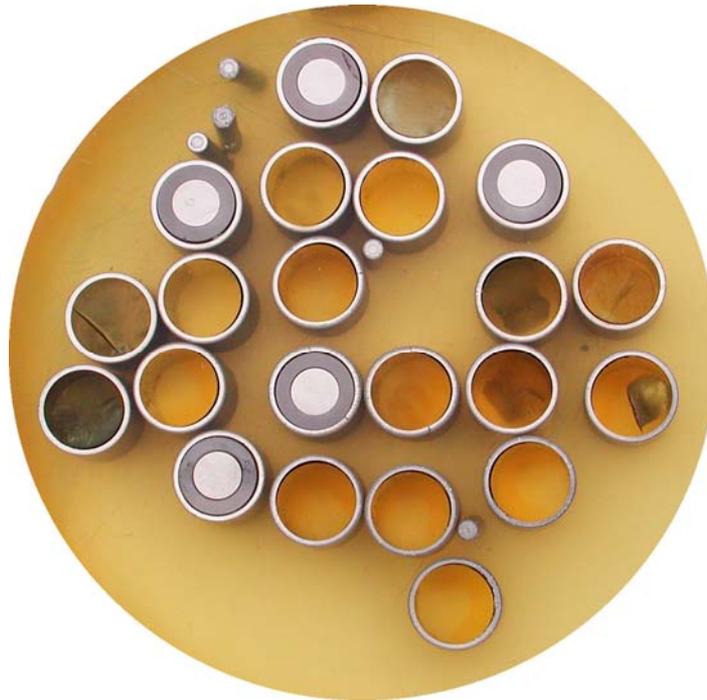
elevation 750 mm
top view

QUENCH-15: bundle rest after dismounting

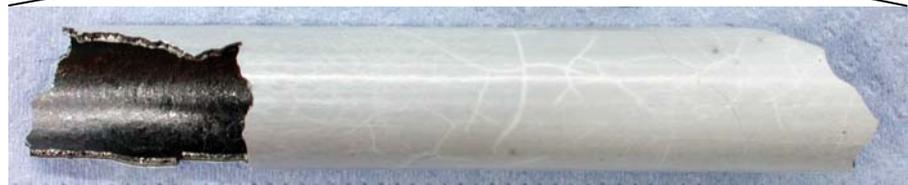
QUENCH-15: oxidation and hydrogenation of cladding (heated rod 24)

Average ZrO₂ layer thickness measured on bundle cross-sections:
 850 mm → 320 μm
 950 mm → 620 μm (max 820 μm)
 1050 mm → 460 μm
