QUENCH-12 test

First results

Objectives of the QUENCH-12 test

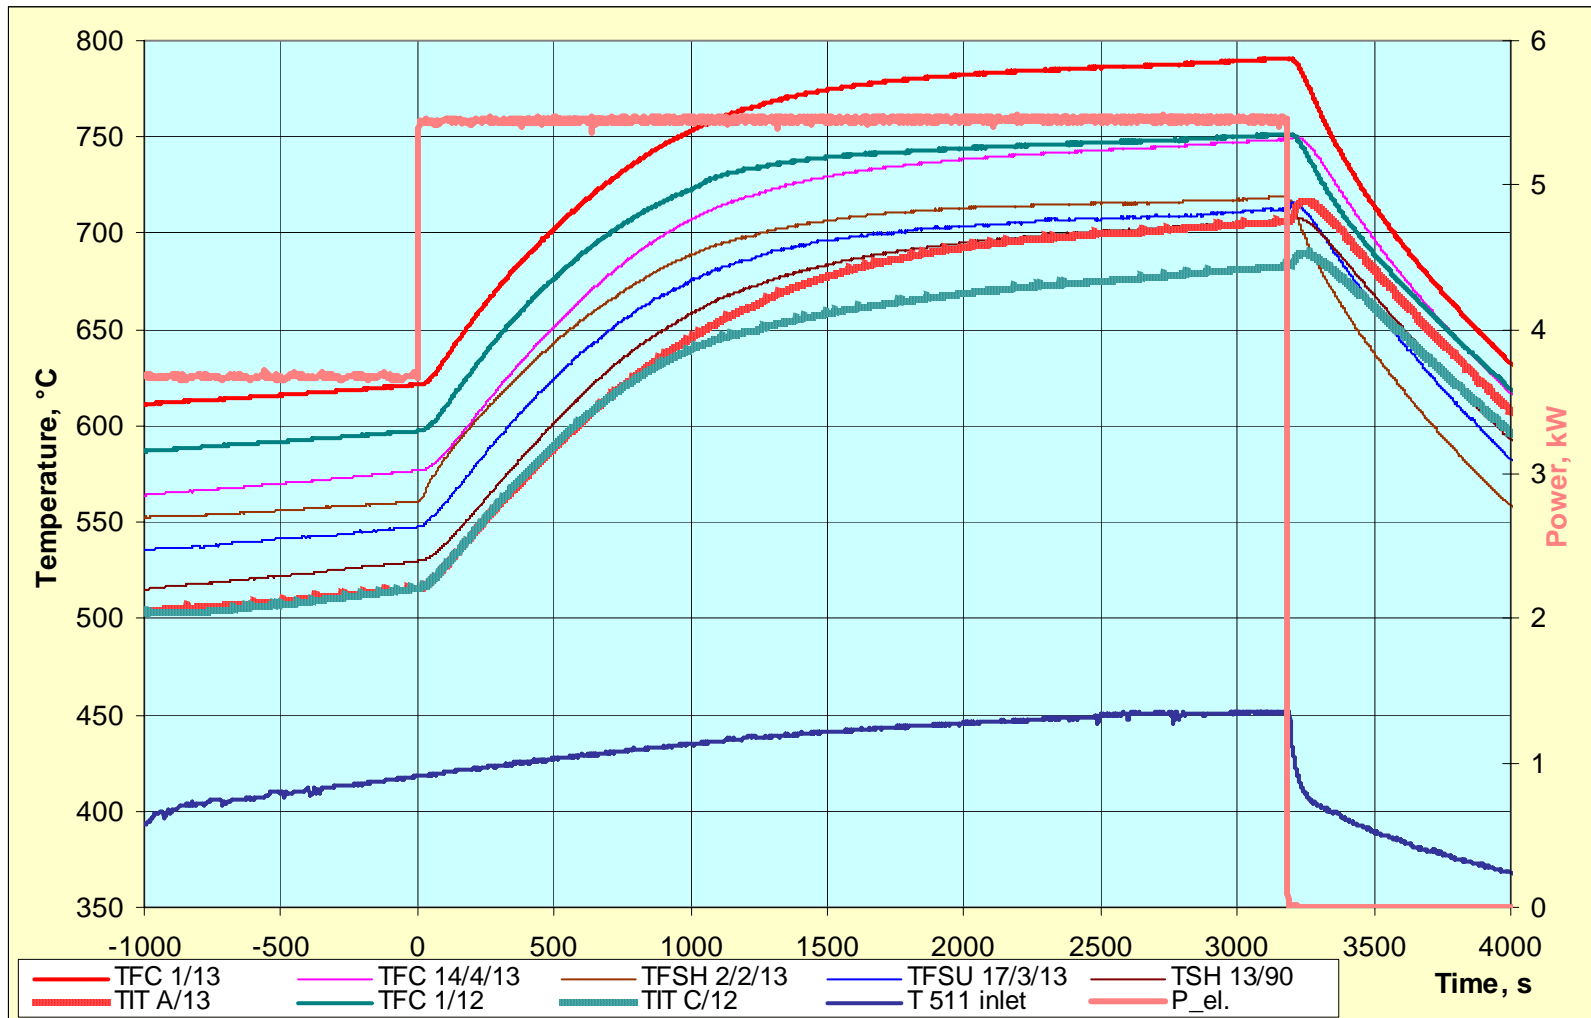
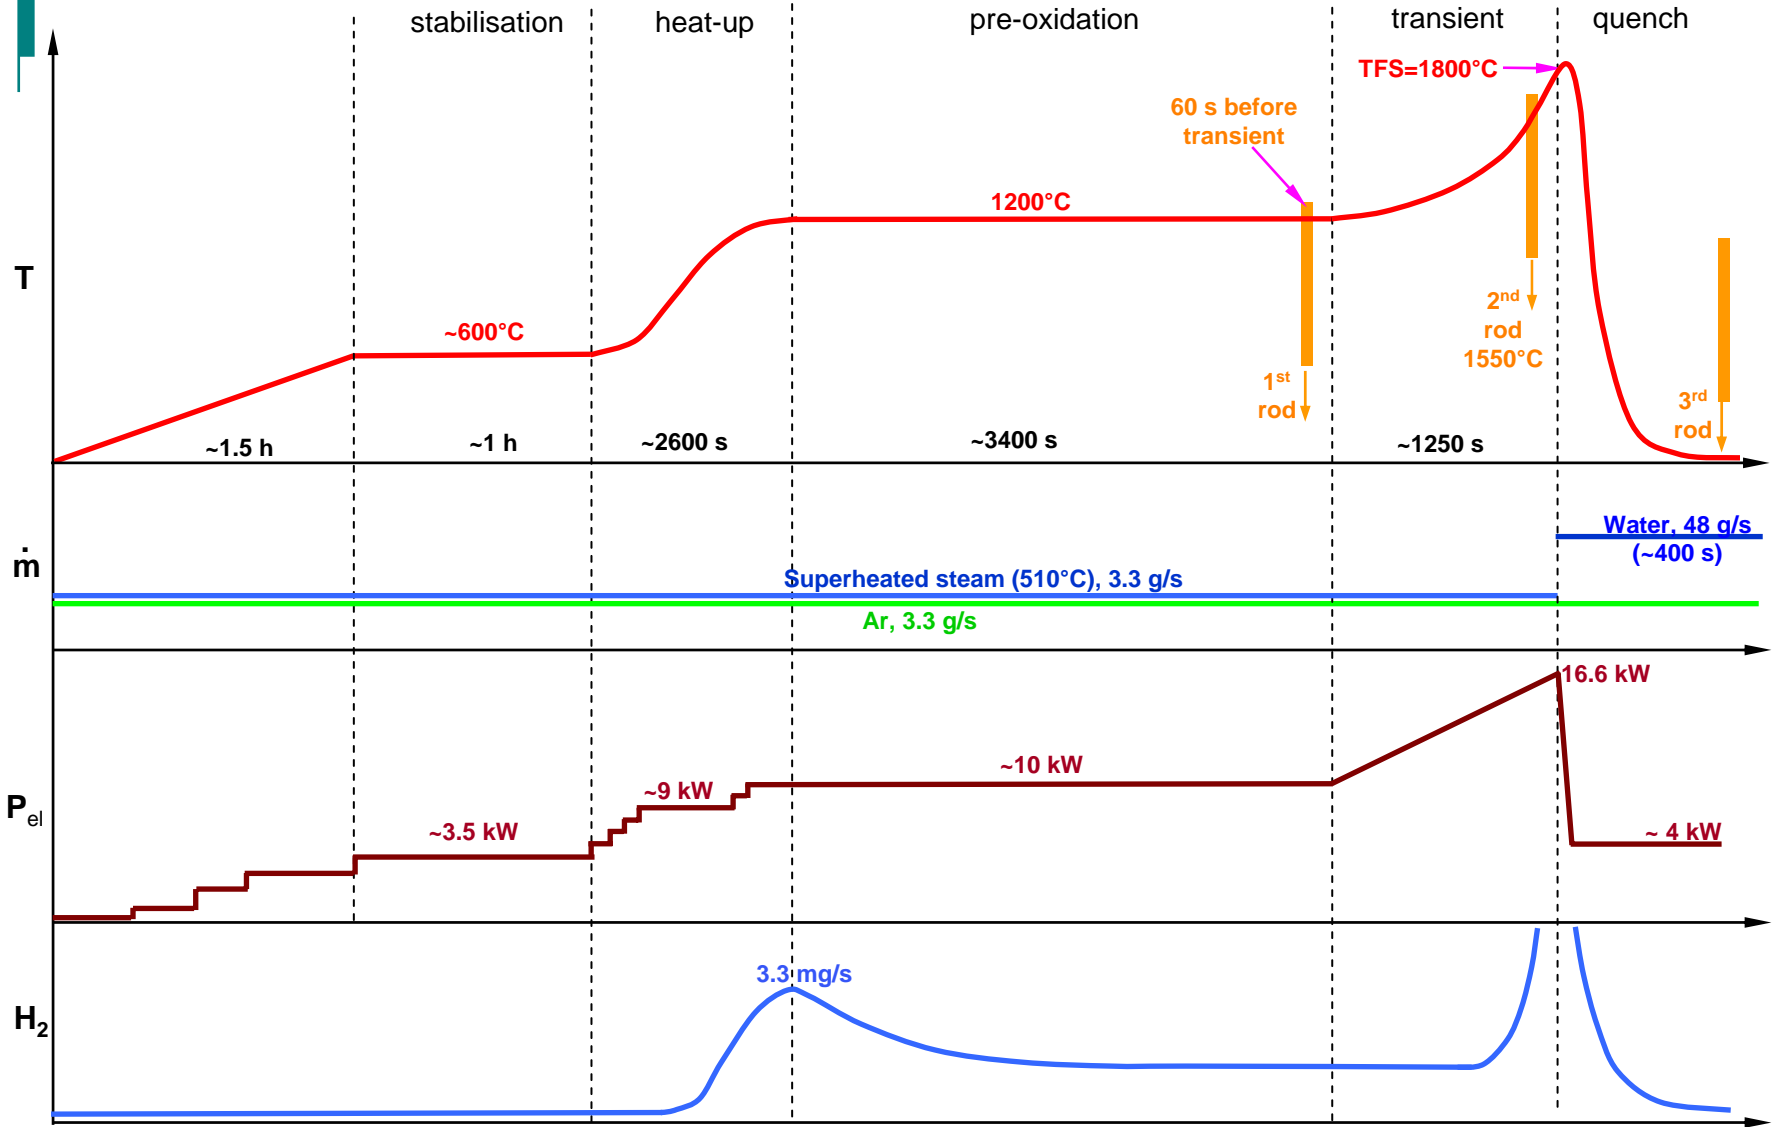
Preliminary test with VVER bundle (without reflood)
to supply the tuning parameter for the pretest calculations to QUENCH-12.

TC readings for elevations 850 mm and 950 mm: significant radial gradient for low temperatures.

- The preliminary test at the maximum temperature 800°C was performed. The corresponding oxidation was negligible: less of 5 µm. The results of this test were used to fine attenuation of the pretest modelling.

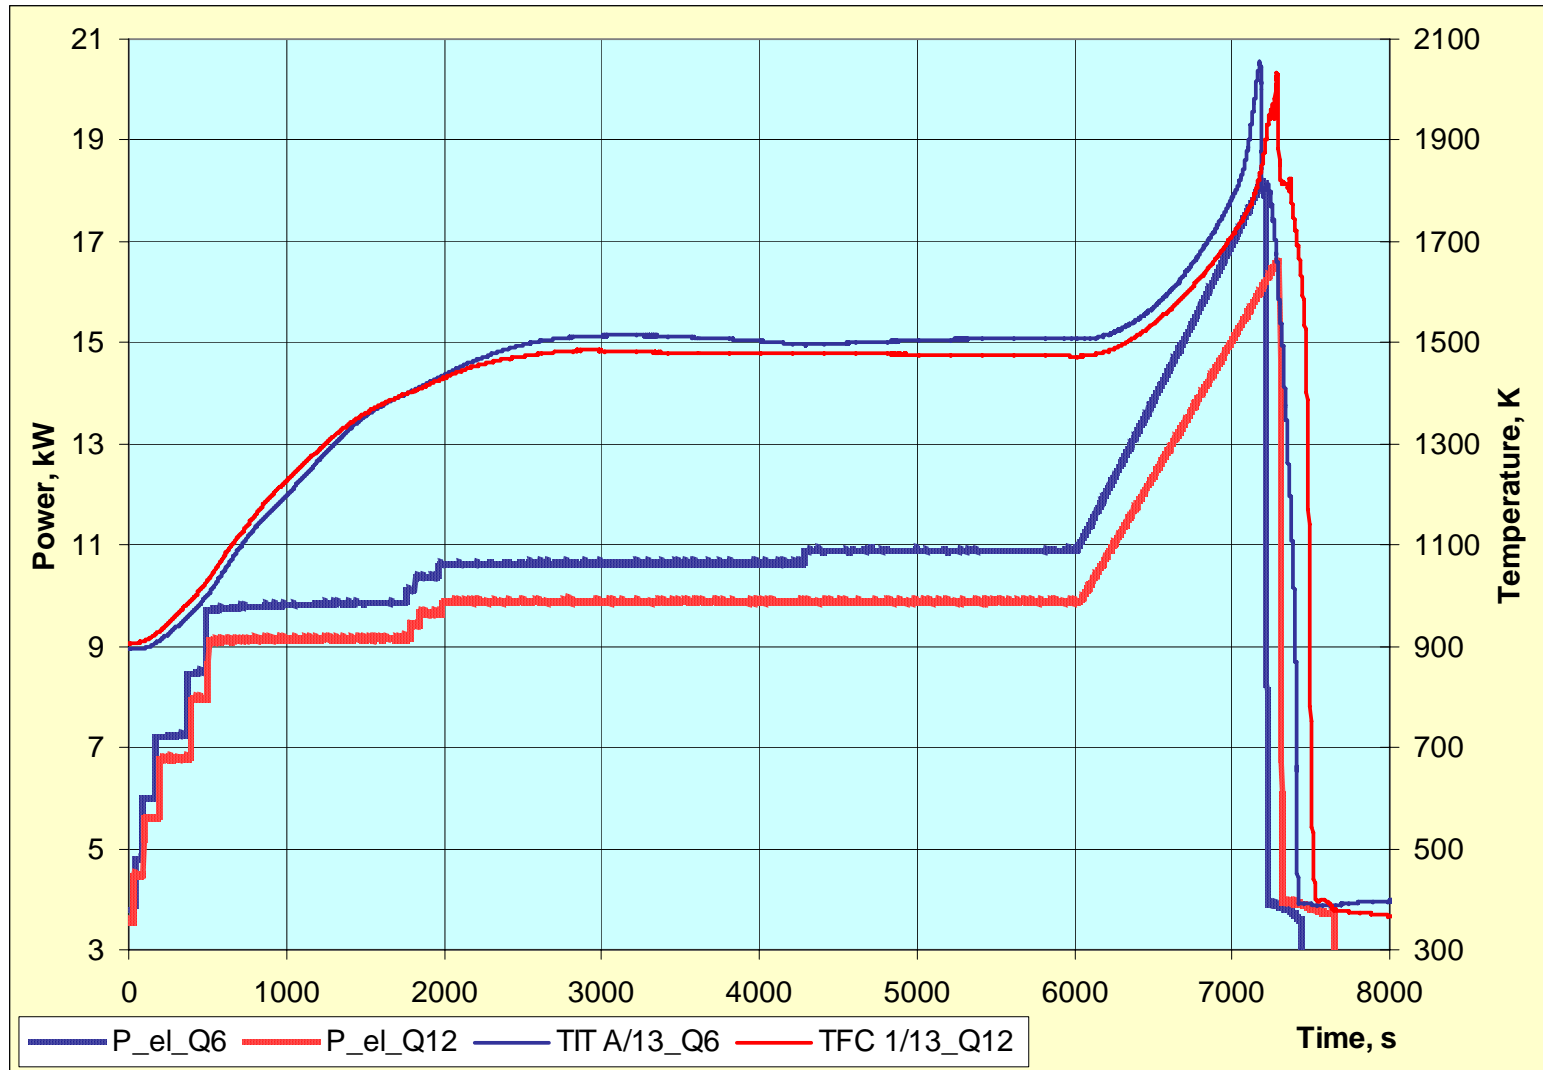
Comparison of temperature and power profiles for **QUENCH-12** and **QUECH-06**.

- The electrical power changing during the test corresponds completely to calculated values up to reflood phase. The temperature history during preoxidation is very similar to the QUENCH-06 temperature history.

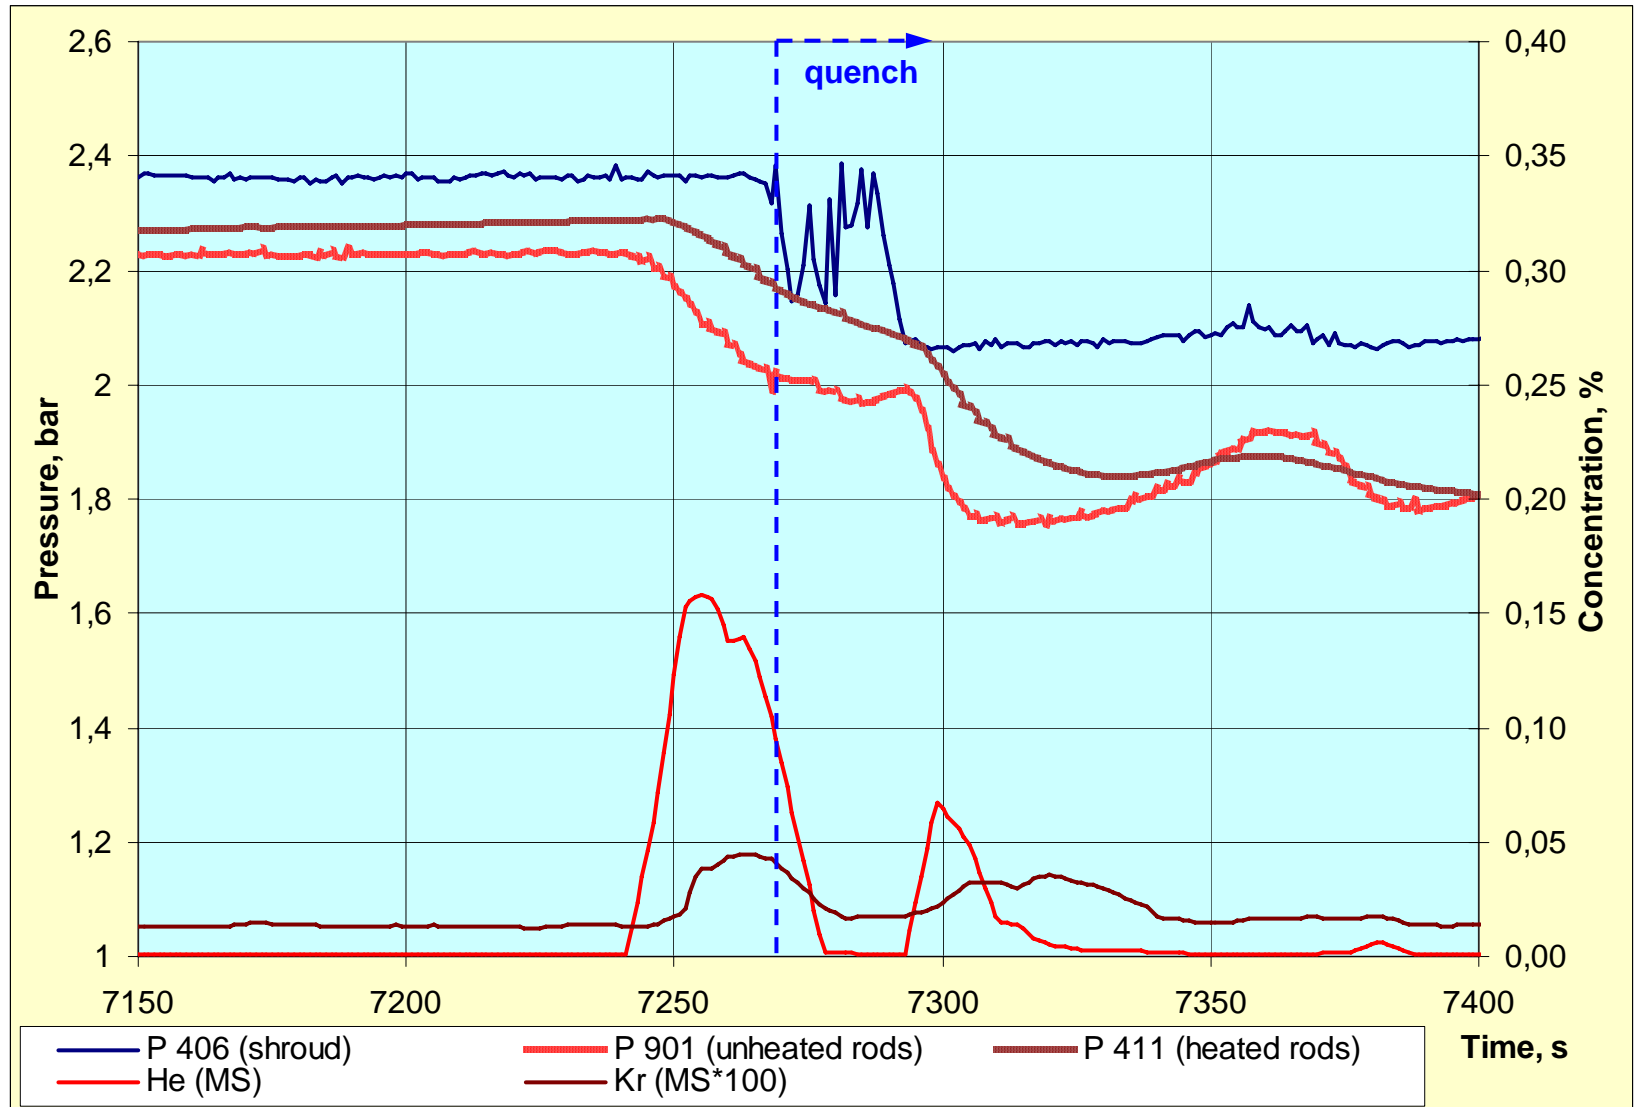
QUENCH-12, before quench phase: failure of **unheated rods**, **heated rods** and **shroud**

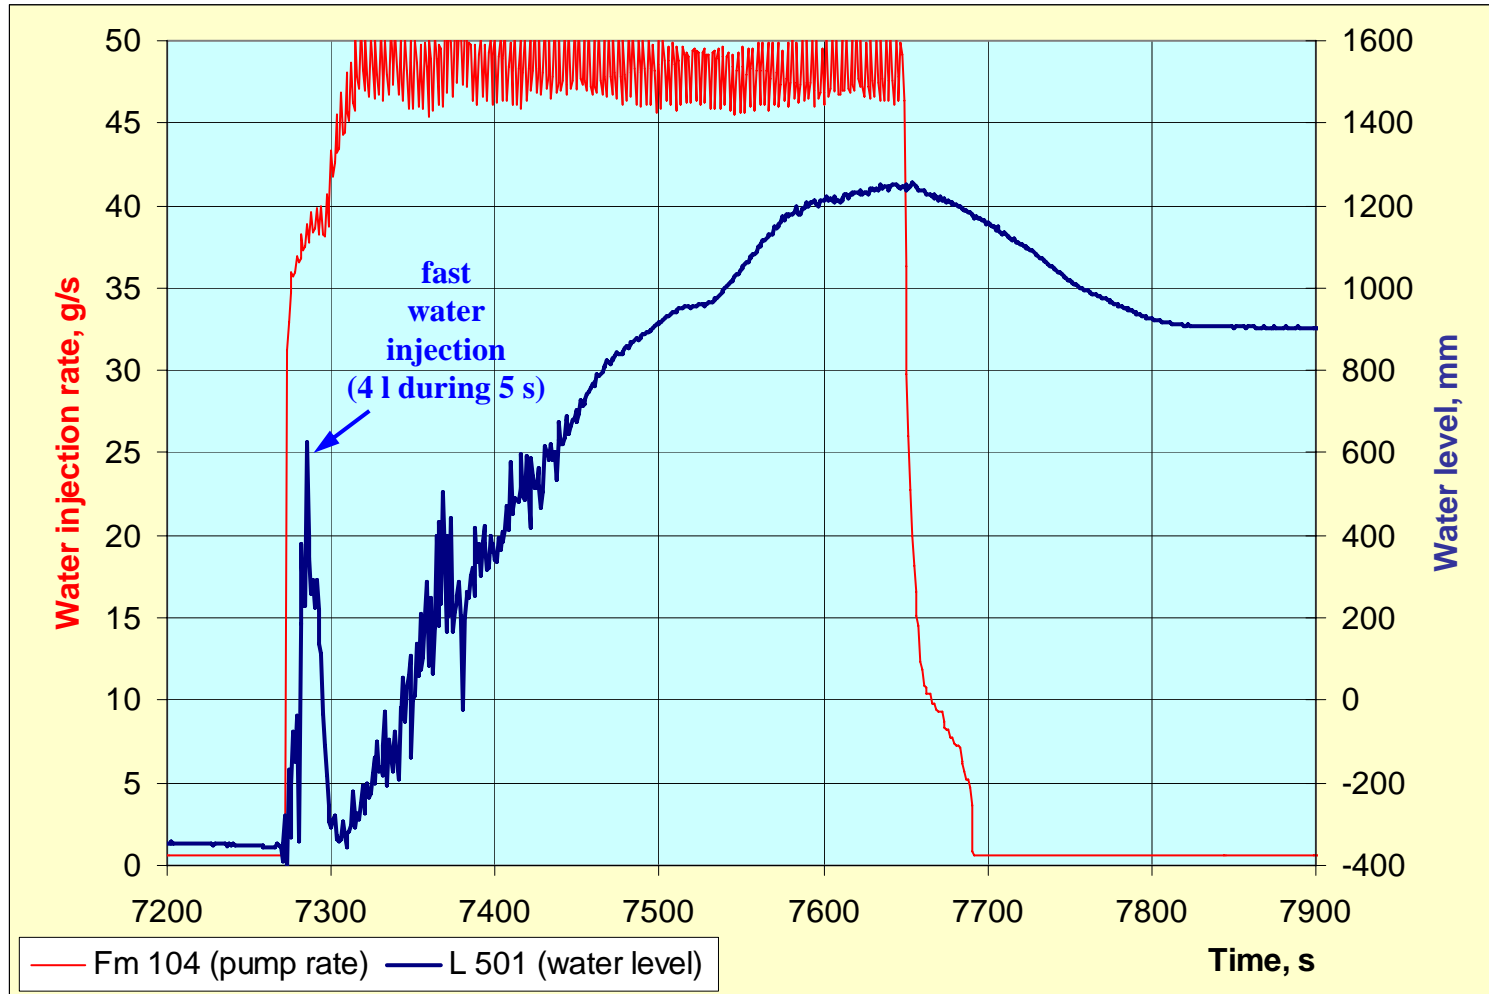
QUENCH-12, quench phase: water injection

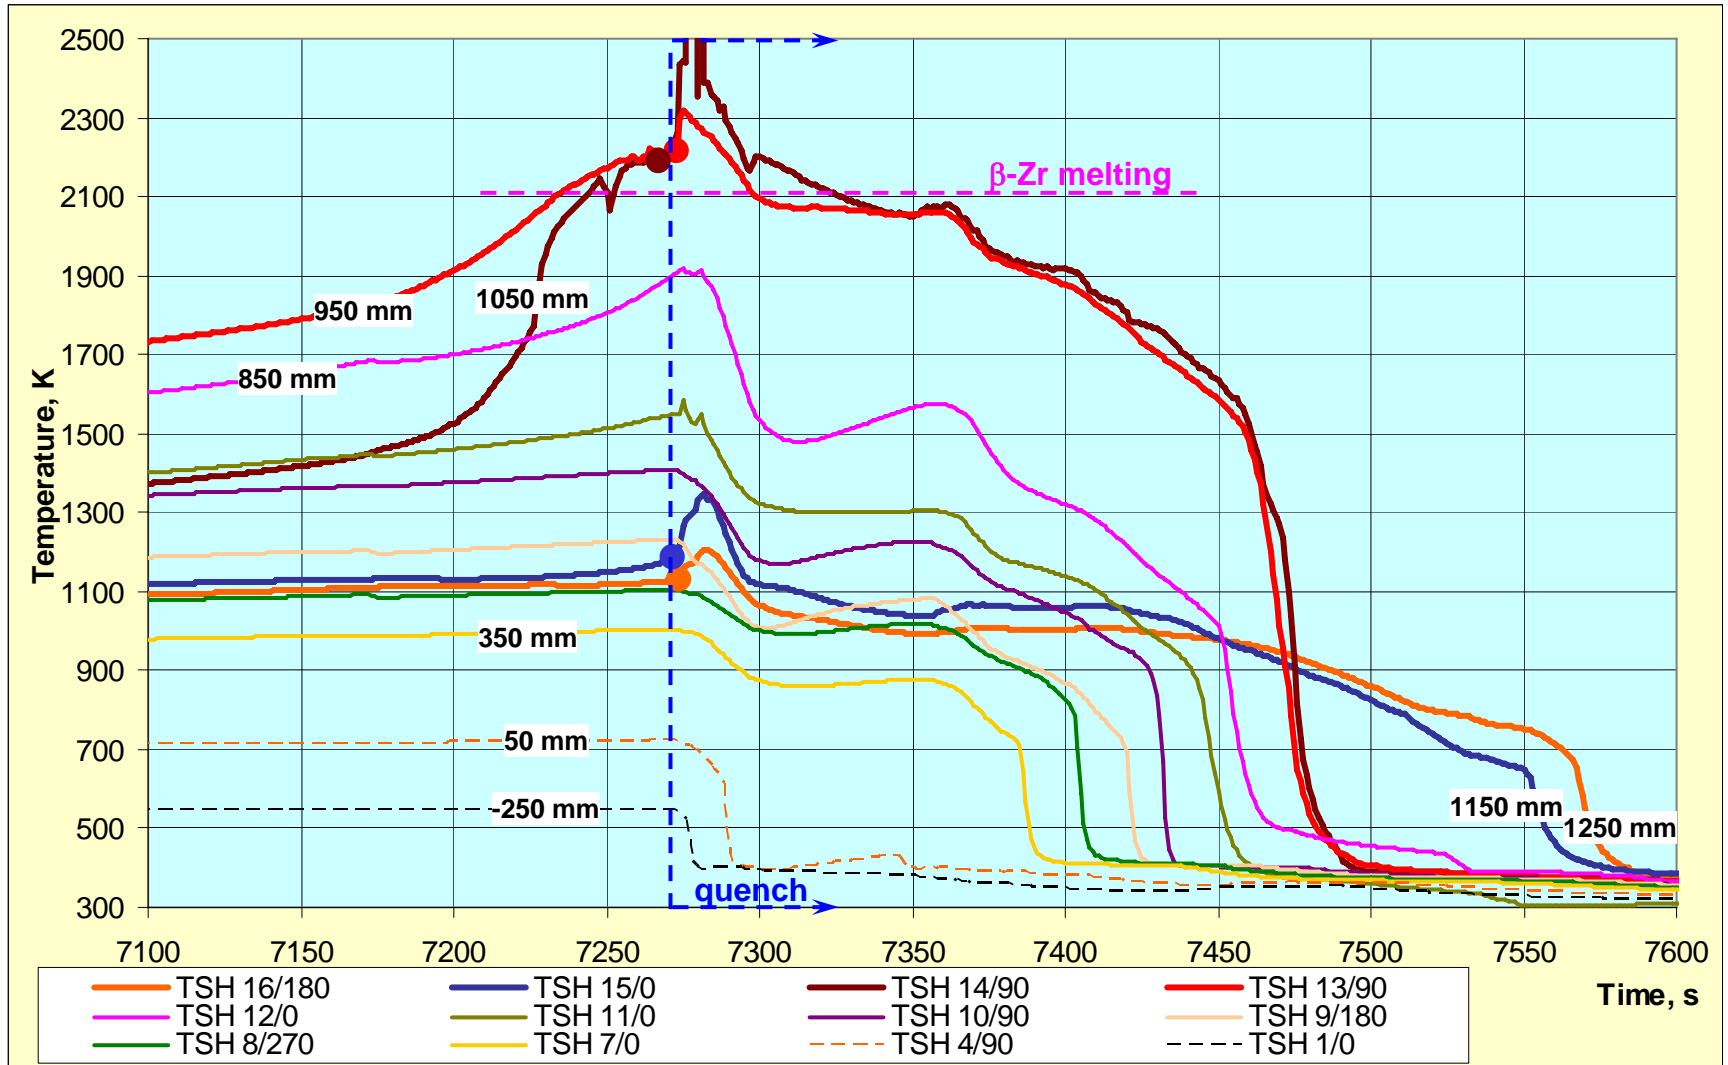
QUENCH-12, quench phase: selected reading of the shroud thermocouples.
Short temperature escalation at elevations 950 mm – 1250 mm.

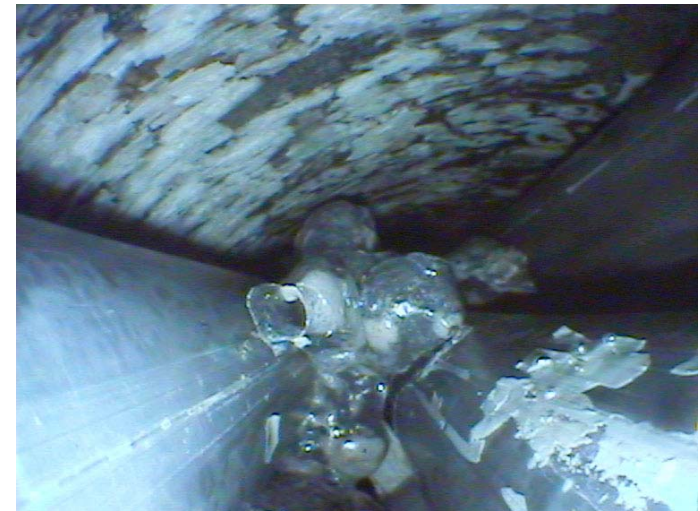
neutronography (M. Große)
shows the deep hole with
irregular diameter

melt formation in bundle at the break
position of the corner rod B (850 mm)

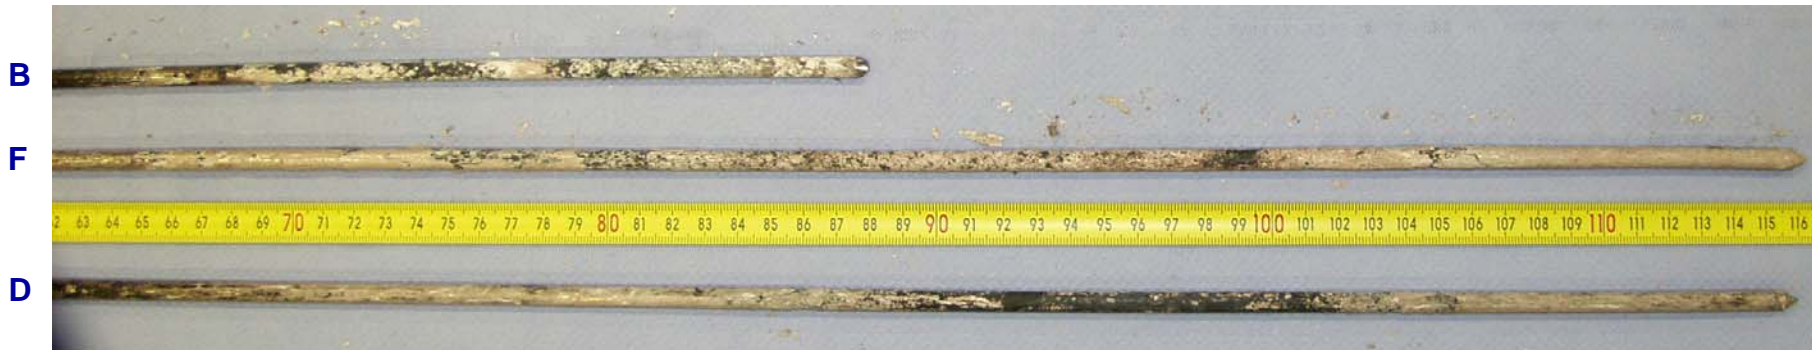
corner rod B after pre-test (800 °C, oxide layer thickness less of 5 µm)

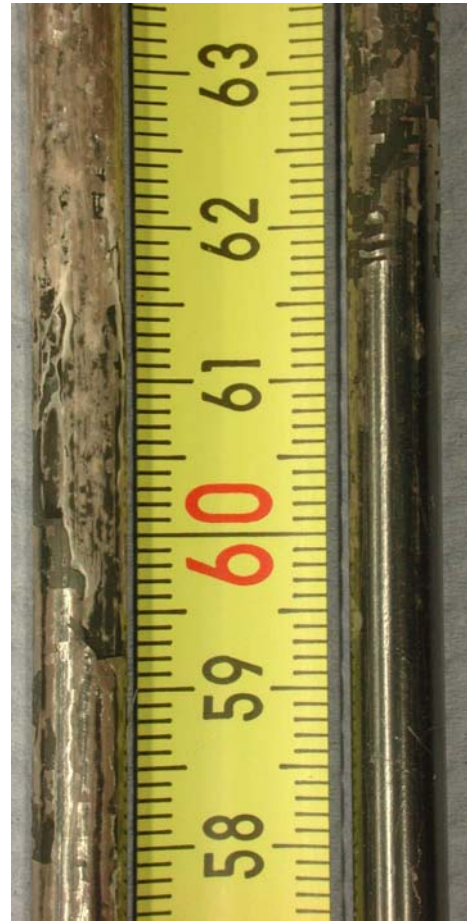
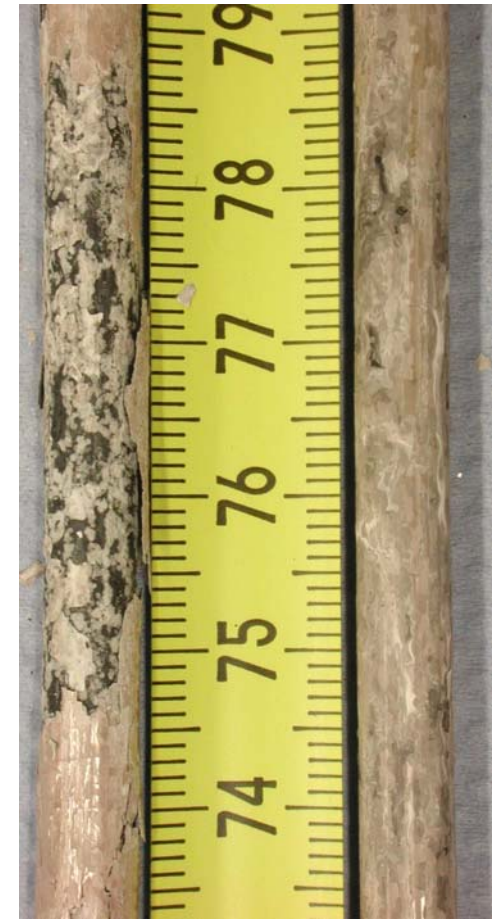
corner rods D, F, B after pre-test: spalling of the outer skin of oxide layer.

D – withdrawn after pre-oxidation,
F – withdrawn before reflow,
B – withdrawn after test.

QUENCH-12: axial sections of different ZrO_2 spalling intensity on withdrawn corner rods

- Two corner rods were withdrawn at the end of preoxidation and transient phases correspondingly. The surface of the rods shows intensive traces of the break-away effect influence. Many oxide scales with thickness about 100 µm were spalled during withdrawn.

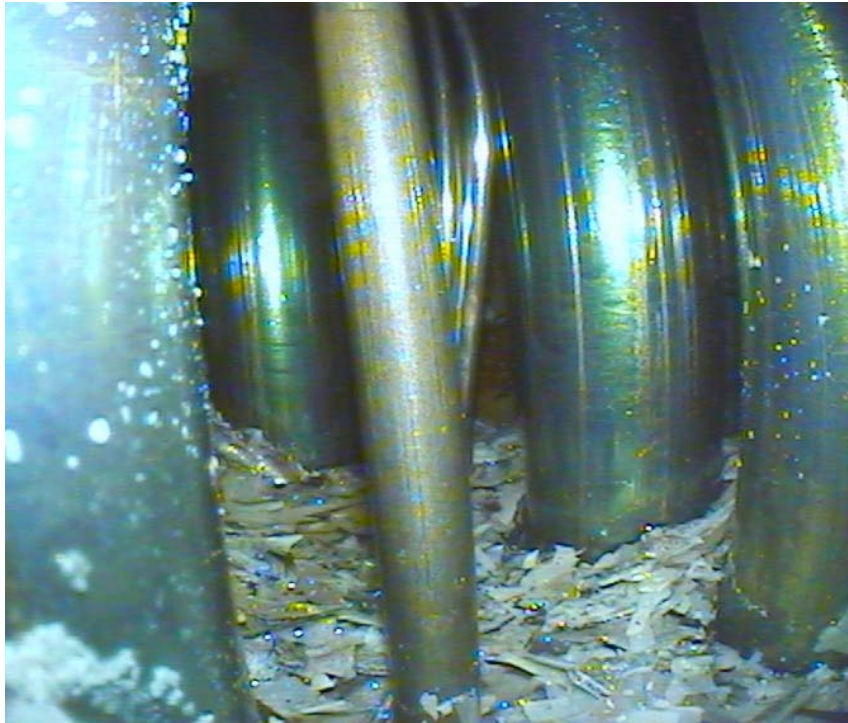
QUENCH-12, videoscope analysis: intensive oxide scale spalling inside of bundle

**side view from corner rod B
on the top of the first spacer (-150 mm)**

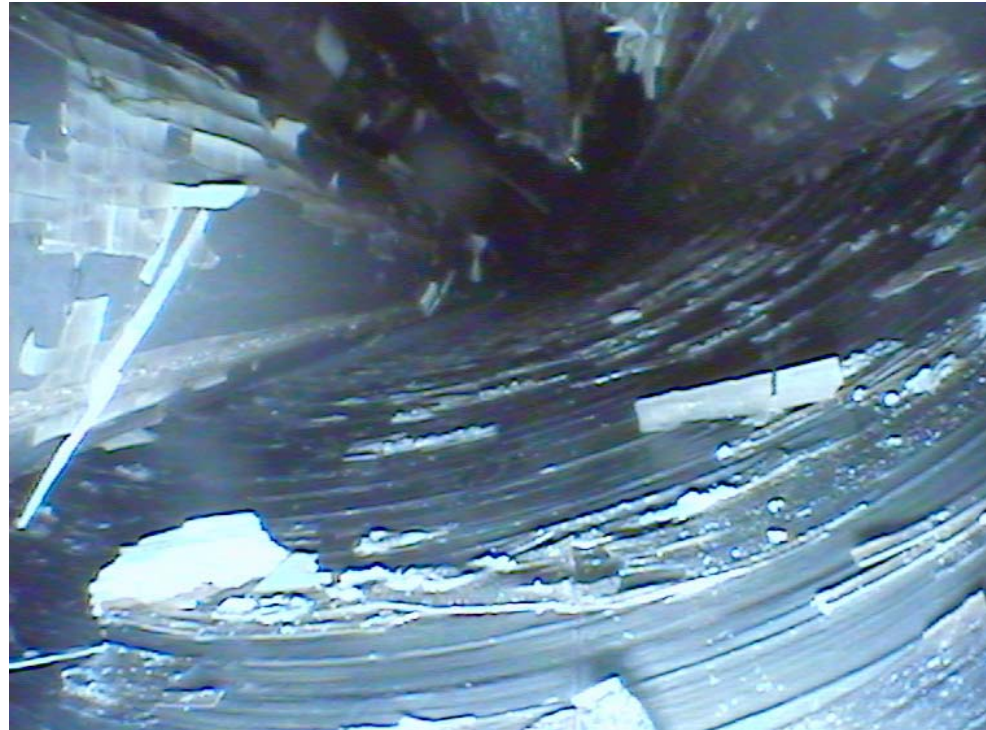
**camera in position of corner rod D at 650 mm:
spalled oxide scales at shroud and cladding**

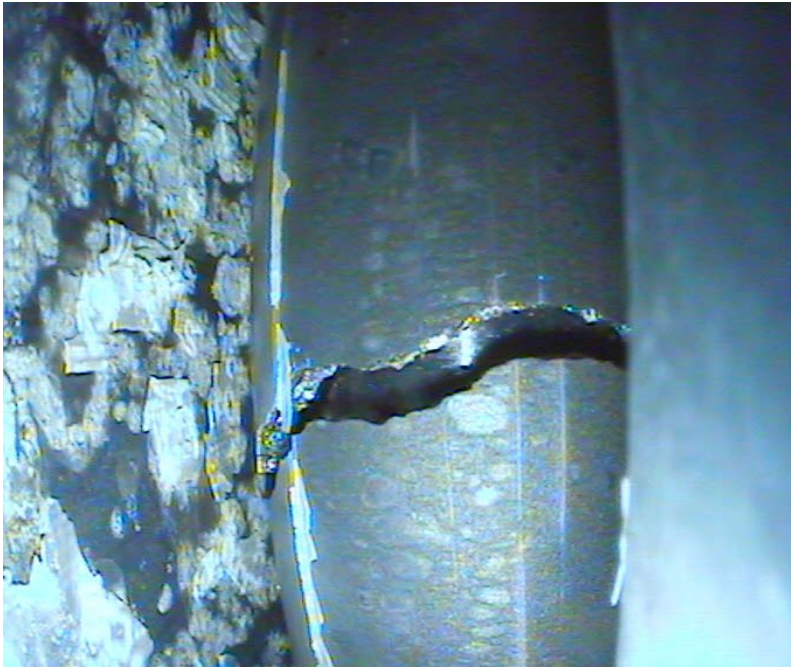
QUENCH-12, videoscope analysis : cladding cracks development

cross crack at 600 mm (rod D)

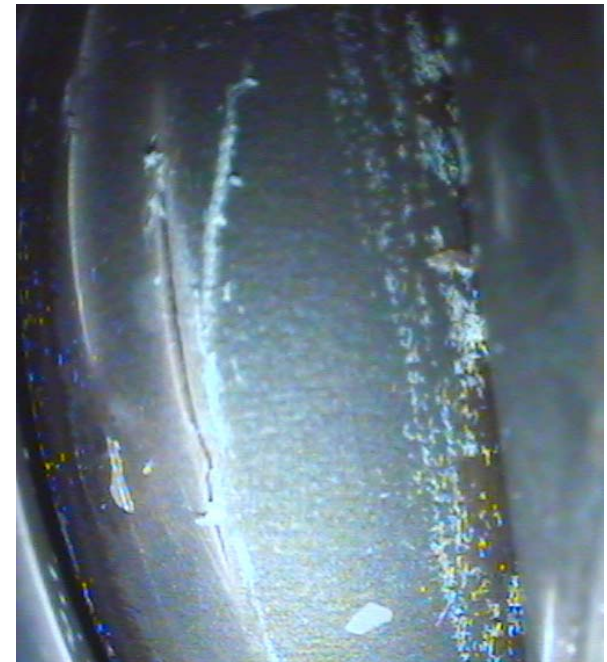
longitudinal crack at 650 mm (rod F)

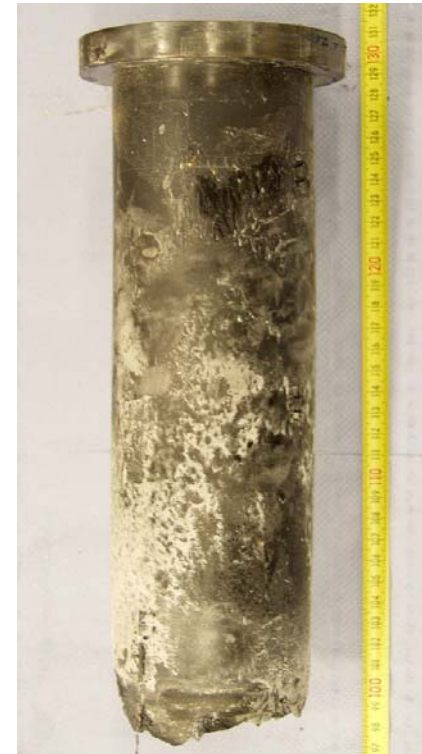
QUENCH-12: bundle posttest view after dismantling of zirconia fiber insulation

upper part of the shroud braked off from the bundle during dismantling (angle position of 180°)

bundle at angle position of 180°

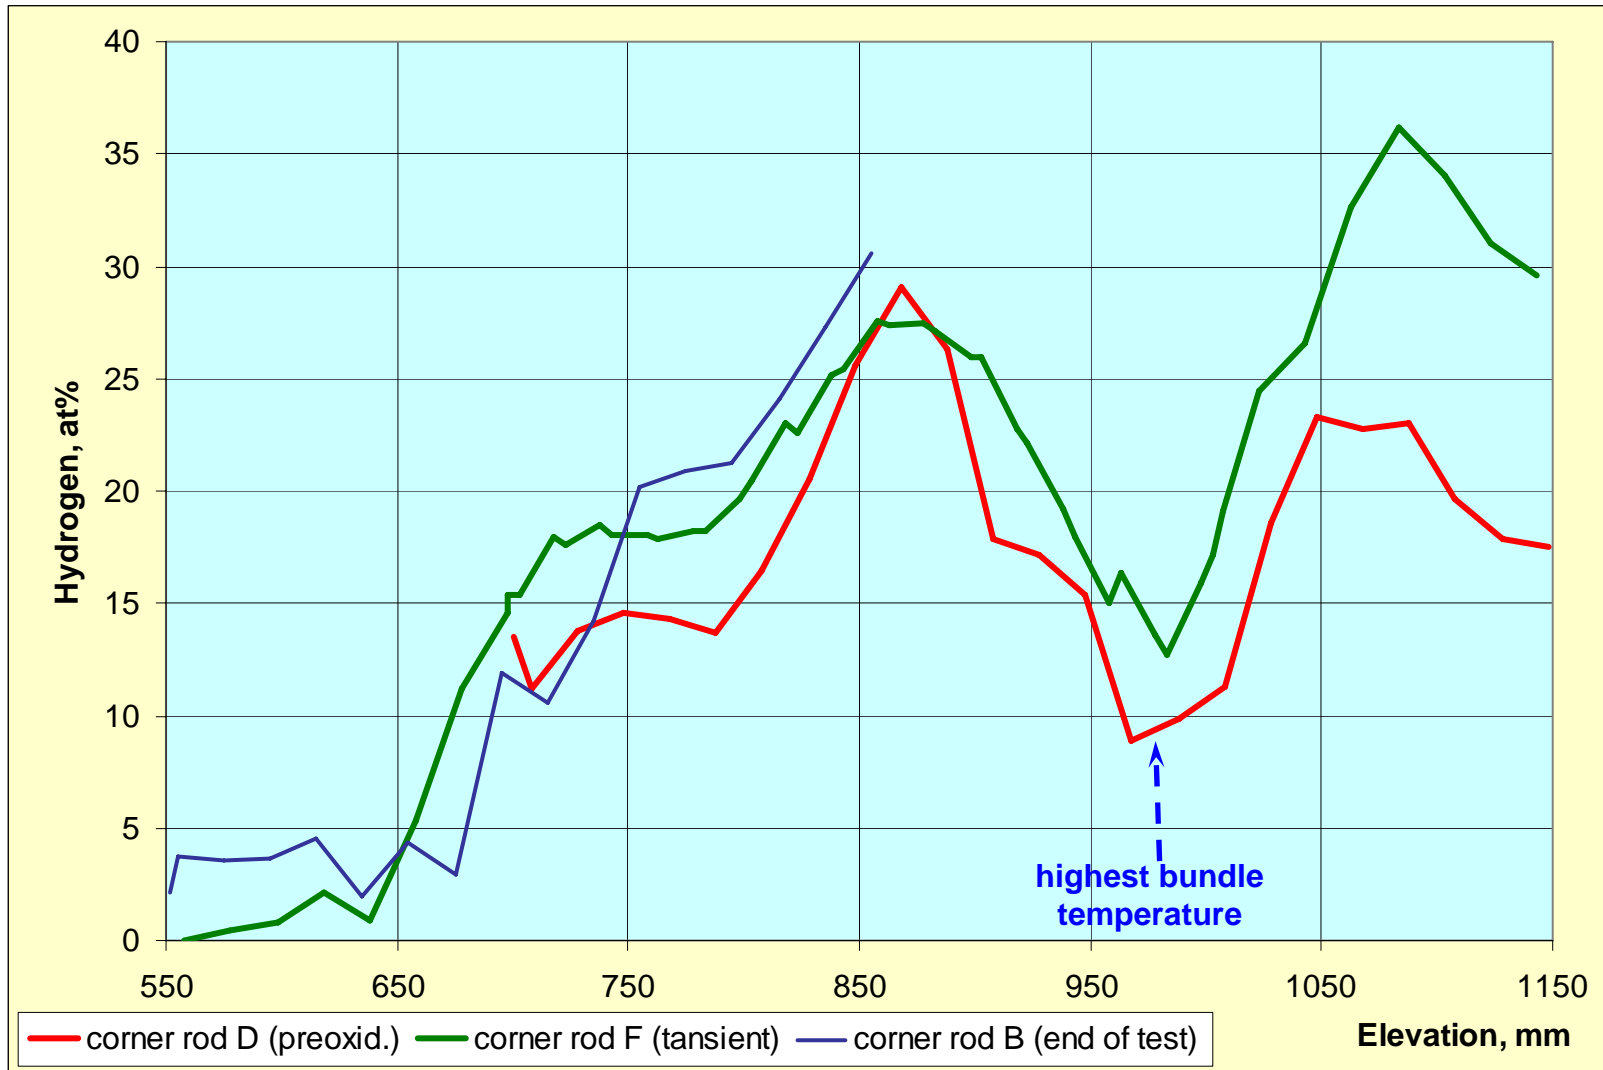
QUENCH-12: hydrogen uptake by corner rods
/results of neutronography/
