Results of the commissioning bundle test QUENCH-L0 performed under LOCA conditions

Objective

- **Modification of electric heated high temperature facility QUENCH at KIT for performance of bundle tests under LOCA conditions.**
- **Bundle test with 21 rod simulators with slightly preoxidized Zircaloy-4 cladding tubes.**
- **Bringing into service two post-test methodologies: 1) laser cladding profilometry; 2) tension and ring compression tests for cladding segments.**

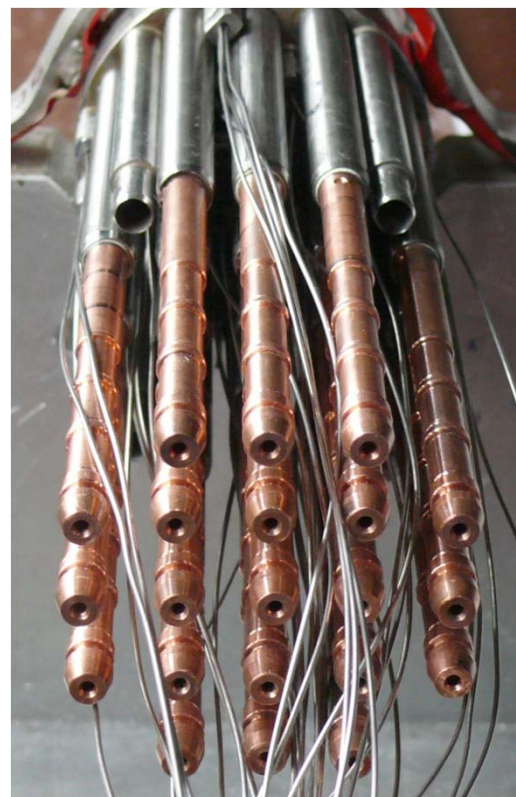
Rod pressurisation

bundle bottom

bundle top

boreholes through bottom Cu-electrodes

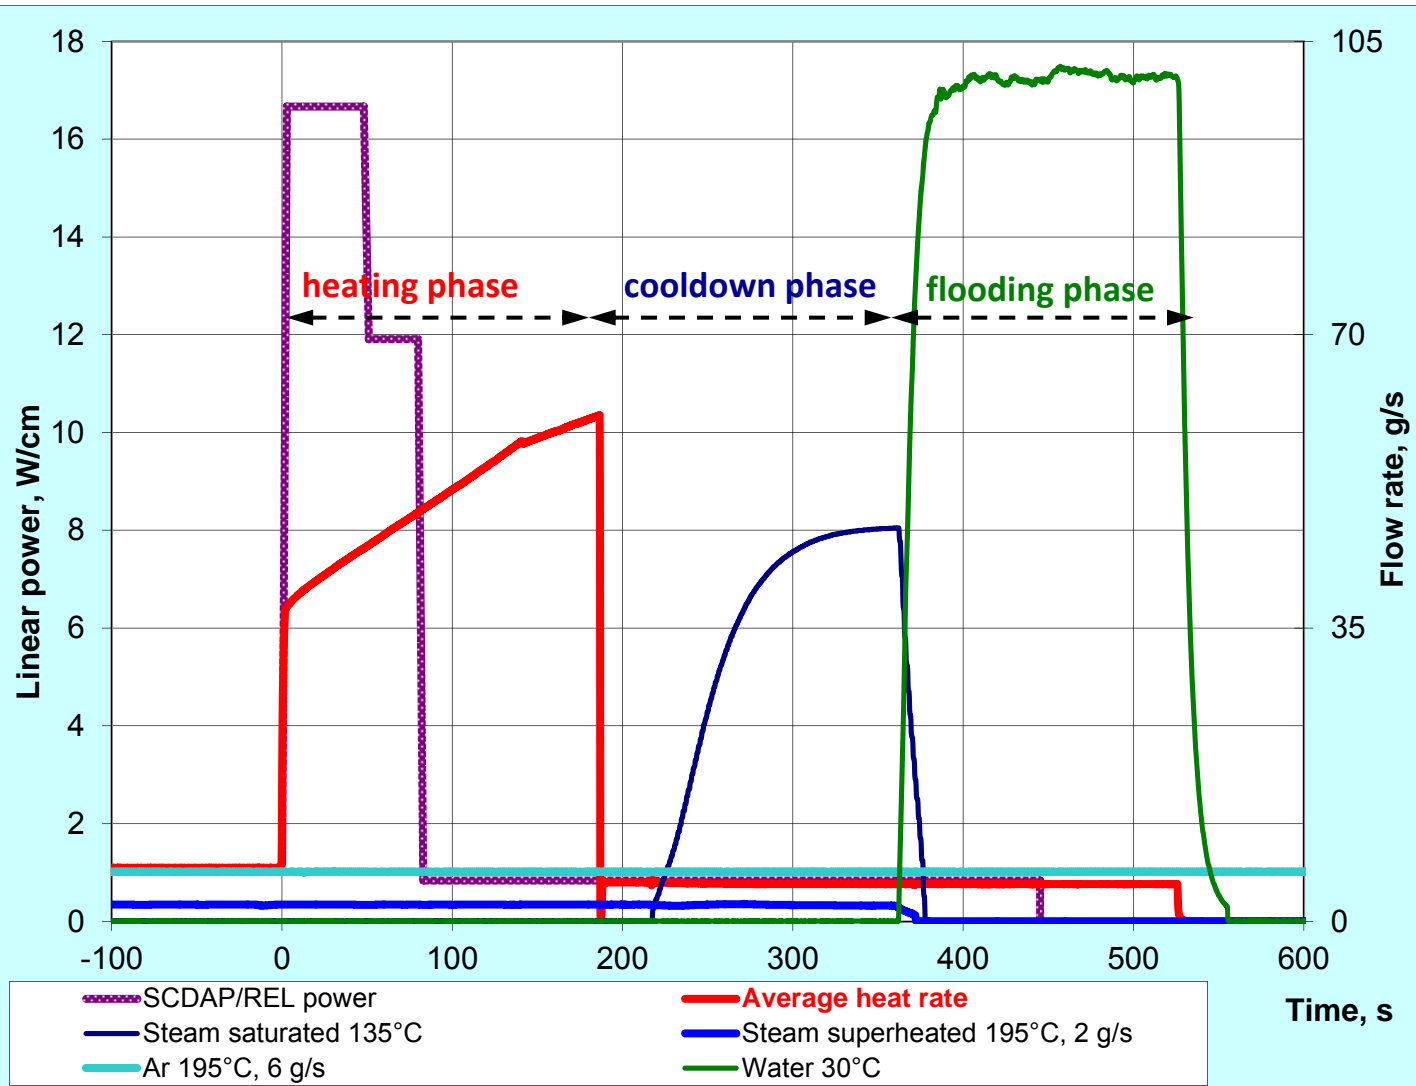
QL0 test progression

2 deviations from scenario:

- 1) extended heating due to current limiting of generator
- 2) abrupt cooldown due to water condensed in steam pipe line

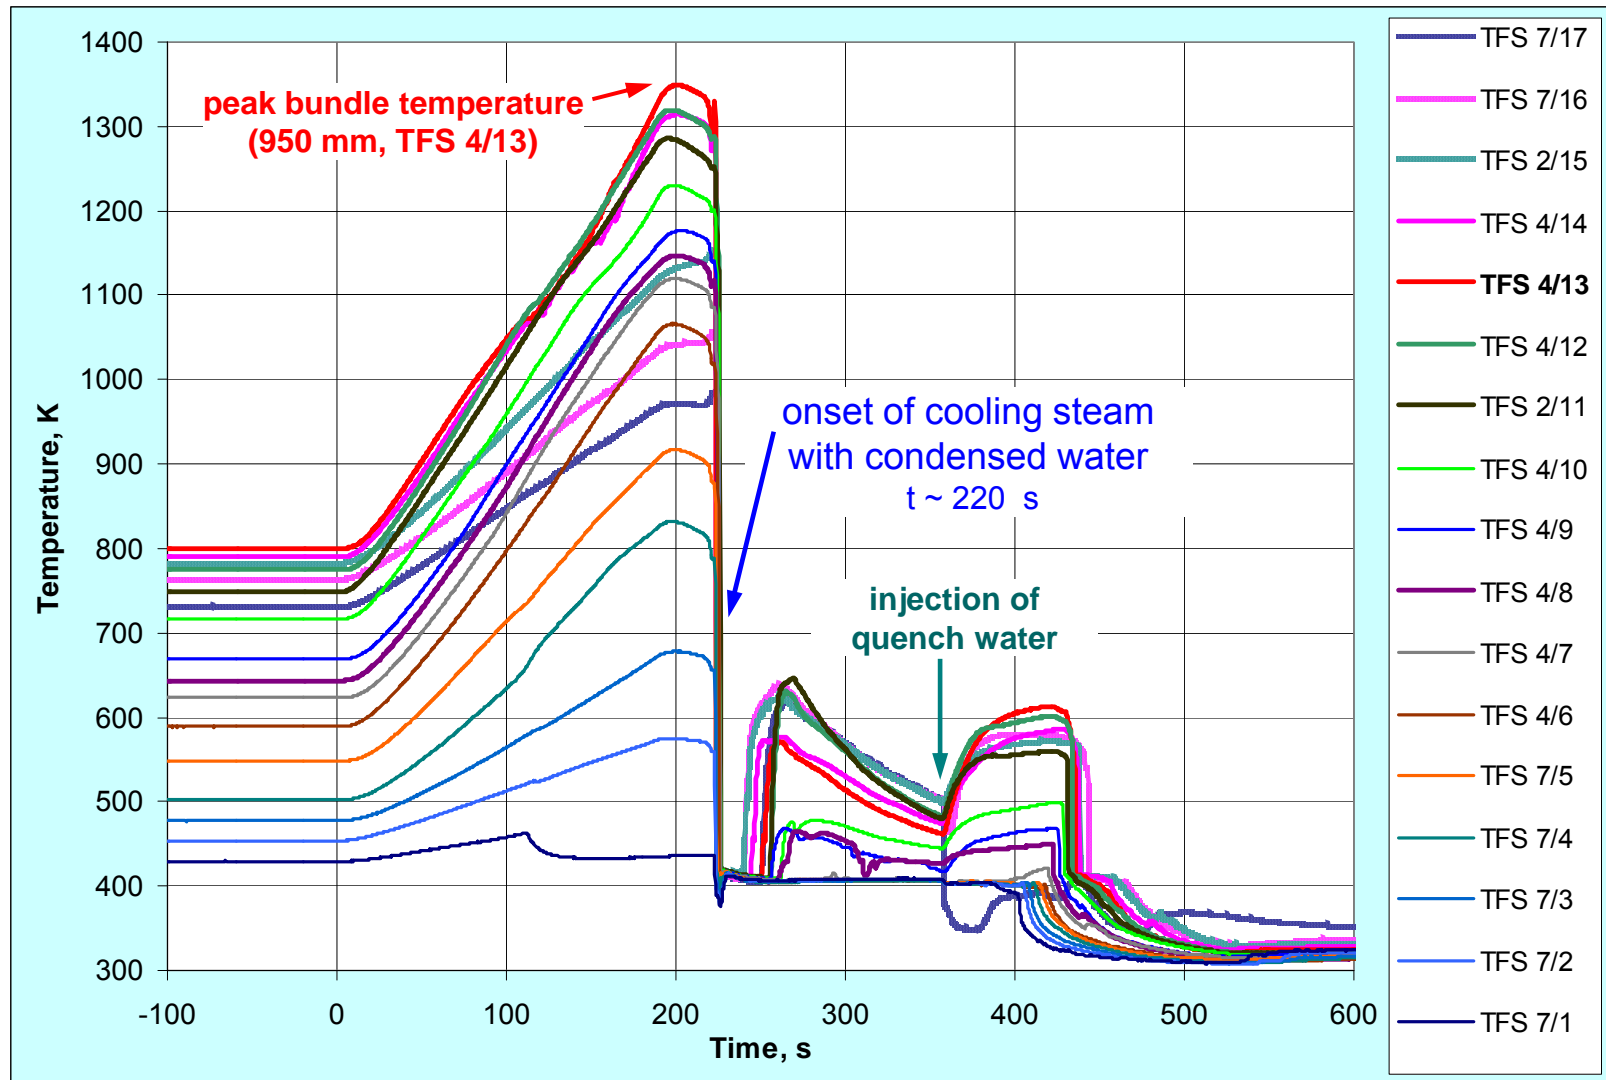
Surface thermocouple readings: 17 elevations between -250 und 1350 mm

thermocouples indicated max temperature at each elevation

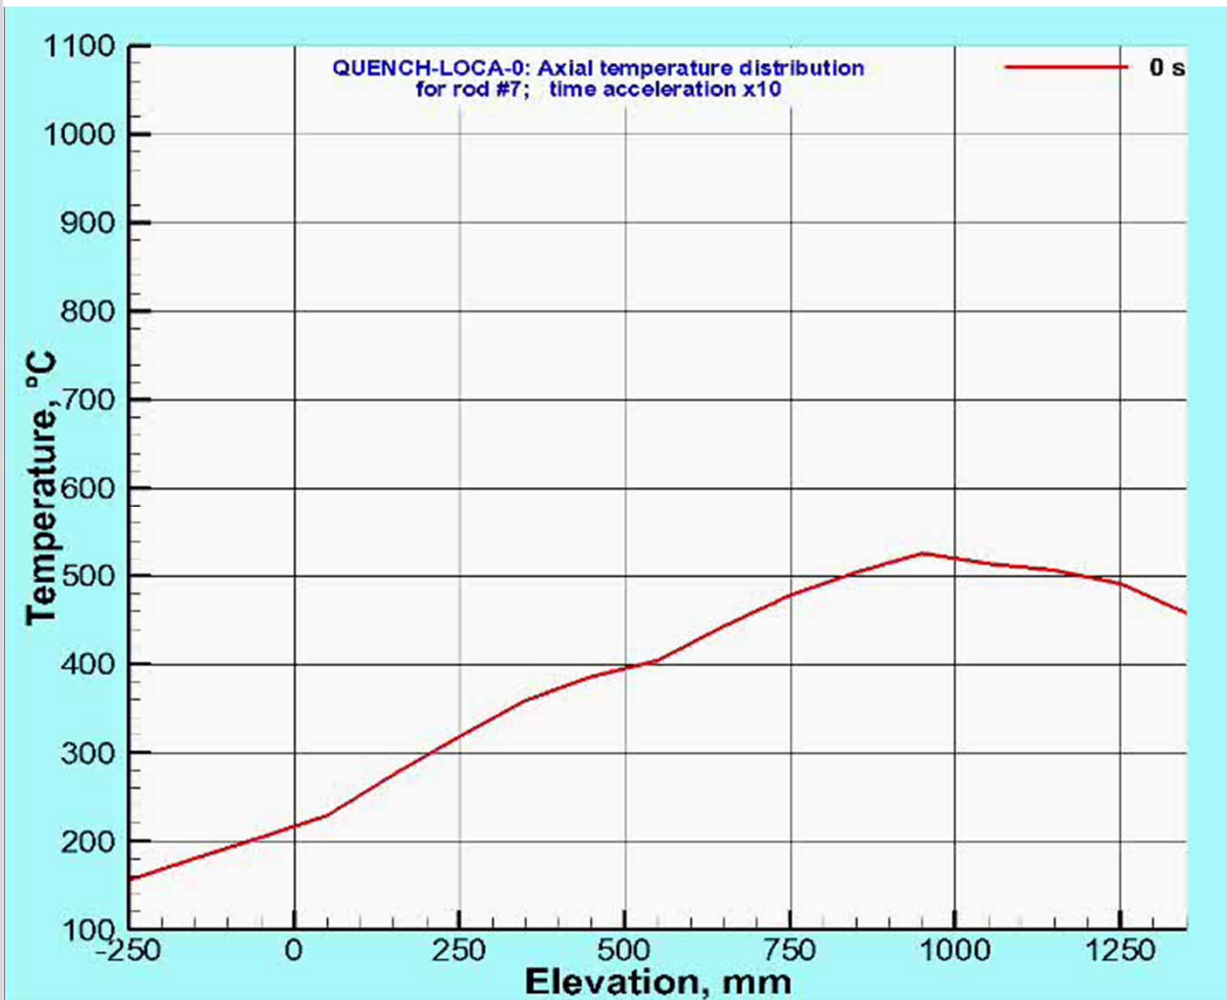
Axial temperature development during the test (movie): surface thermocouples of rod #7

t = 200 s:
cladding surface temperature maximum
reached: $T_{max} = TFS\ 4/13 = 1349\ K = 1076^\circ C$

t ~ 224 s:
beginning of abrupt cladding cooling
to ~ 400 K by entrainment of water
condensed in steam supply tubes

*t = 362 s (not showed):
initiation of quench water supply*

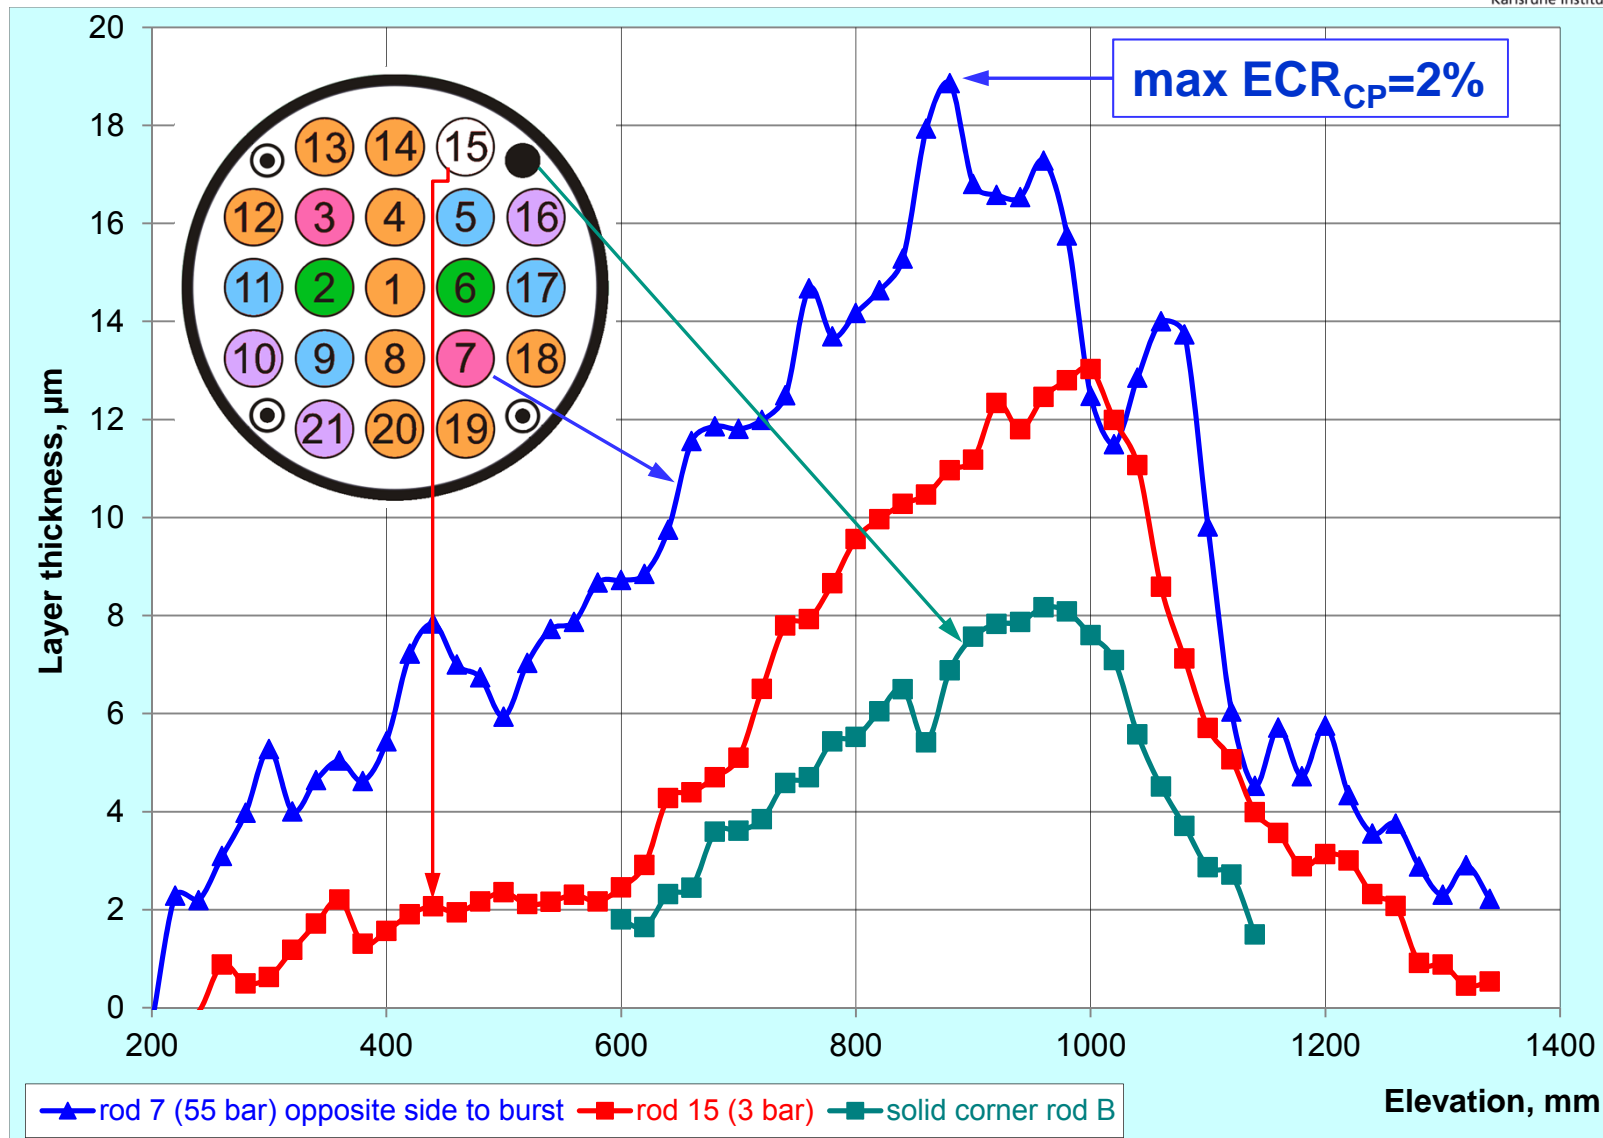
Post-test axial thickness distribution for oxide+ α -Zr(O) : eddy current measurement

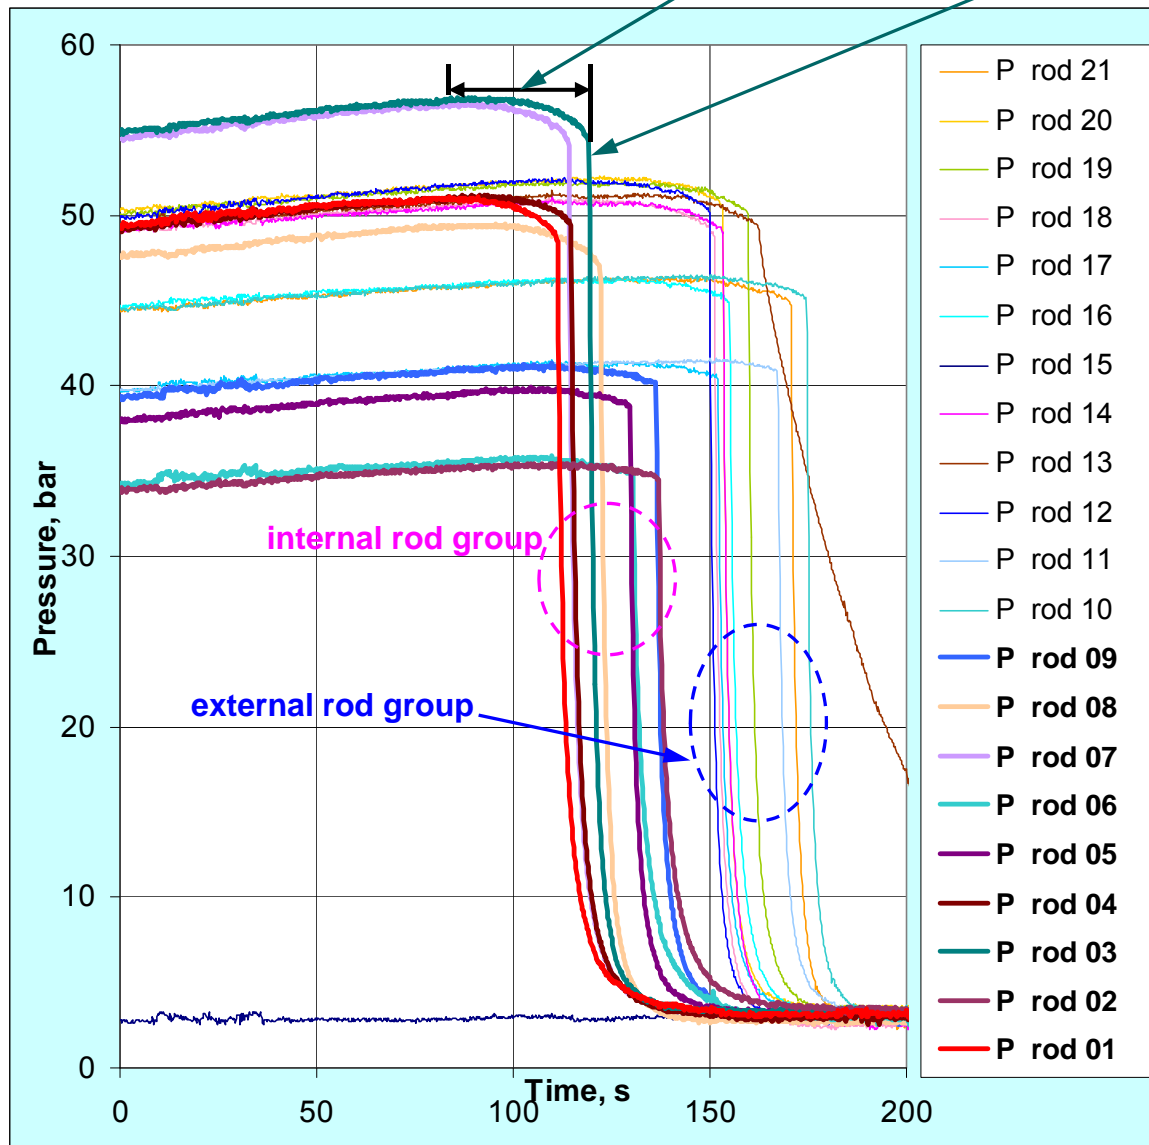
Pressure changing during heating phase (0-187 s) , ballooning and burst

rod	start p, bar	burst p, bar	burst time, s	T@950 mm, C
1	49,3	48,5	111,2	796
7	54,6	54,1	114,2	793
4	49,2	49,5	114,6	800
3	55	54,4	119,2	816
8	47,7	46,8	122,0	813
5	38	38,9	129,6	835
6	34,2	34,7	130,4	833
9	39,2	40,1	136,2	860
2	33,8	34,5	136,8	861 max T
12	49,9	50,2	150,0	815
18	49	48,7	151,2	830
17	39,6	40,4	152,0	854
20	50,3	50,4	153,2	776 min T
14	49	49,0	153,4	821
16	44,6	44,9	155,0	818
19	50	50,0	159,6	850
13	49,4	49,0	162,5	805
11	39,8	40,8	167,2	868
21	44,4	44,8	170,6	795
10	44,5	45,2	174,4	791

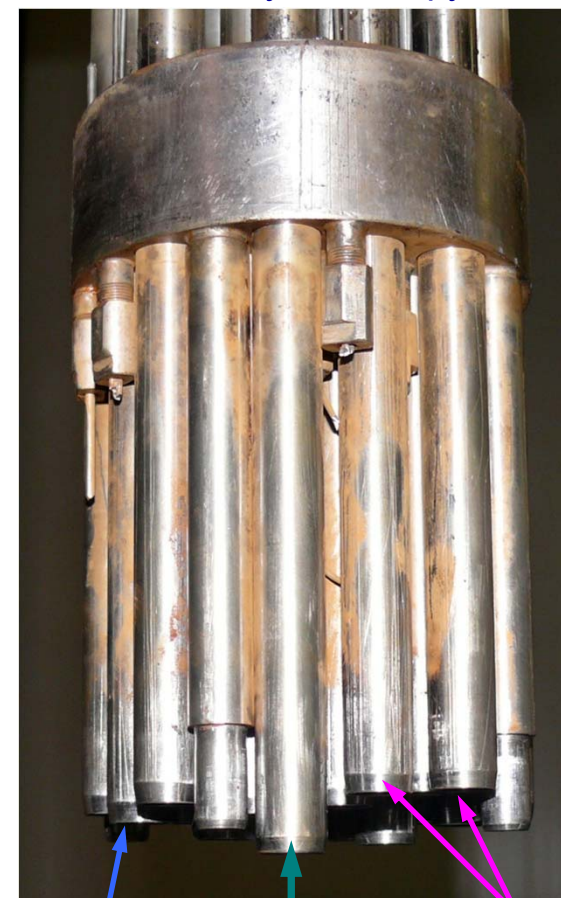
35 bar
not pressurised rod #15
50 bar

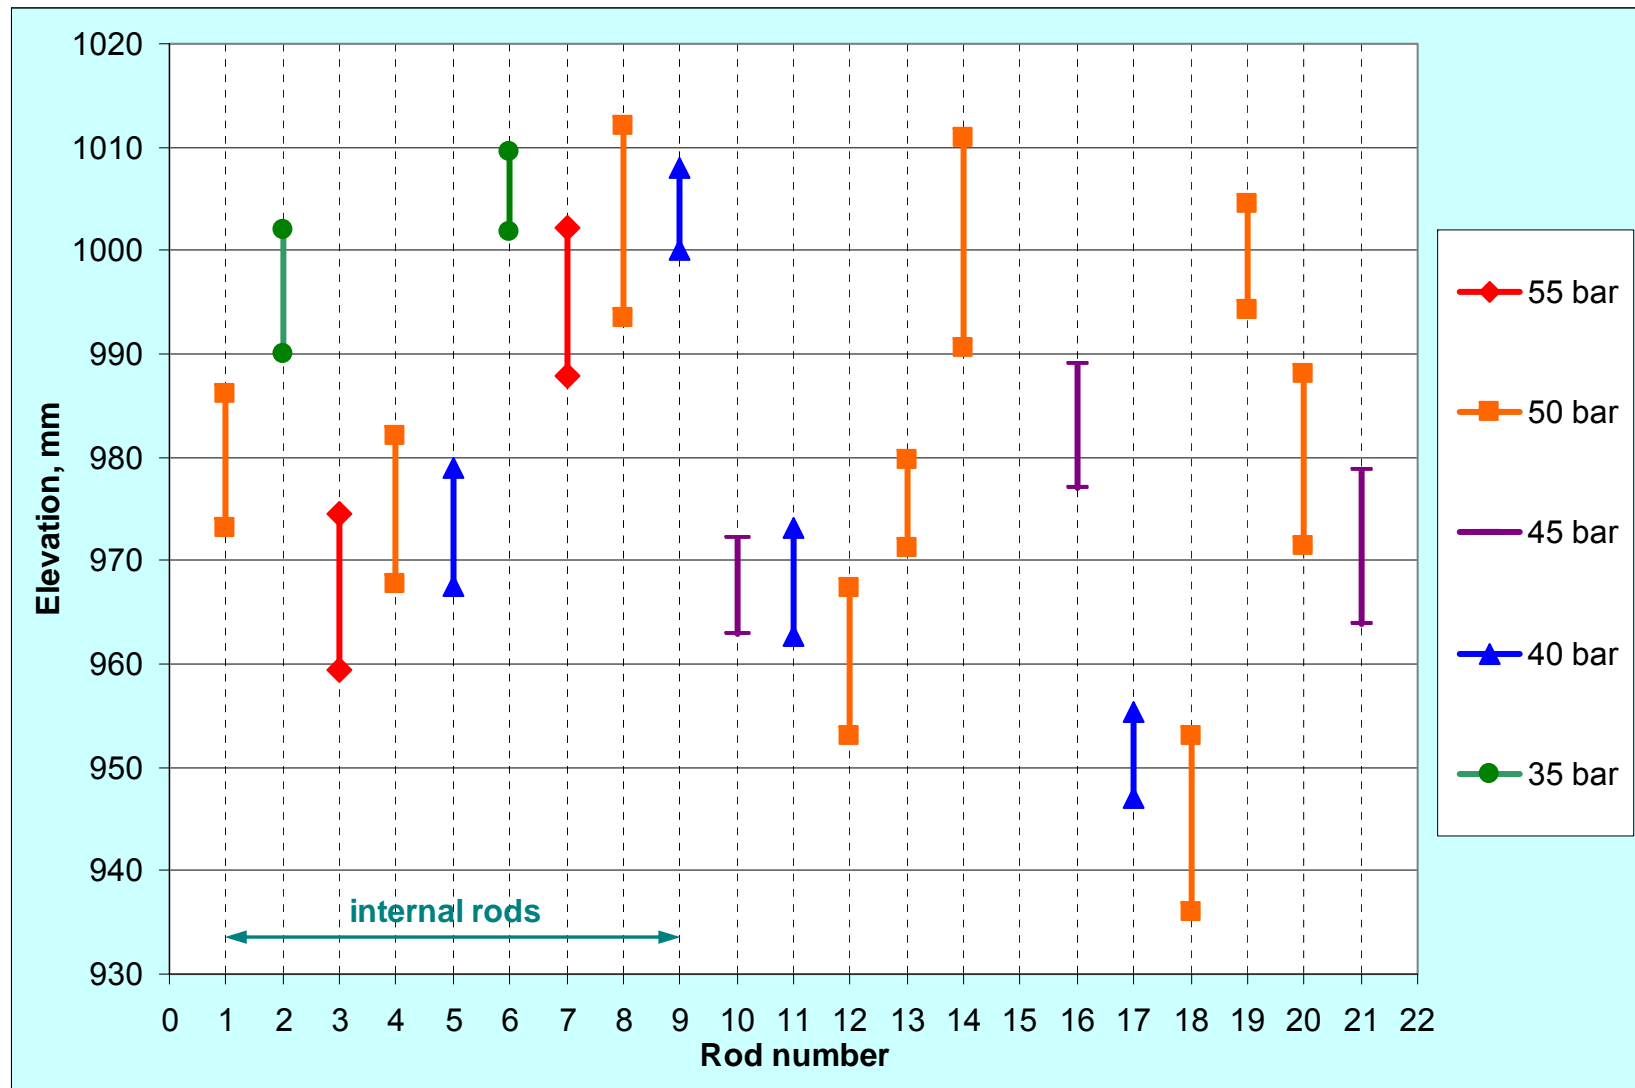
Axial burst positions;

burst length: no clear dependence on pressure

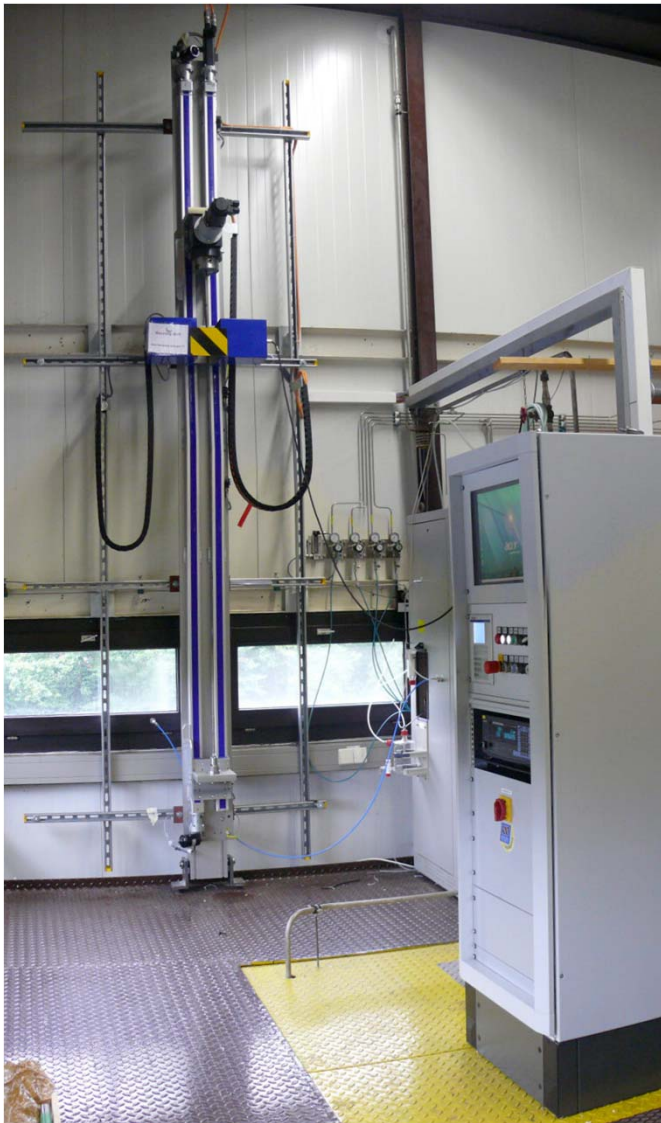
Tube scanner: laser profilometry

scanner facility

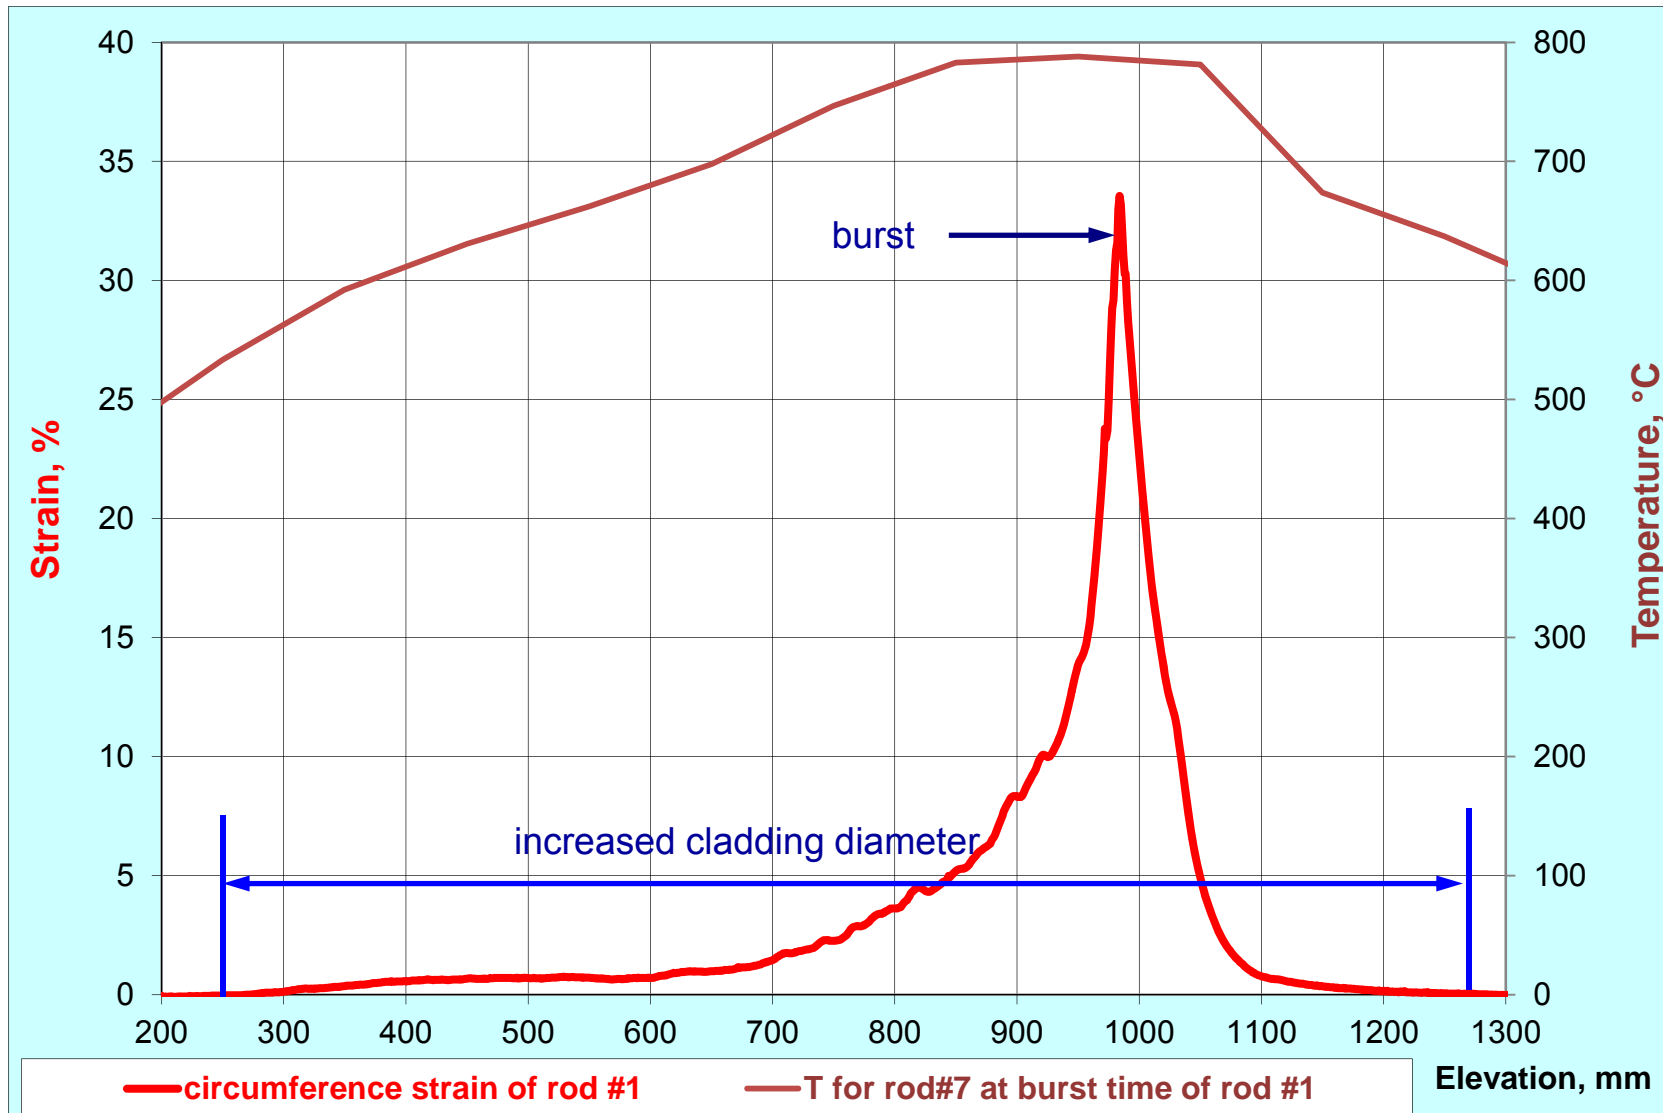
Axial changing of circumference strain (central rod)

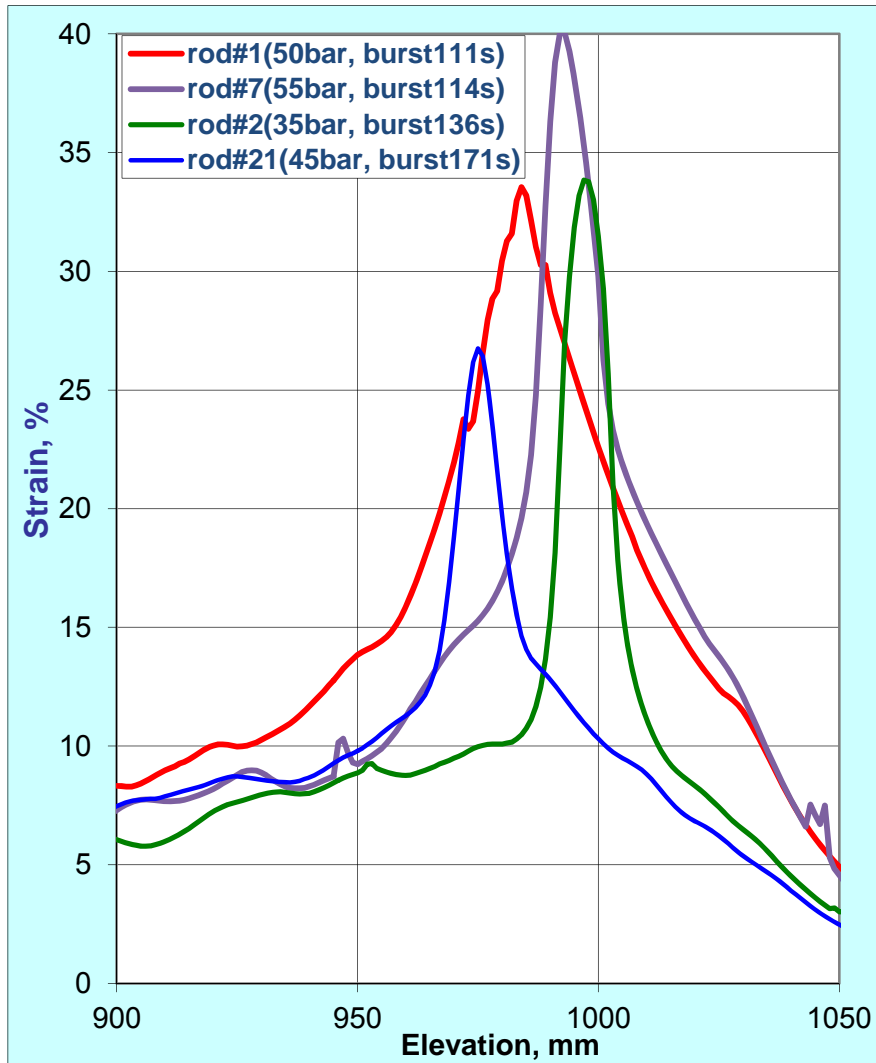
Strain comparison for different rods

ballooning region:
extended ballooning for central rod (#1)

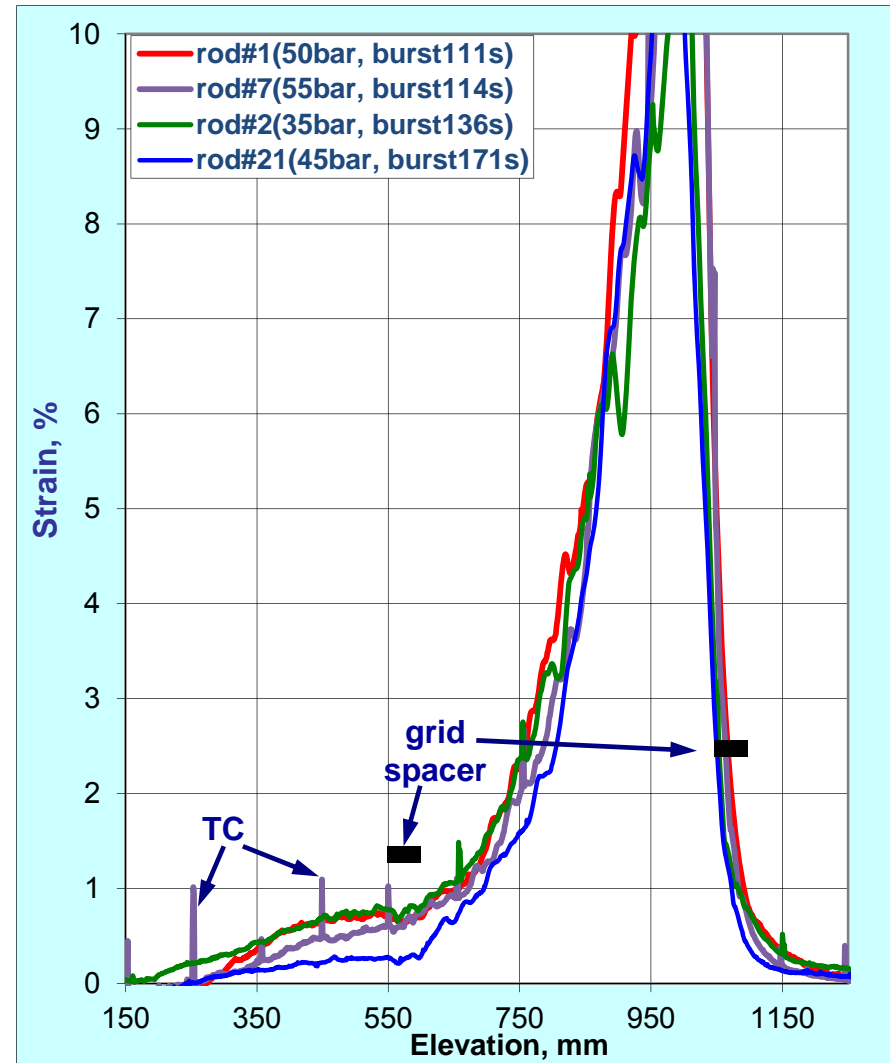
total strain region between 150 and 1300 mm

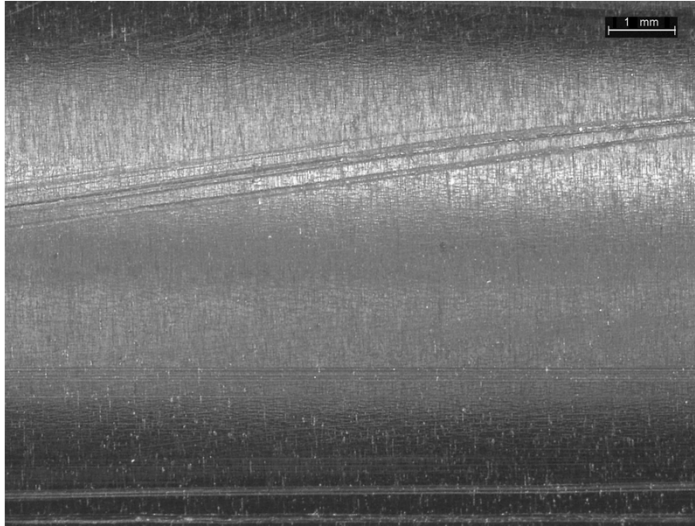
Cladding surface structure: formation of axial surface cracks during ballooning

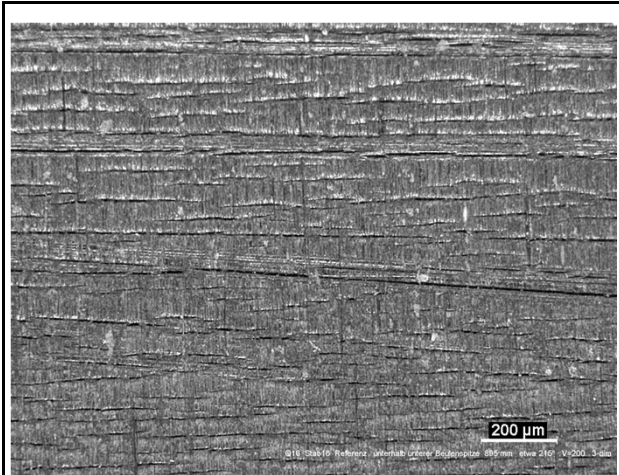
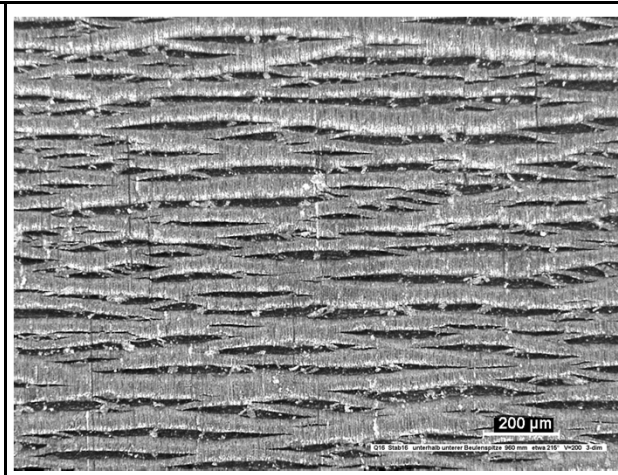
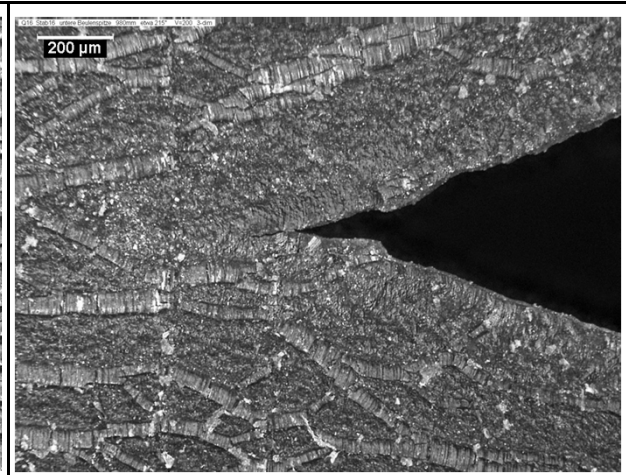
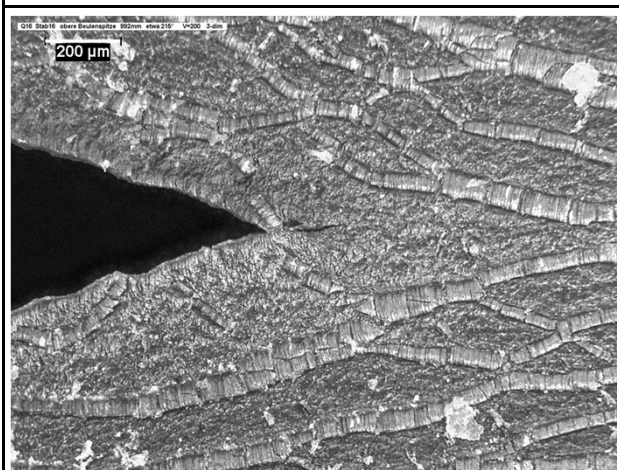
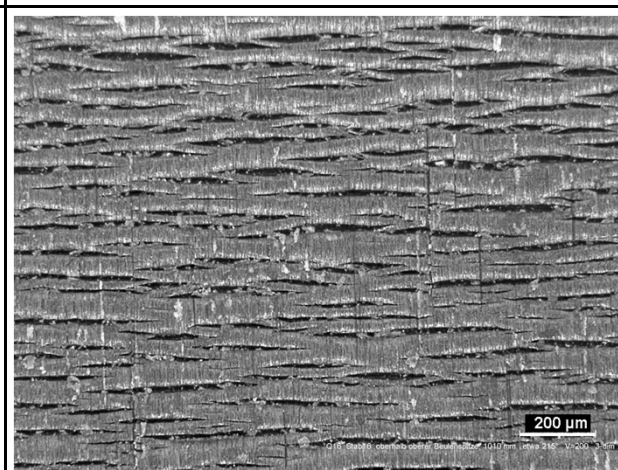
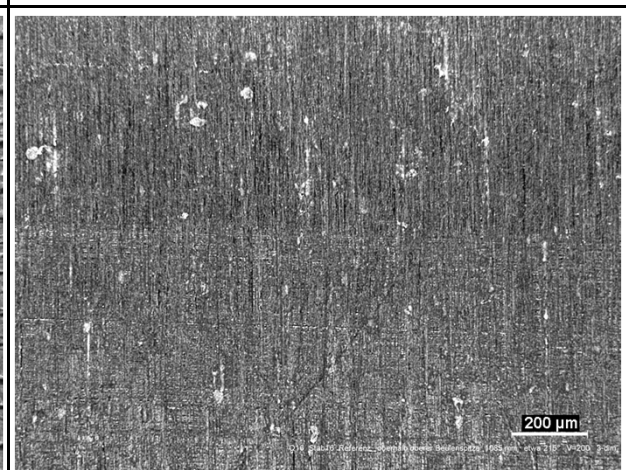
Axial changing of surface crack structure downwards and upwards from burst; rod #16 (45 bar), angle 215°

<p style="text-align: center;">Elevation 895 mm: thin axial cracks</p>	<p style="text-align: center;">Elevation 960 mm: thick axial cracks</p>	<p style="text-align: center;">Elevation 980 mm: large cells</p>

<p style="text-align: center;">Elevation 992 mm: large cells</p>	<p style="text-align: center;">Elevation 1010 mm: thick axial cracks</p>	<p style="text-align: center;">Elevation 1085 mm: absence of axial cracks</p>

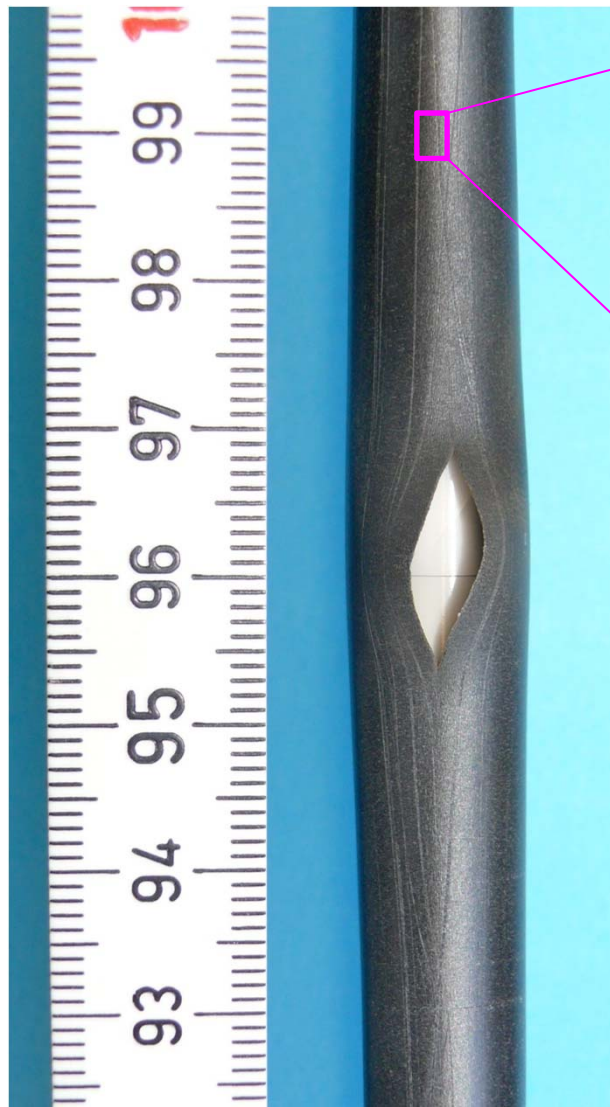
“Self-healing” surface cracks developed during ballooning rod #3 (55 bar), angle 140°

surface structure:
network of
longitudinal cracks
(“tree bark”)

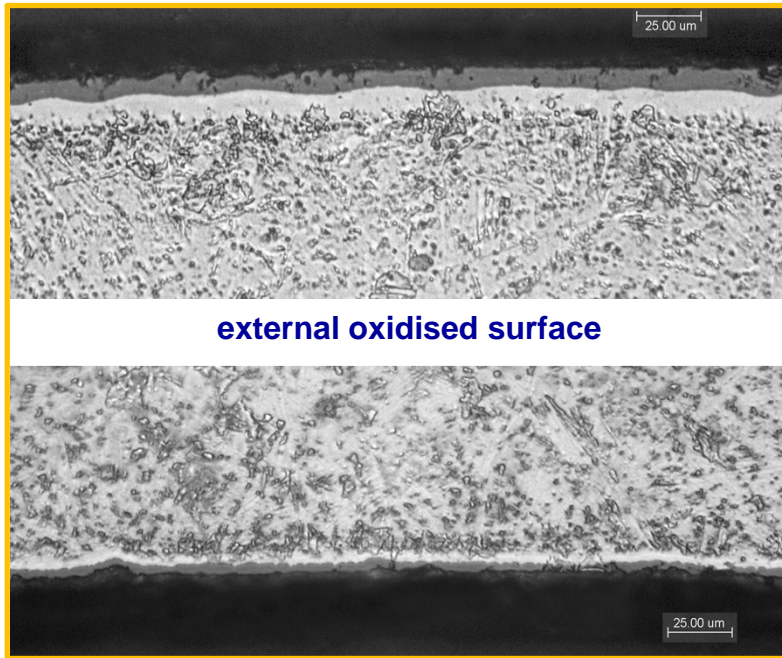
Different internal and external oxidation degree outside burst elevation /rod #3 (55 bar)/

external oxidised surface

internal oxidised surface

internal negligible oxidised surface

external oxidised cracked surface

**crack development during
circumferential extension**

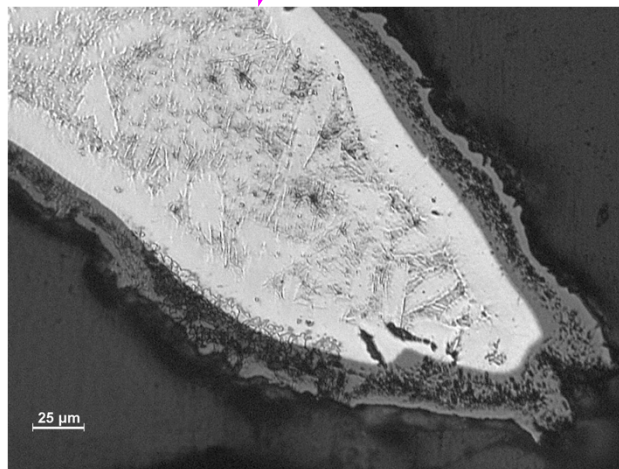
Similar internal and external oxidation degree at burst elevation rod #3 (55 bar)

external
oxidised
surface

internal
oxidised
surface

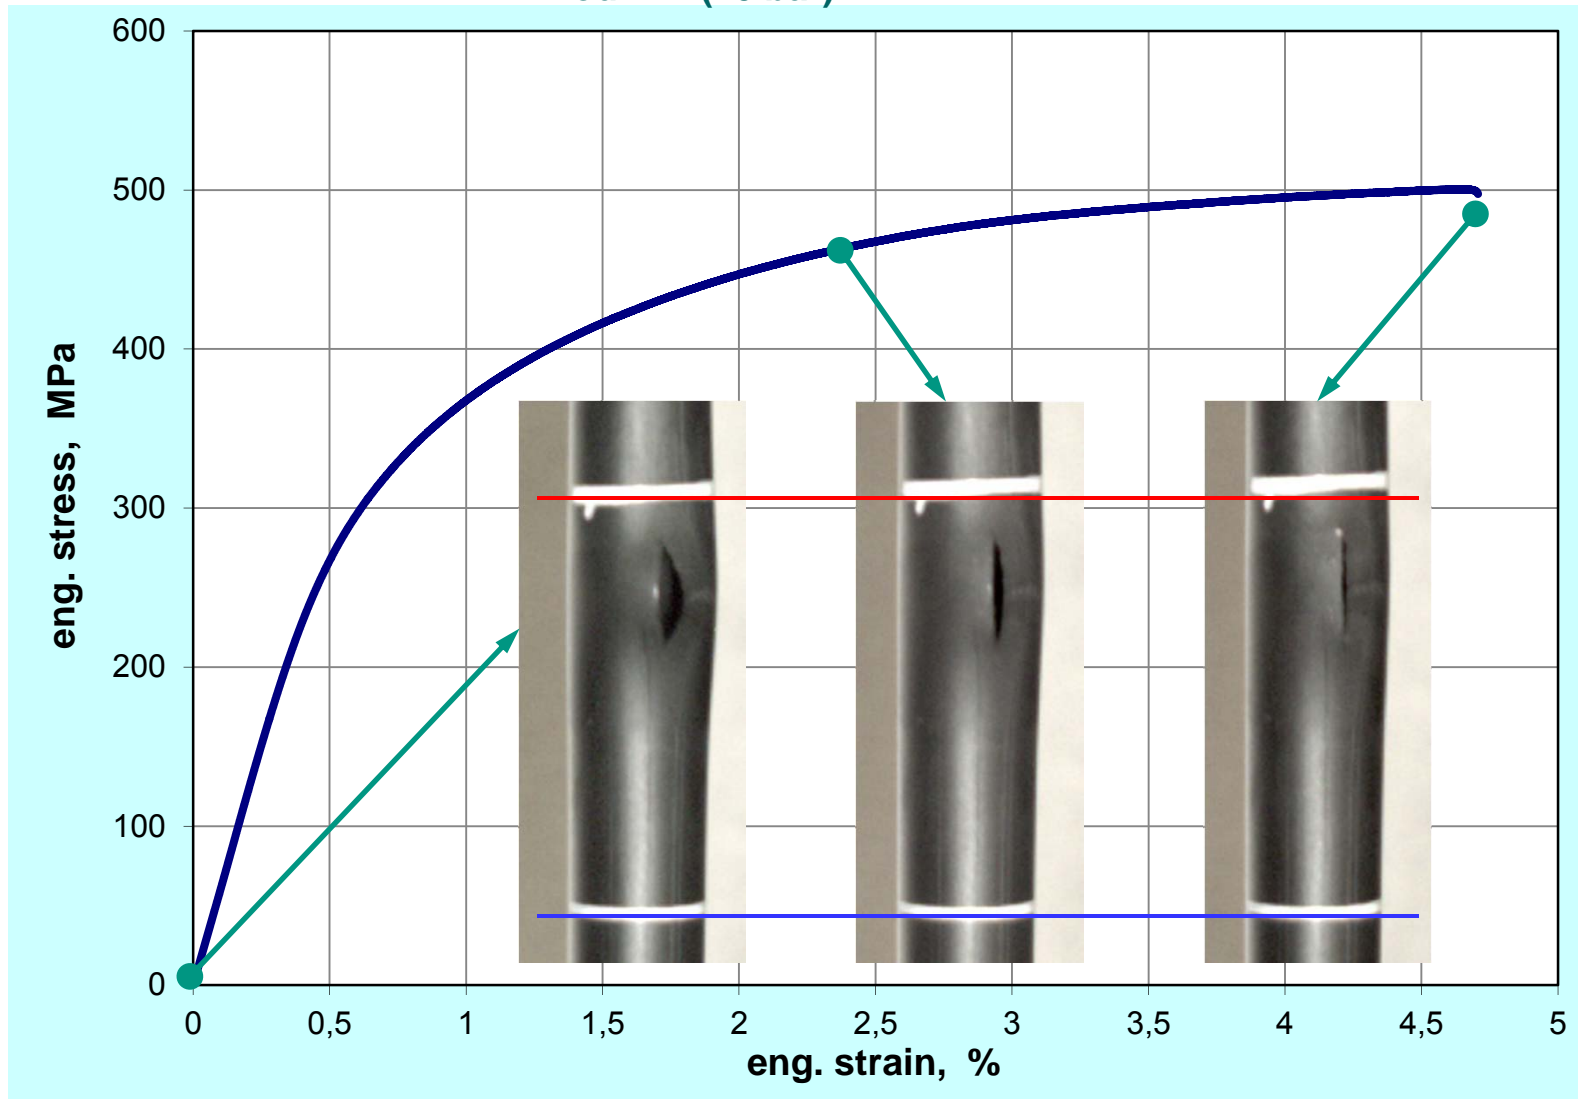
Cladding deformation during tension test: axial extension and radial contraction with burst closing rod #17 (40 bar)

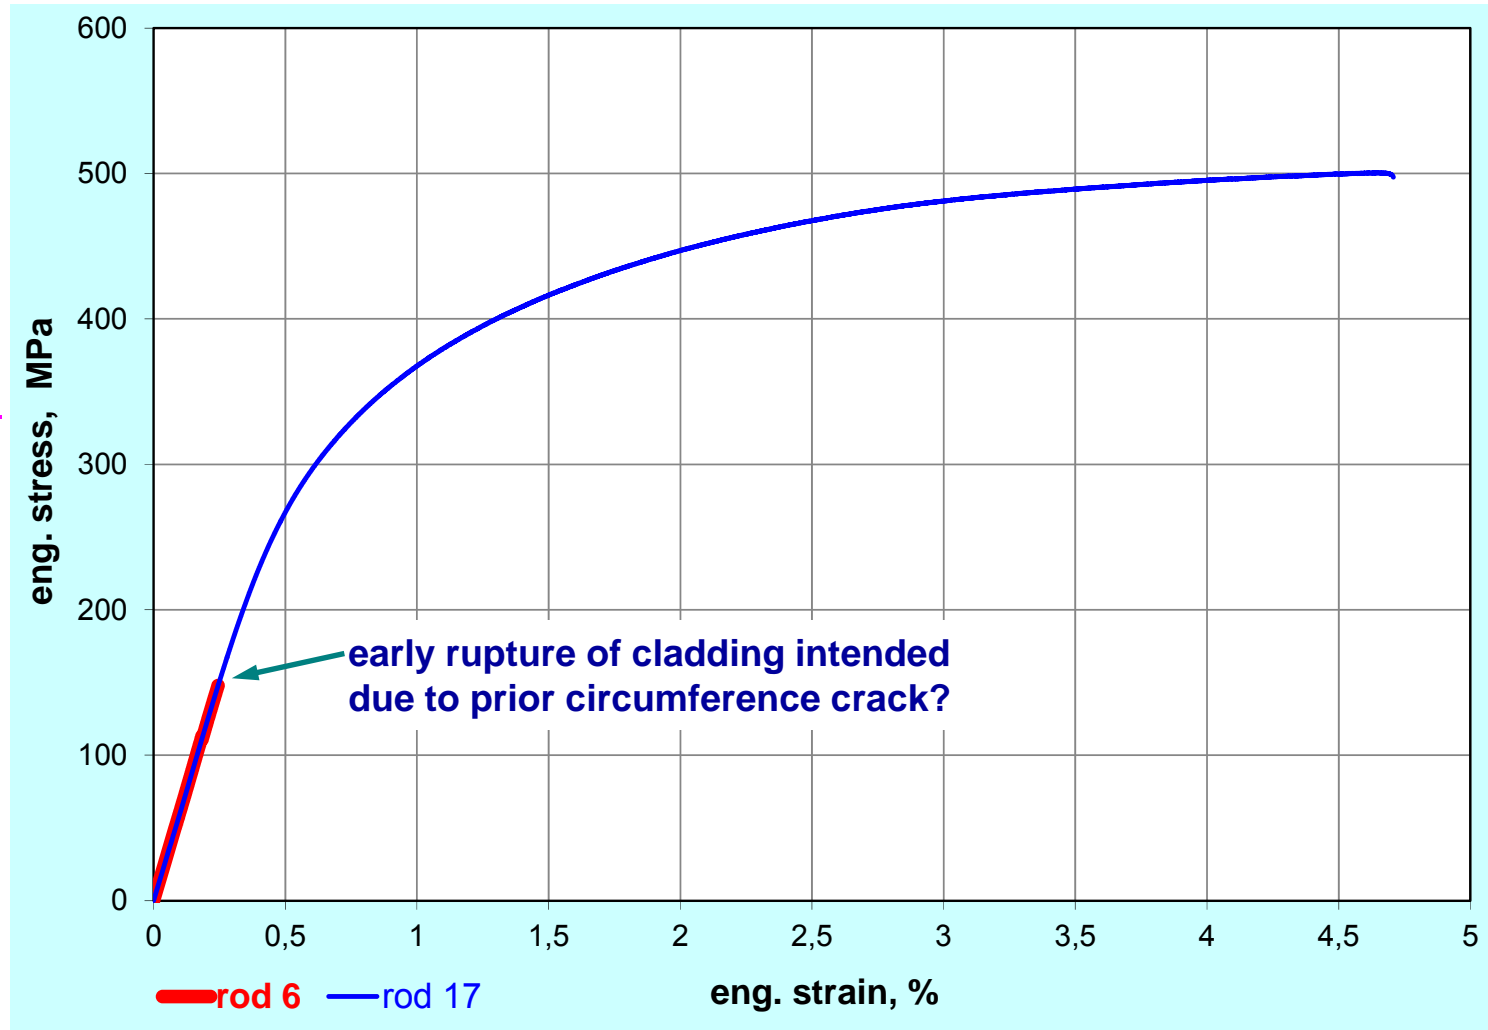
Tension test at rod #6: early rupture at burst position
