Results of the commissioning bundle test QUENCH-L0 performed under LOCA conditions

Objective

- **Modification of electric heated high temperature facility QUENCH at KIT for performance of bundle tests under LOCA conditions.**
- **Bundle test with 21 rod simulators with slightly preoxidized Zircaloy-4 cladding tubes.**
- **Bringing into service two post-test methodologies: 1) laser cladding profilometry; 2) tension and ring compression tests for cladding segments.**

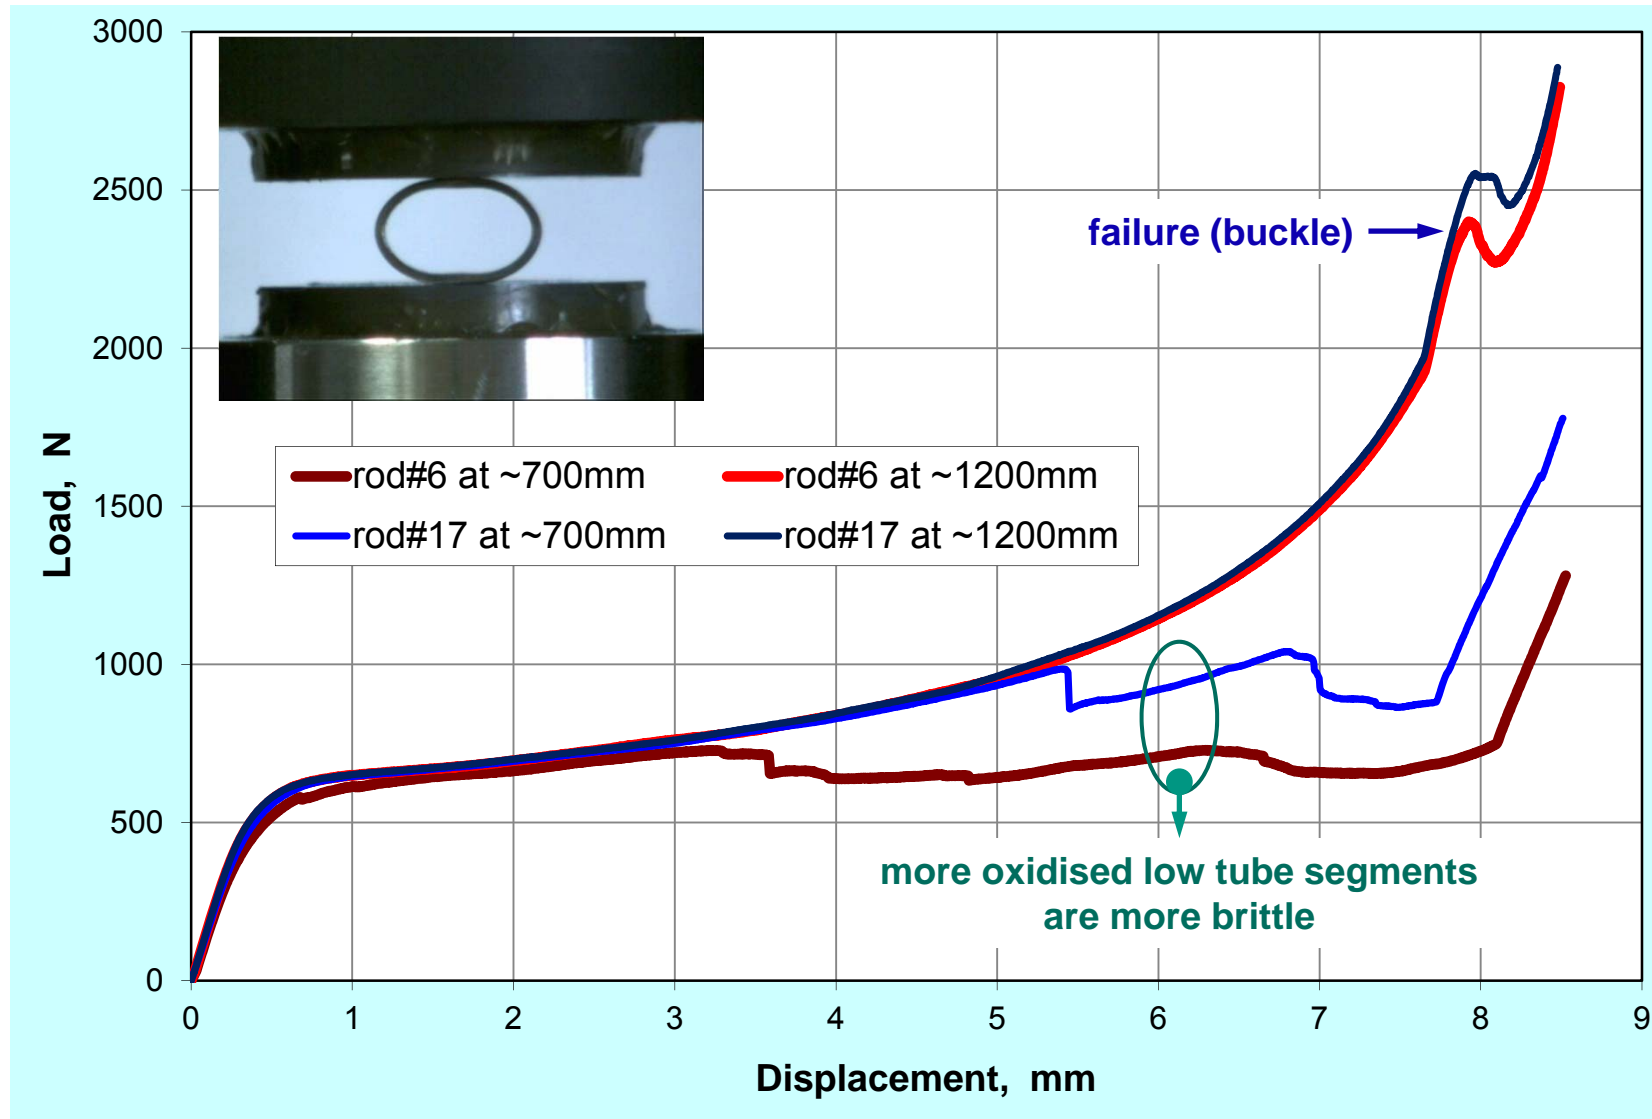
Results of ring compression tests: rings with $h \sim 10$ mm from two elevations
