Results of the reference bundle test **QUENCH-L1** with Zircaloy-4 claddings and future planning of the **QUENCH- LOCA** program

QWS18, Karlsruhe 2012

Institute for Applied Materials; Program NUKLEAR

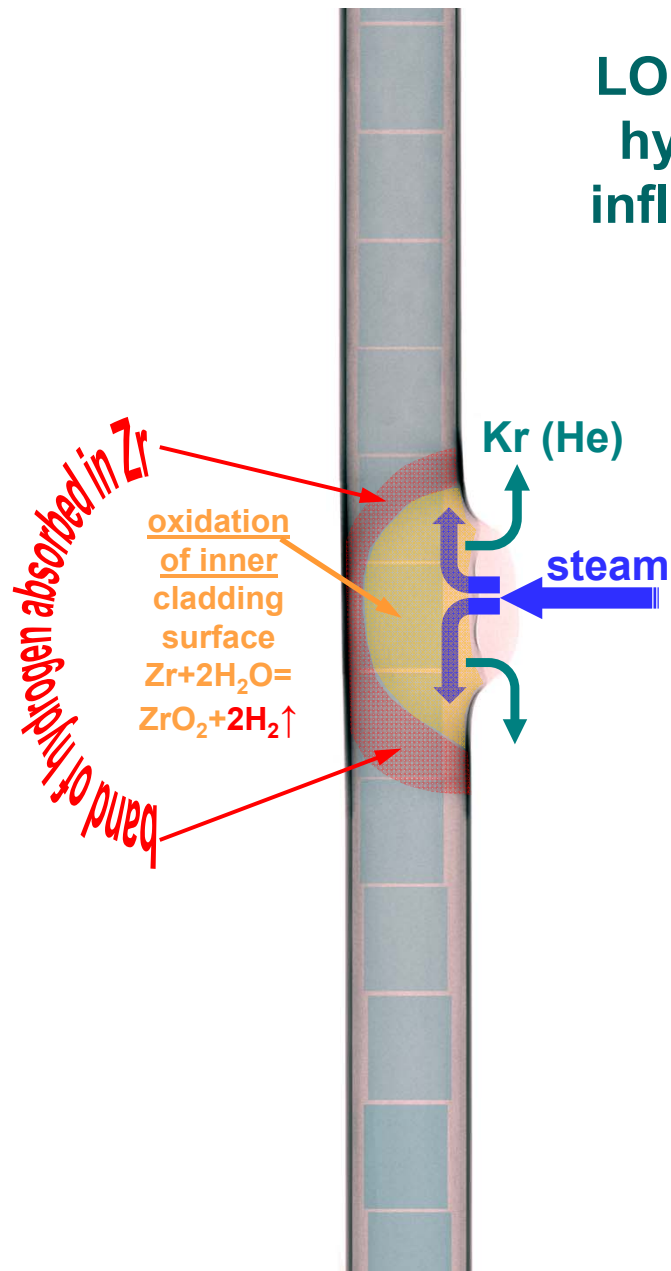
LOCA program at KIT on secondary hydrogenation of cladding and its influence on cladding embrittlement

Sequence of phenomena:

- cladding ballooning and burst, relief of inner rod pressure
- steam penetration through the burst opening, steam propagation in decreasing gap between cladding and pellet
- oxidation of inner cladding surface with hydrogen release
- absorption of hydrogen by cladding at the boundary of inner oxidised area
- local embrittlement of cladding near to burst opening

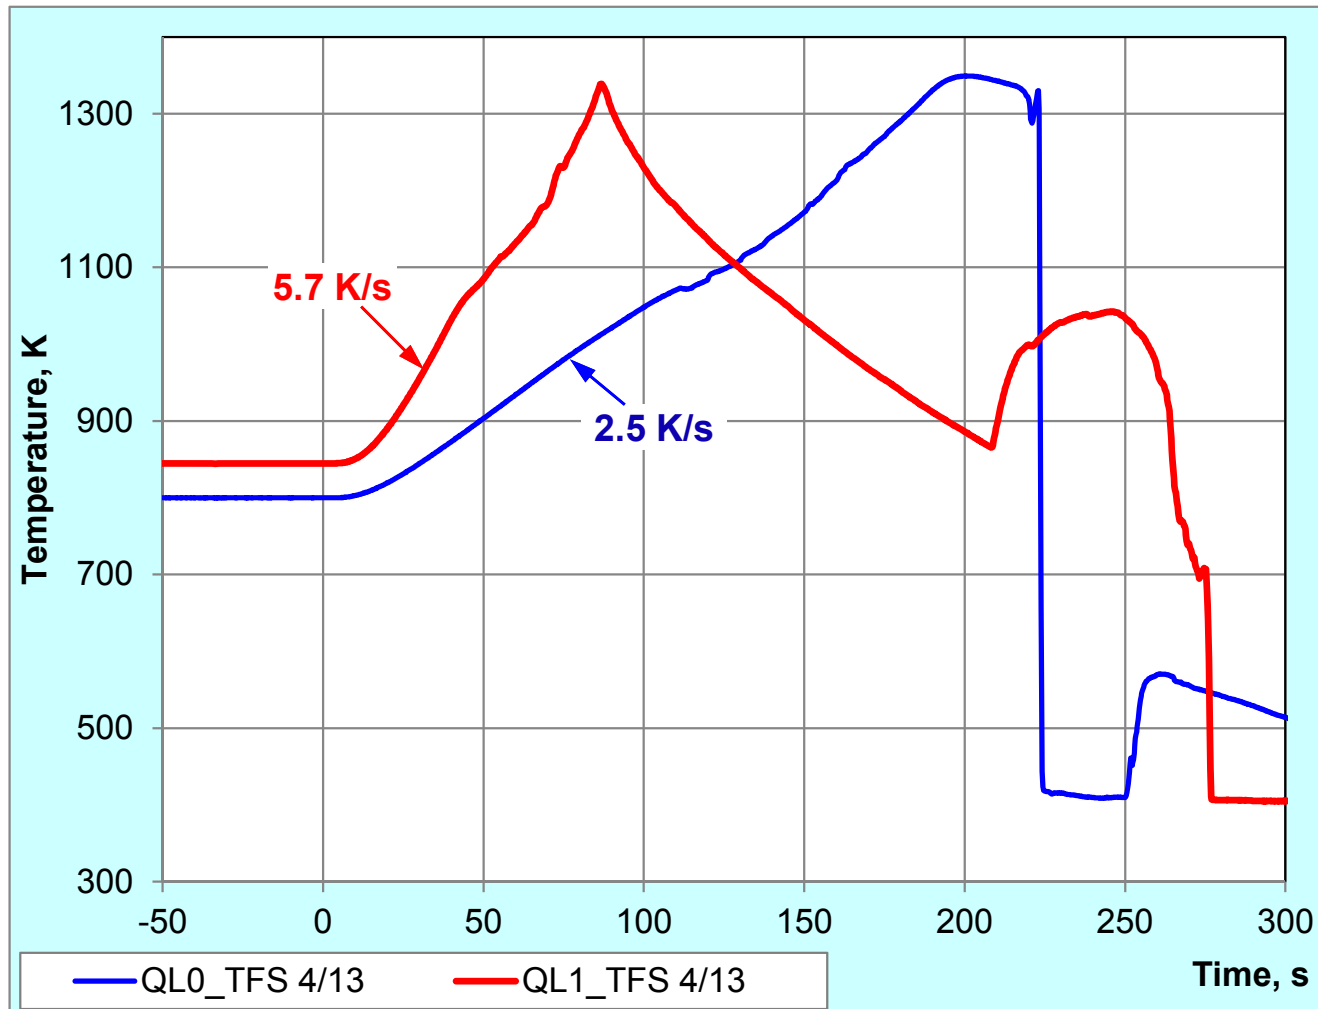
Comparison of cladding temperatures at hottest bundle elevation of 950 mm for QUENCH-L0 and -L1

enhancements for QUENCH-L1:
1) prototypical high heating rate; 2) prototypical cool-down phase

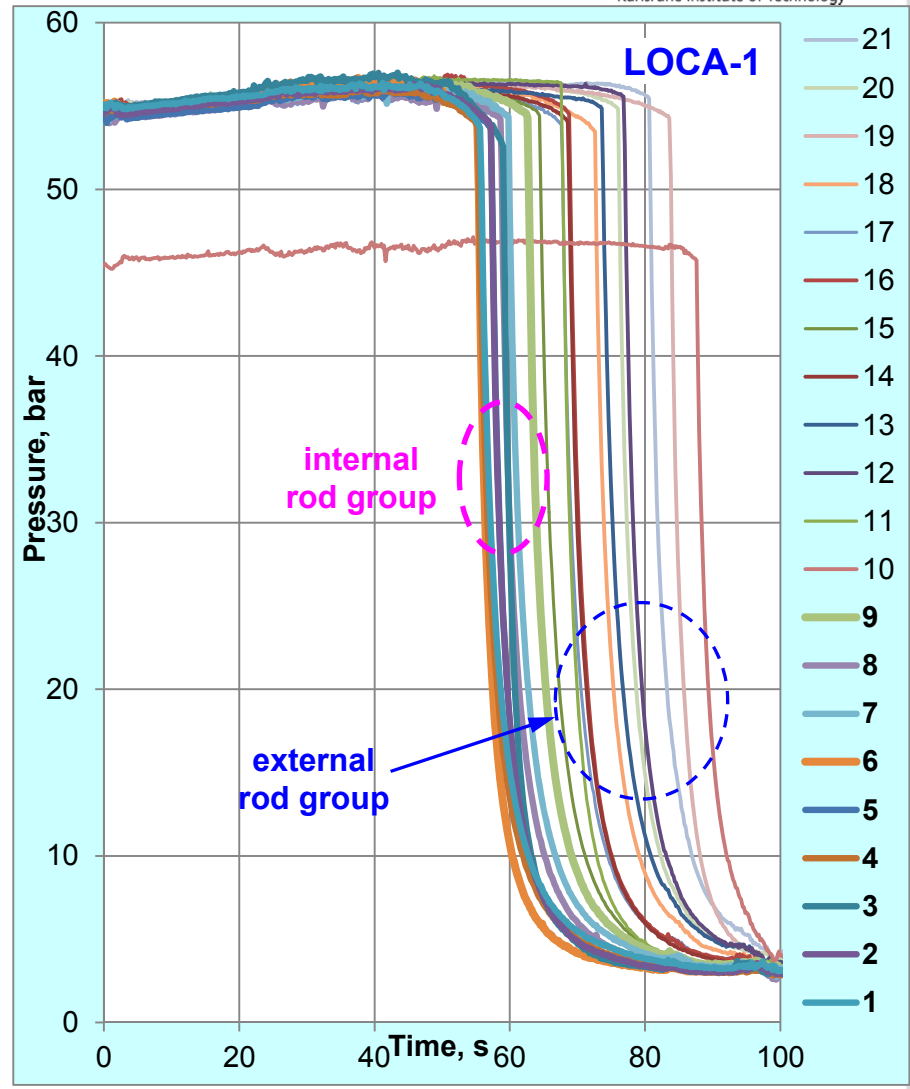
Rod pressure evolution during heating phase for QUENCH-L0 and -L1: burst time indication (coincided with MS results on Kr release)

duration of decrease of the inner pressure to the system pressure: $\tau_0 \approx 38$ s

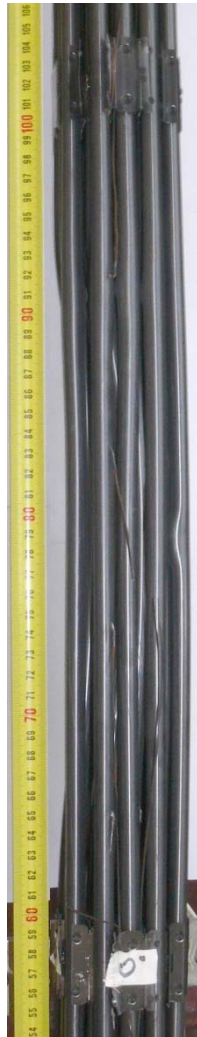
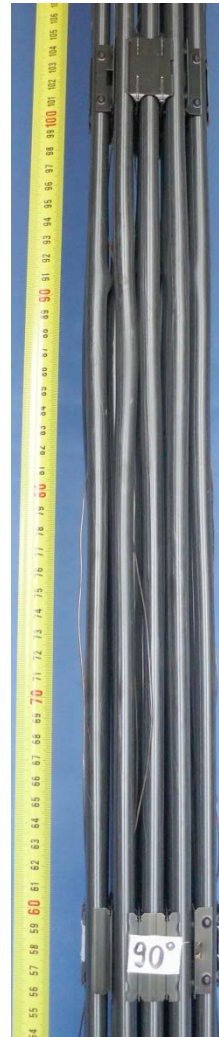
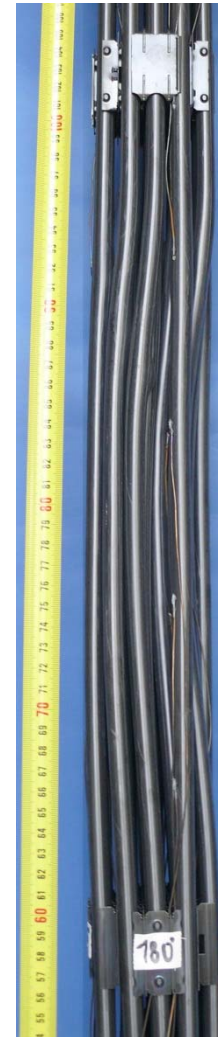
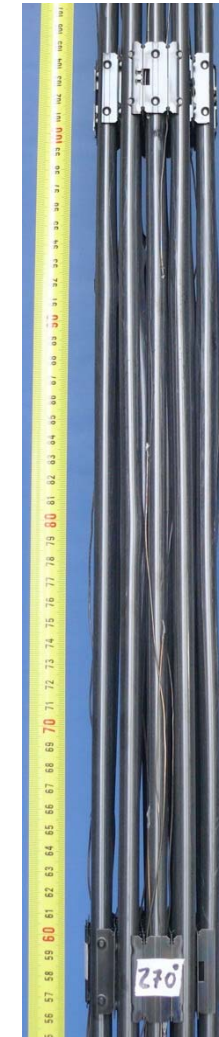
Post-test QL1 bundle view between GS3 and GS4

180°: rod bending

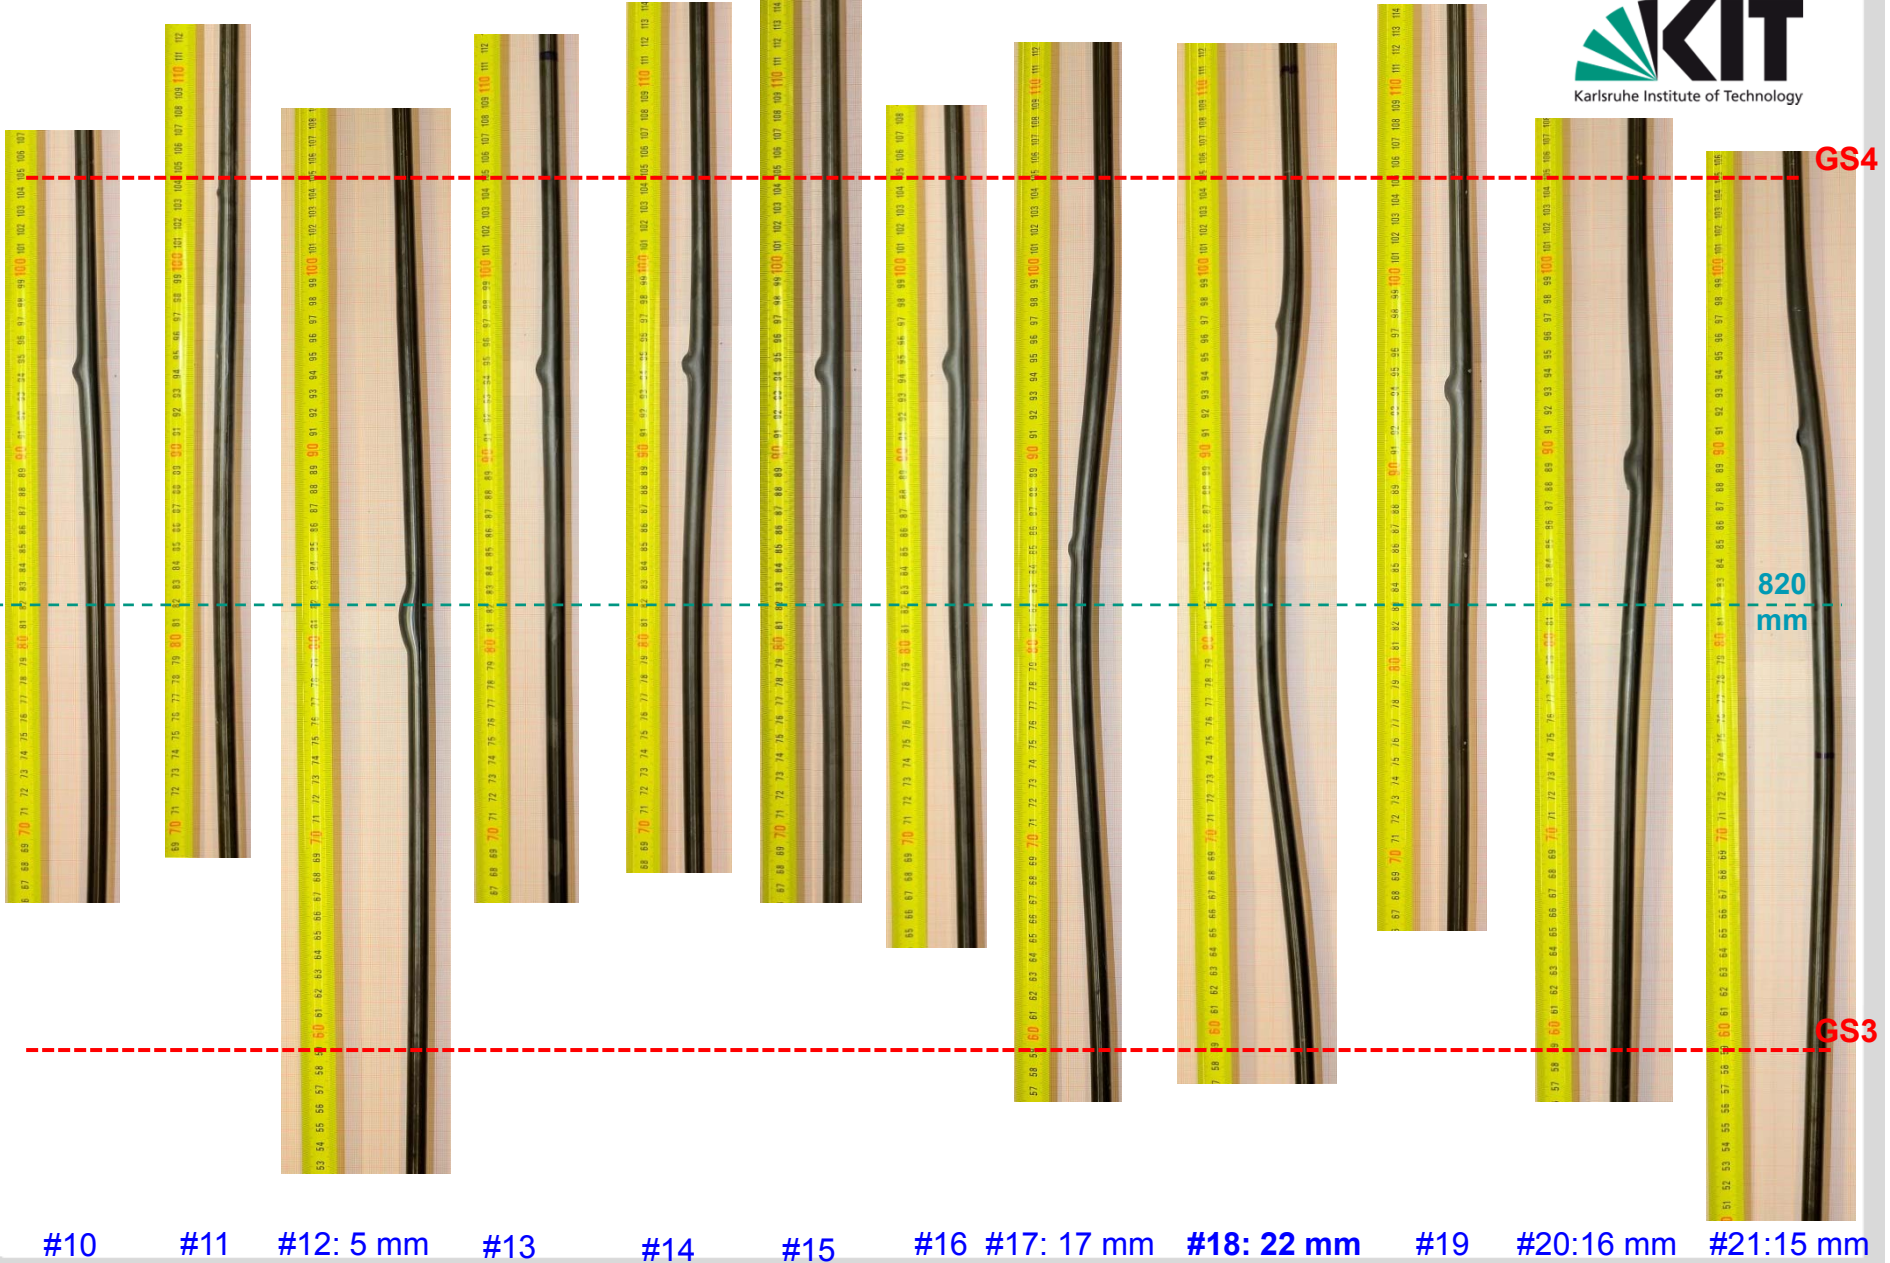
QL1: Bending of periphery rods

#10 #11 #12: 5 mm #13 #14 #15 #16 #17: 17 mm #18: 22 mm #19 #20: 16 mm #21: 15 mm

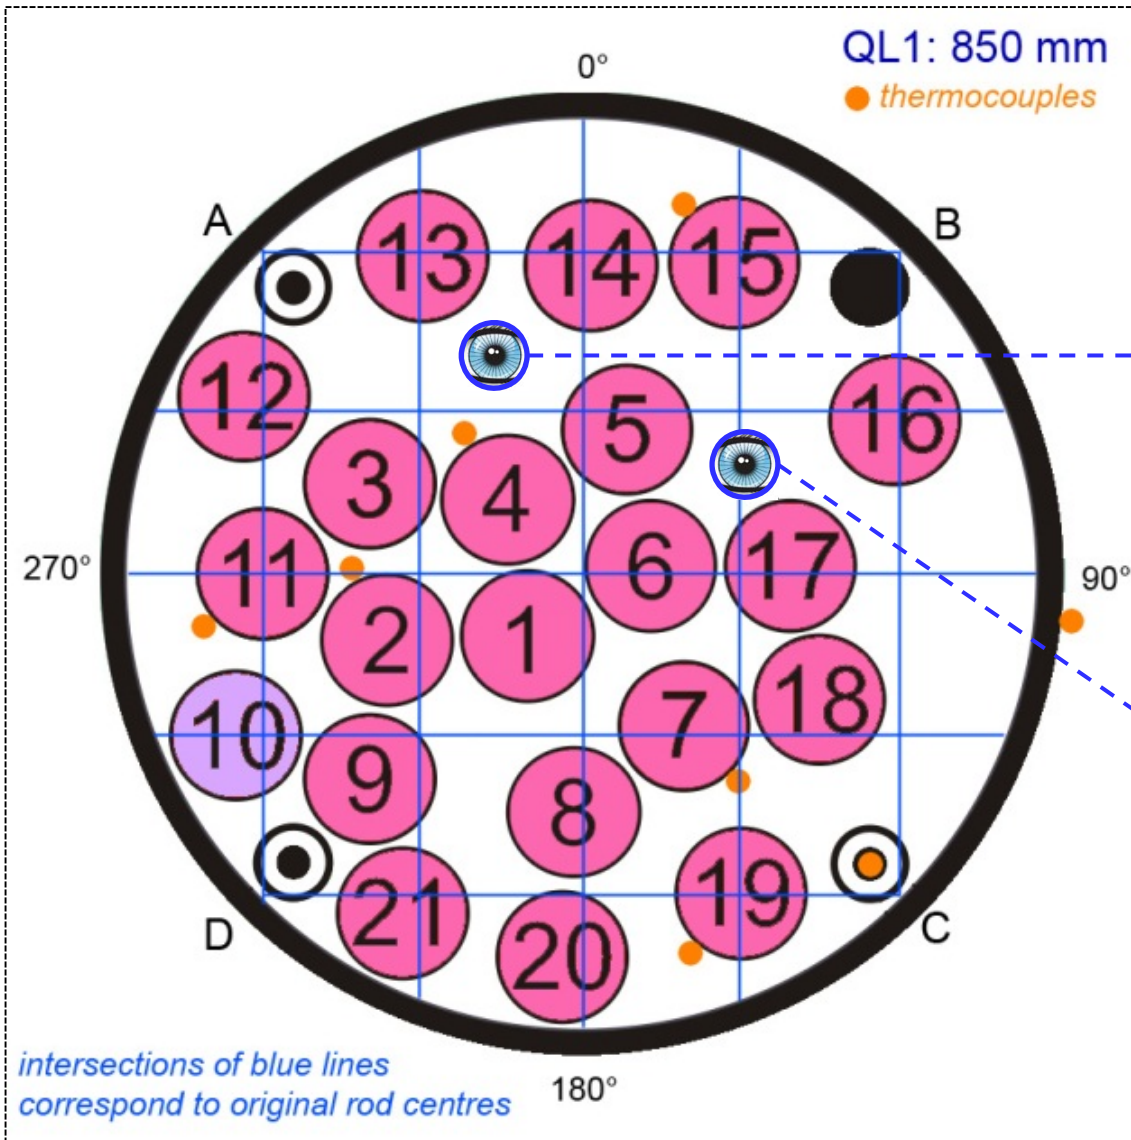
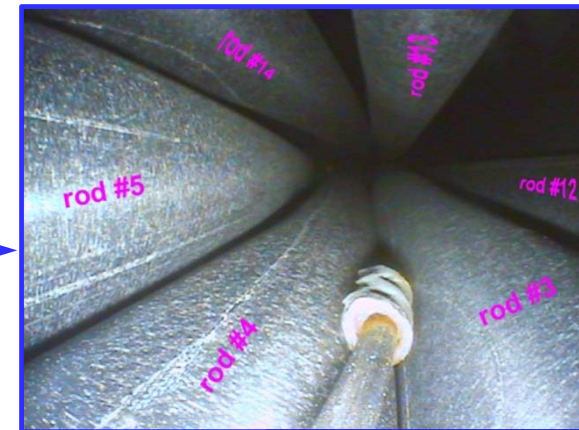
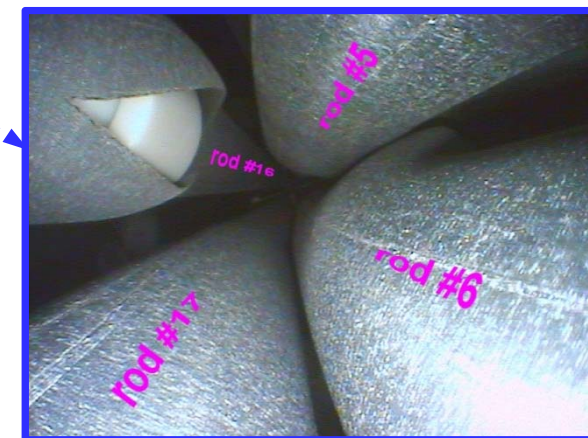
QL1: estimation of rod position near to middle position between two spacer grids according to measured rod bending and videoscope observations

850 mm: touched rods # 3, 4, 5

950 mm: touched rods # 5, 6, 17

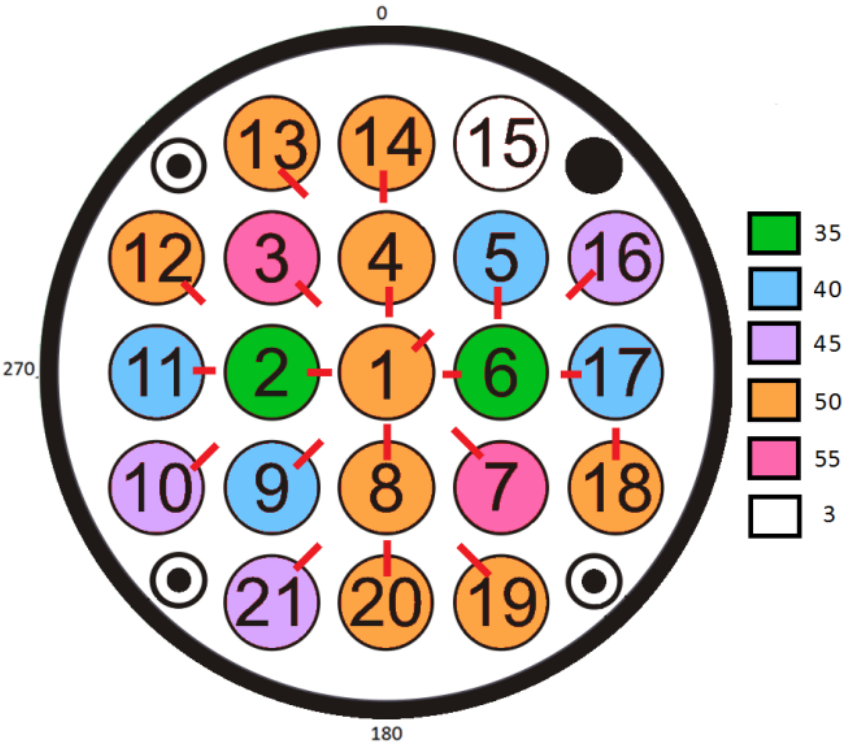
Circumferential position of burst openings

LOCA-0:
 openings oriented
 to bundle center
 due to strong radial T gradient

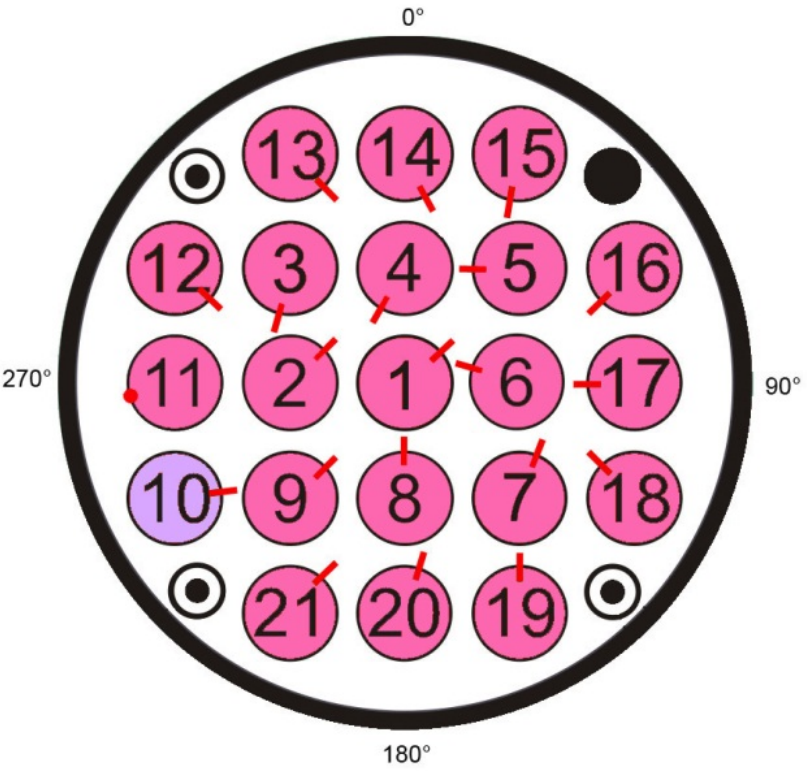
LOCA-1:
 not strong orientation
 to bundle center

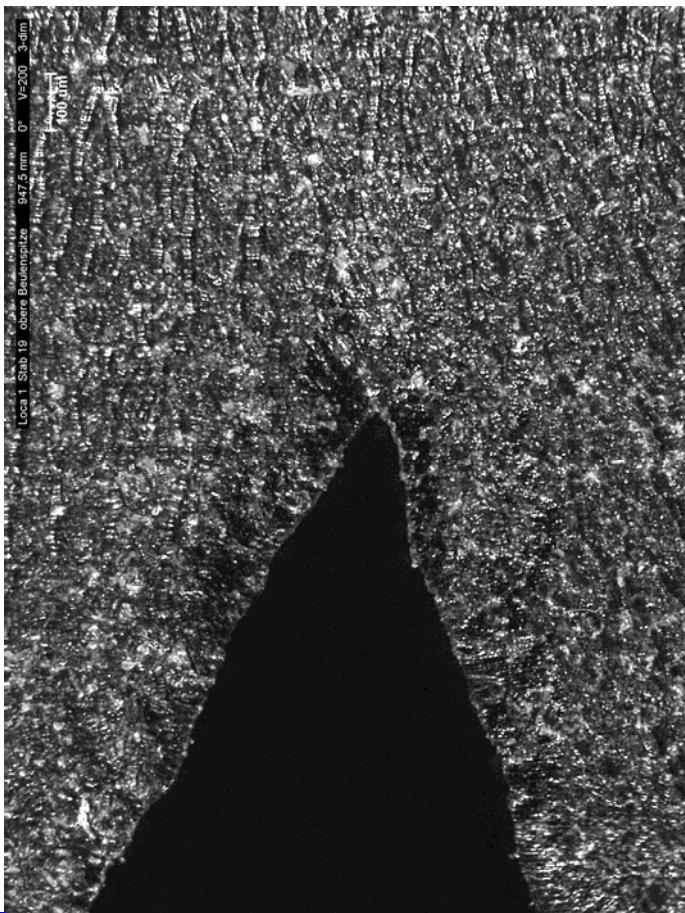
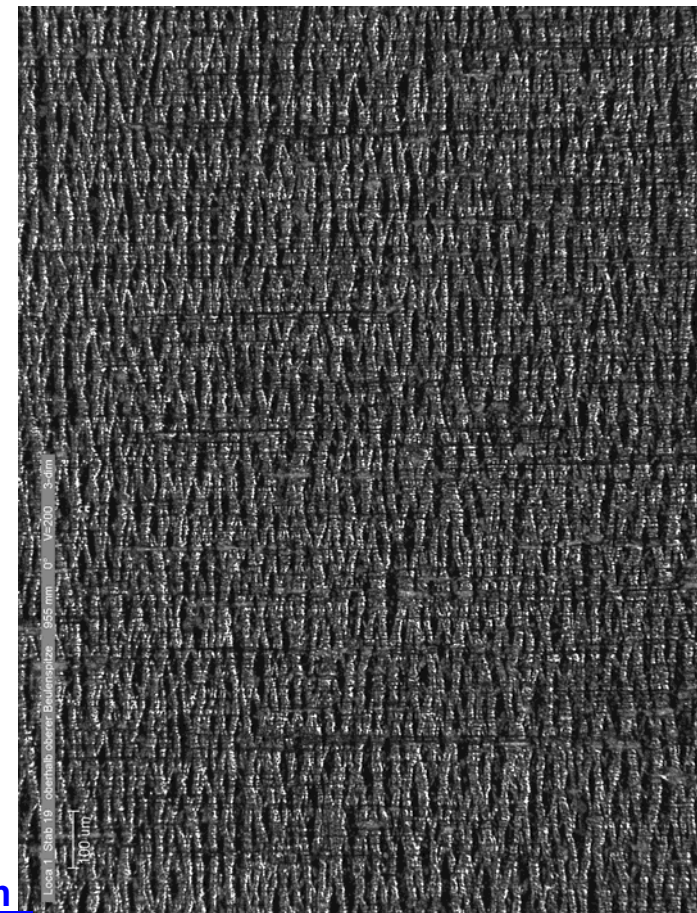
LOCA-1, oxidised outer surface of ballooning region (rod #19): typical tree bark structure with micro cracks formed due to strain during ballooning

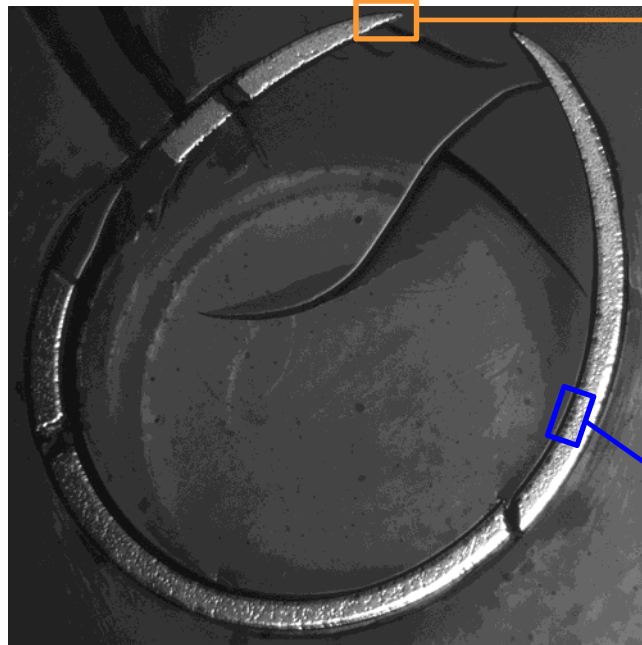
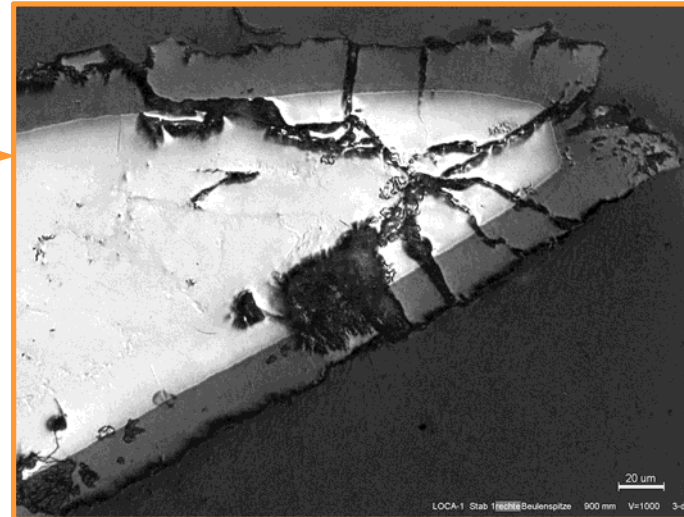
Outer and inner cladding oxidation at 900 mm for LOCA-1, rod #1

inner and outer oxide:
20 μm

inner oxide:
20 μm

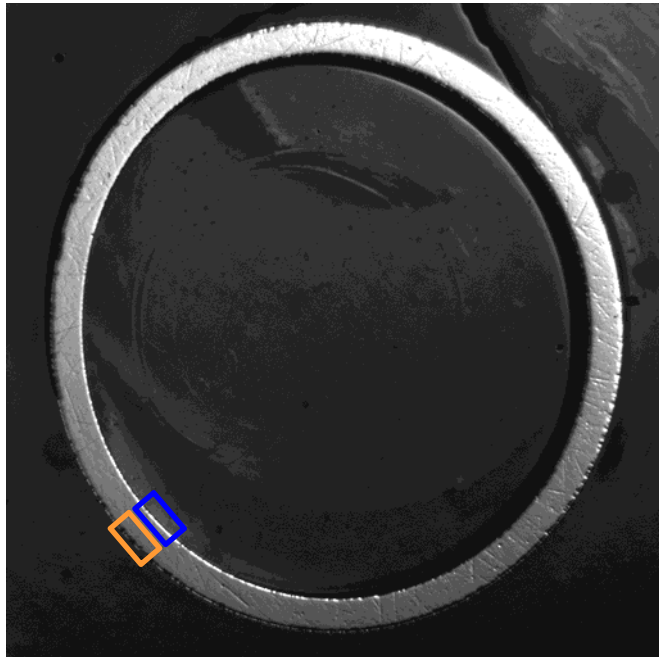
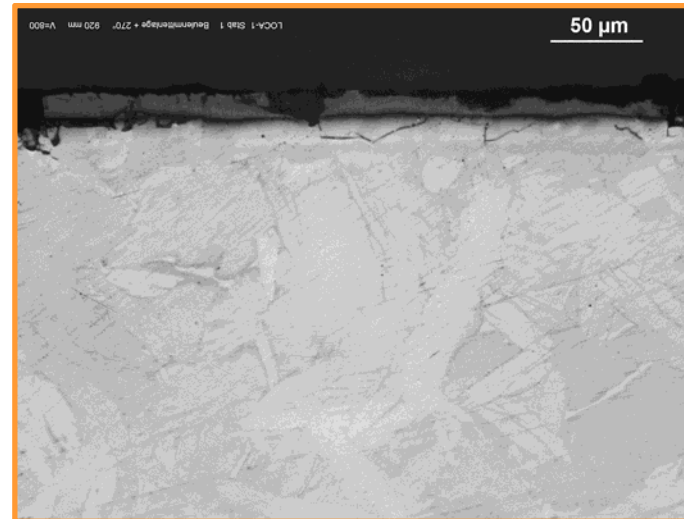
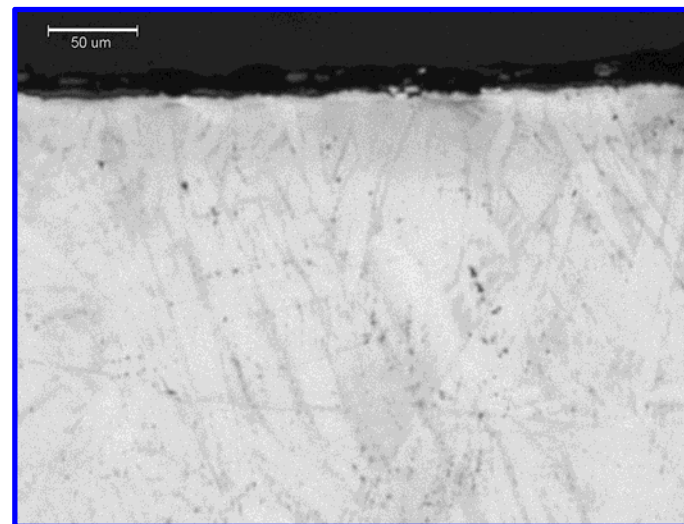
Outer and inner cladding oxidation at 920 mm of LOCA-1, rod #1

outer oxide:
12 µm

inner oxide:
4 µm

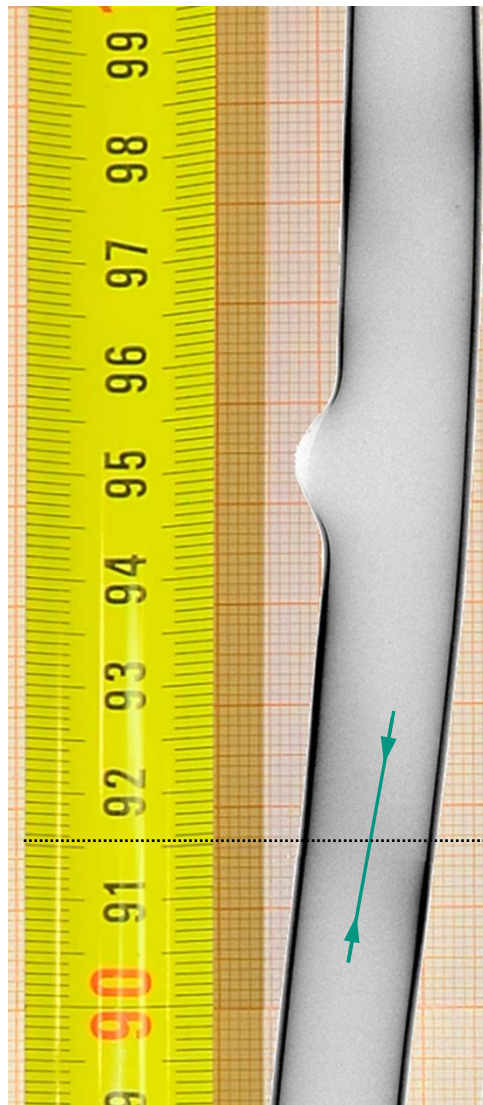
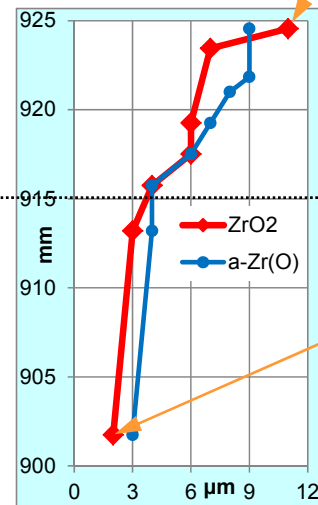
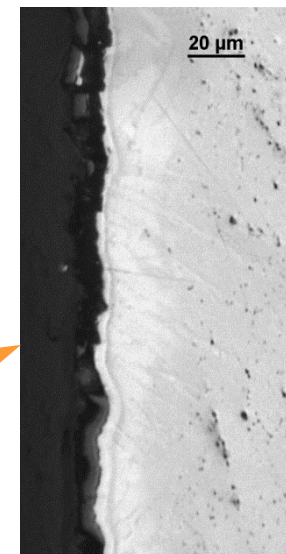
QL1, rod #6: axial distribution of inner oxidation in region of secondary hydrogenation

metallographic measurements along longitudinal cut:

- Similar to QUENCH-L0, the oxide layer thickness on the inner cladding surface was measured up to 25 μm at burst elevations and less 2 μm at hydrogenated bands.
- No zirconium hydrides with sizes more 10 nm were detected. Concentration of hydrogen dissolved in matrix estimated as < 300 wppm.
- All claddings (excluding central rod #1) were fractured due to stress concentration (strengthened due to bending?) at the burst position – similar to inner rods of QL0 with hydrogen concentration about 1000 wppm. Rod #1 was destroyed brittle during pulling out of heater with hand.
- Future bundle tests supposed to perform with tungsten heaters to avoid significant rod bending caused partially by electrodes friction.

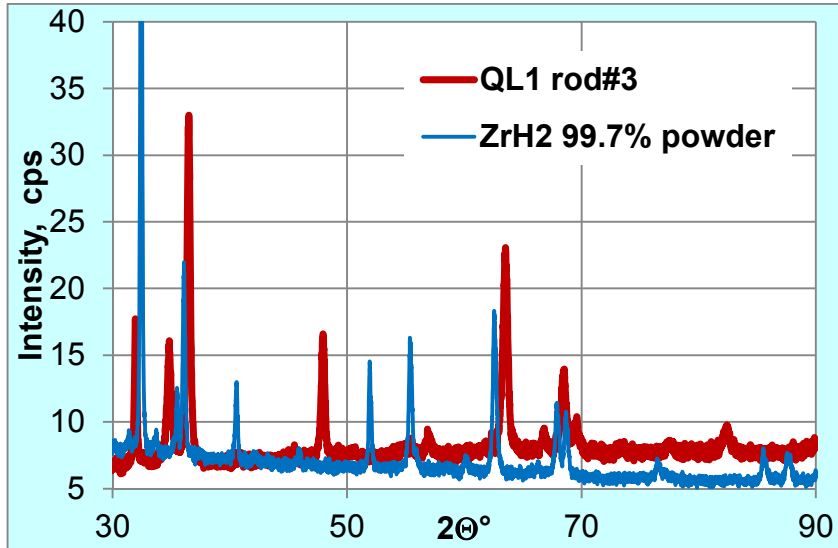
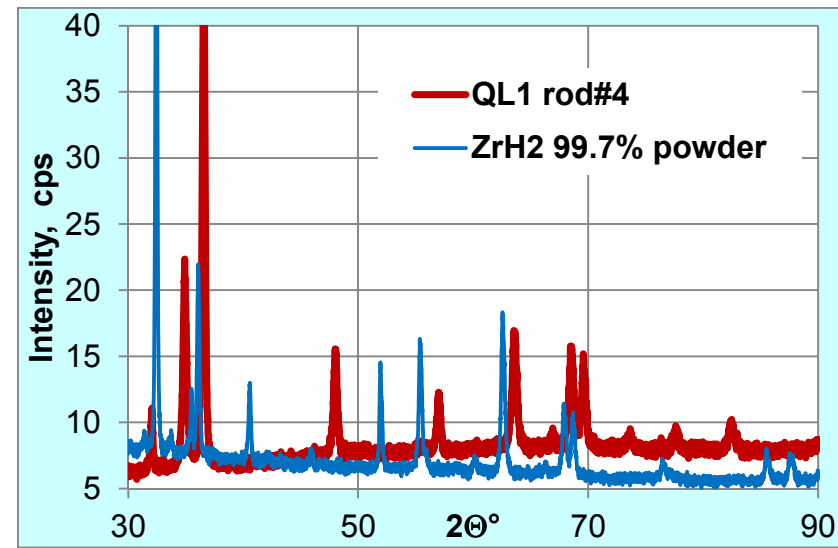
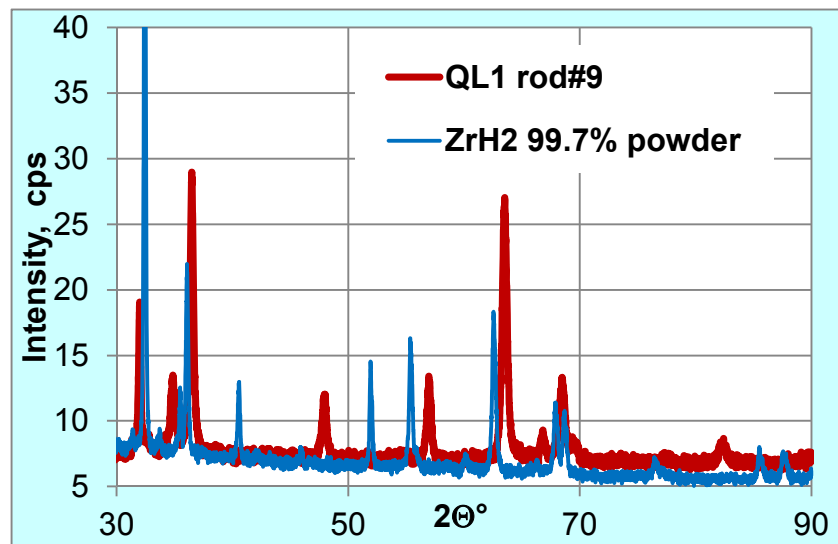
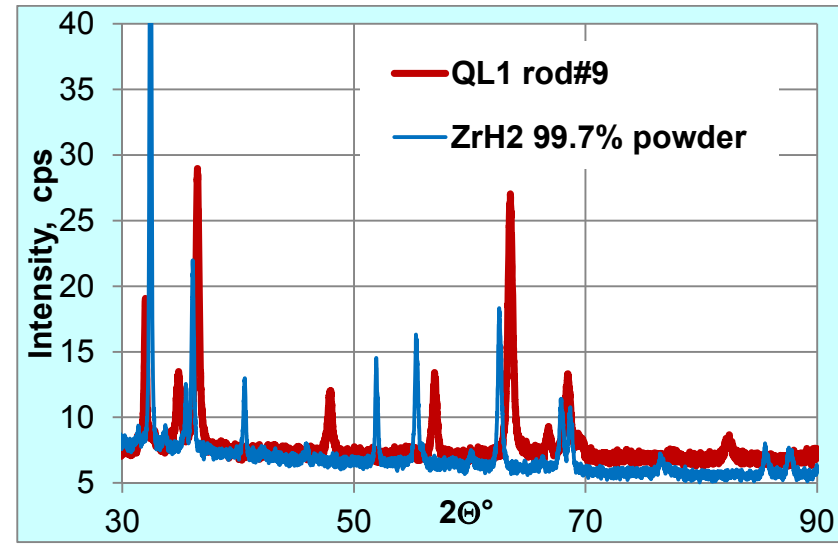
QL1, results of X-ray ($\lambda=154$ pm) diffractometry: no evidence of hydrides with sizes more 10 nm

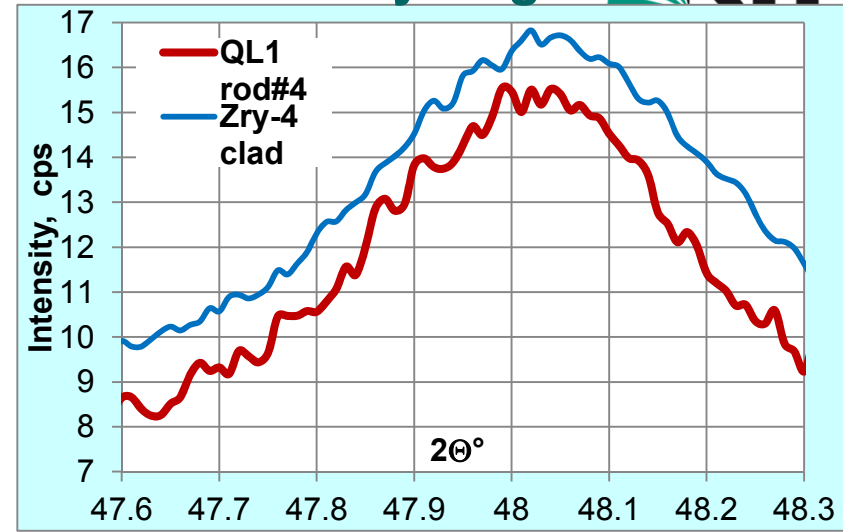
QL1, shift of XRD peaks:

increase of lattice parameters due to dissolved hydrogen

$\Delta\Theta = -0.07^\circ \rightarrow C_H \approx 260 \text{ wppm}$

$\Delta\Theta = -0.02^\circ \rightarrow C_H \approx 75 \text{ wppm}$

$\Delta\Theta = -0.04^\circ \rightarrow C_H \approx 150 \text{ wppm}$

$\Delta\Theta = -0.05^\circ \rightarrow C_H \approx 190 \text{ wppm}$

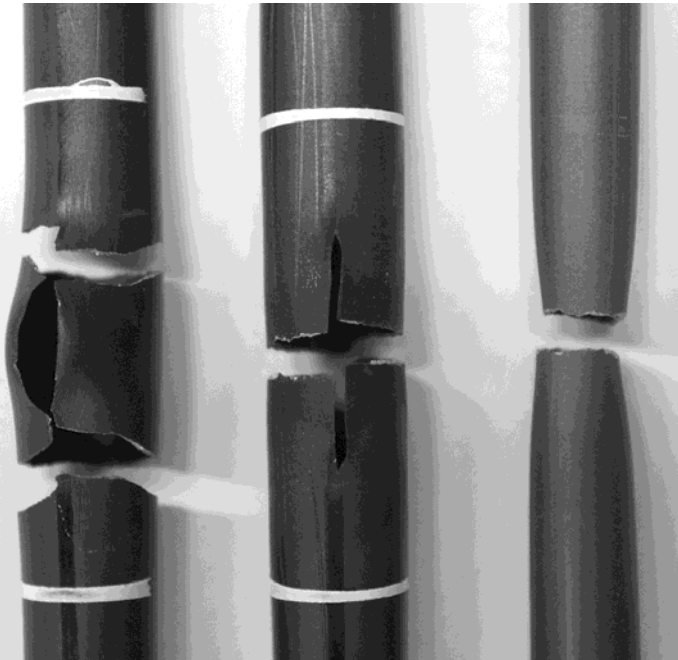
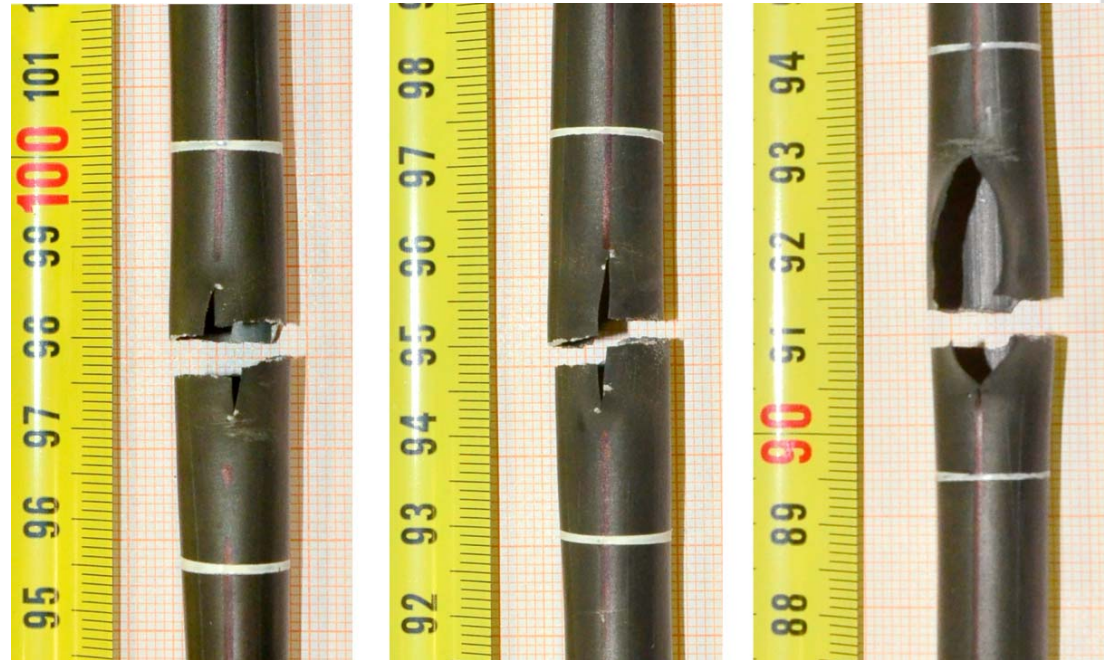
Failure behavior during tensile tests

QL0: 3 types

QL1: only stress concentration
(excepted rod #1 brittle ruptured during handling)

hydrogen embrittlement (inner rods with $C_H \sim 2000 \text{ wppm}$)	stress concentration (outer rods with $C_H \sim 1000 \text{ wppm}$)	necking (outer rods)
---	---	----------------------------

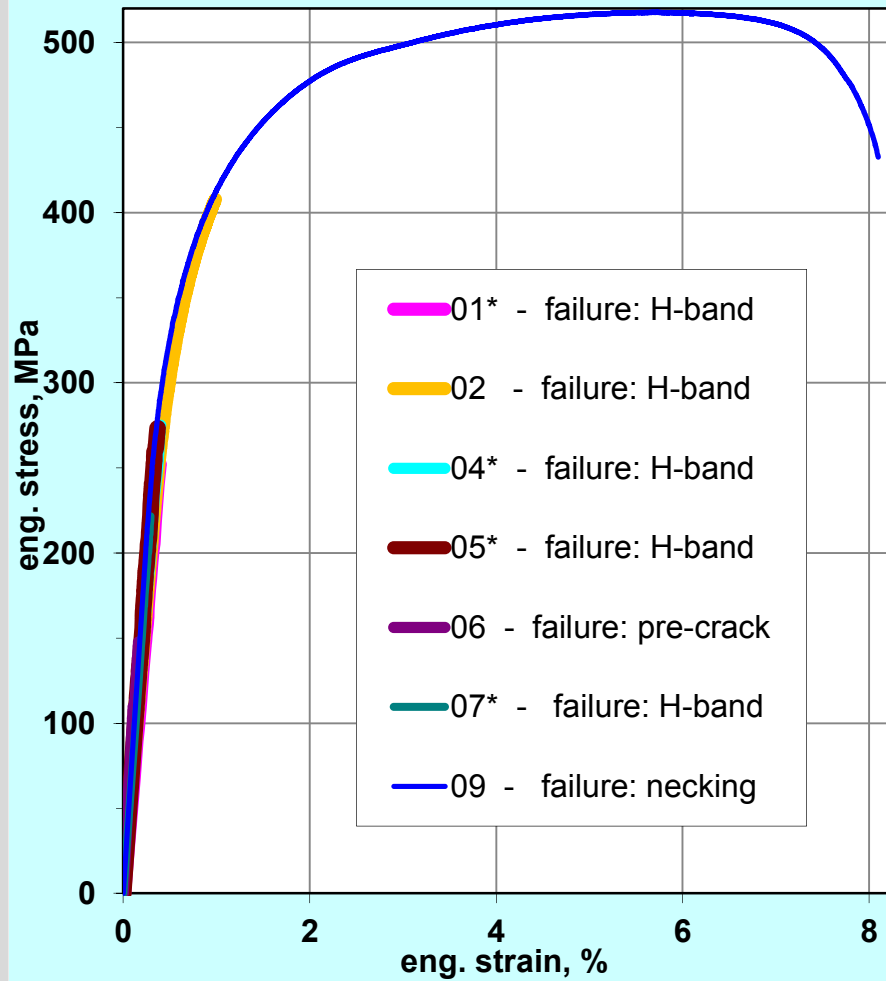
Tensile tests for inner rods

QL0 sample length 500 mm or 250 mm*

QL1 sample length 1000 mm or 250 mm*

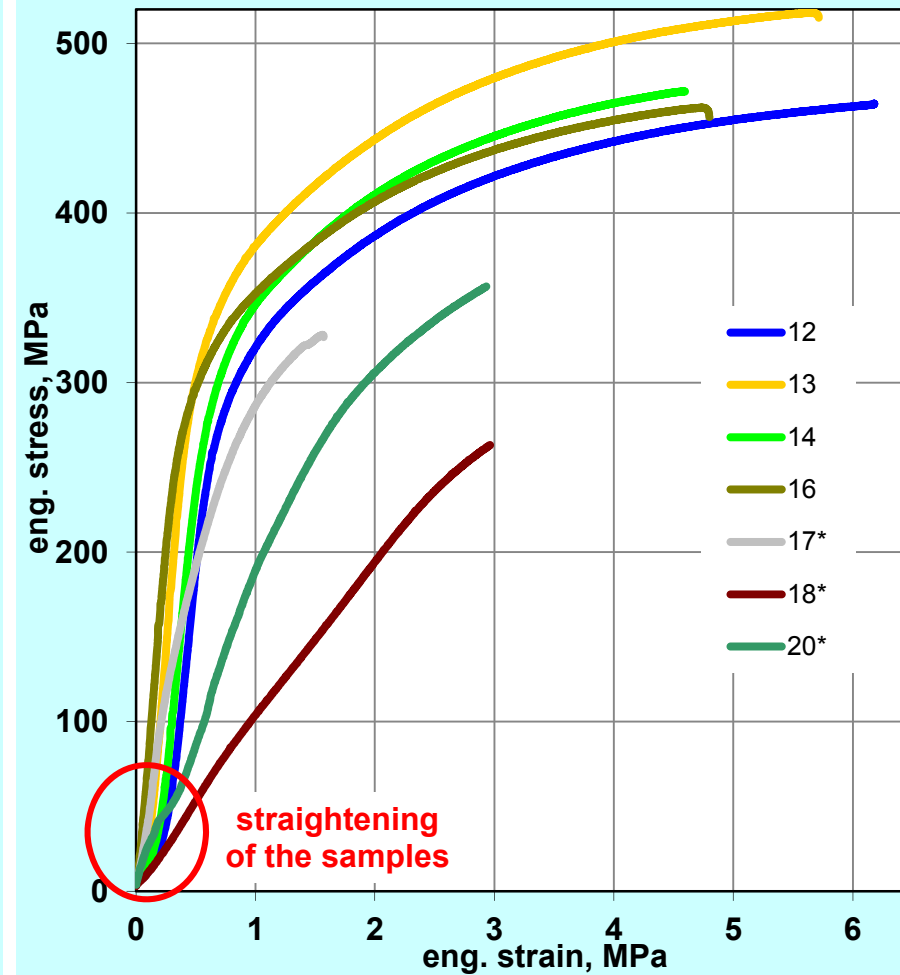
Tensile tests for outer rods

QL0 sample length 500 mm

QL1 sample length 1000 mm or 250 mm*

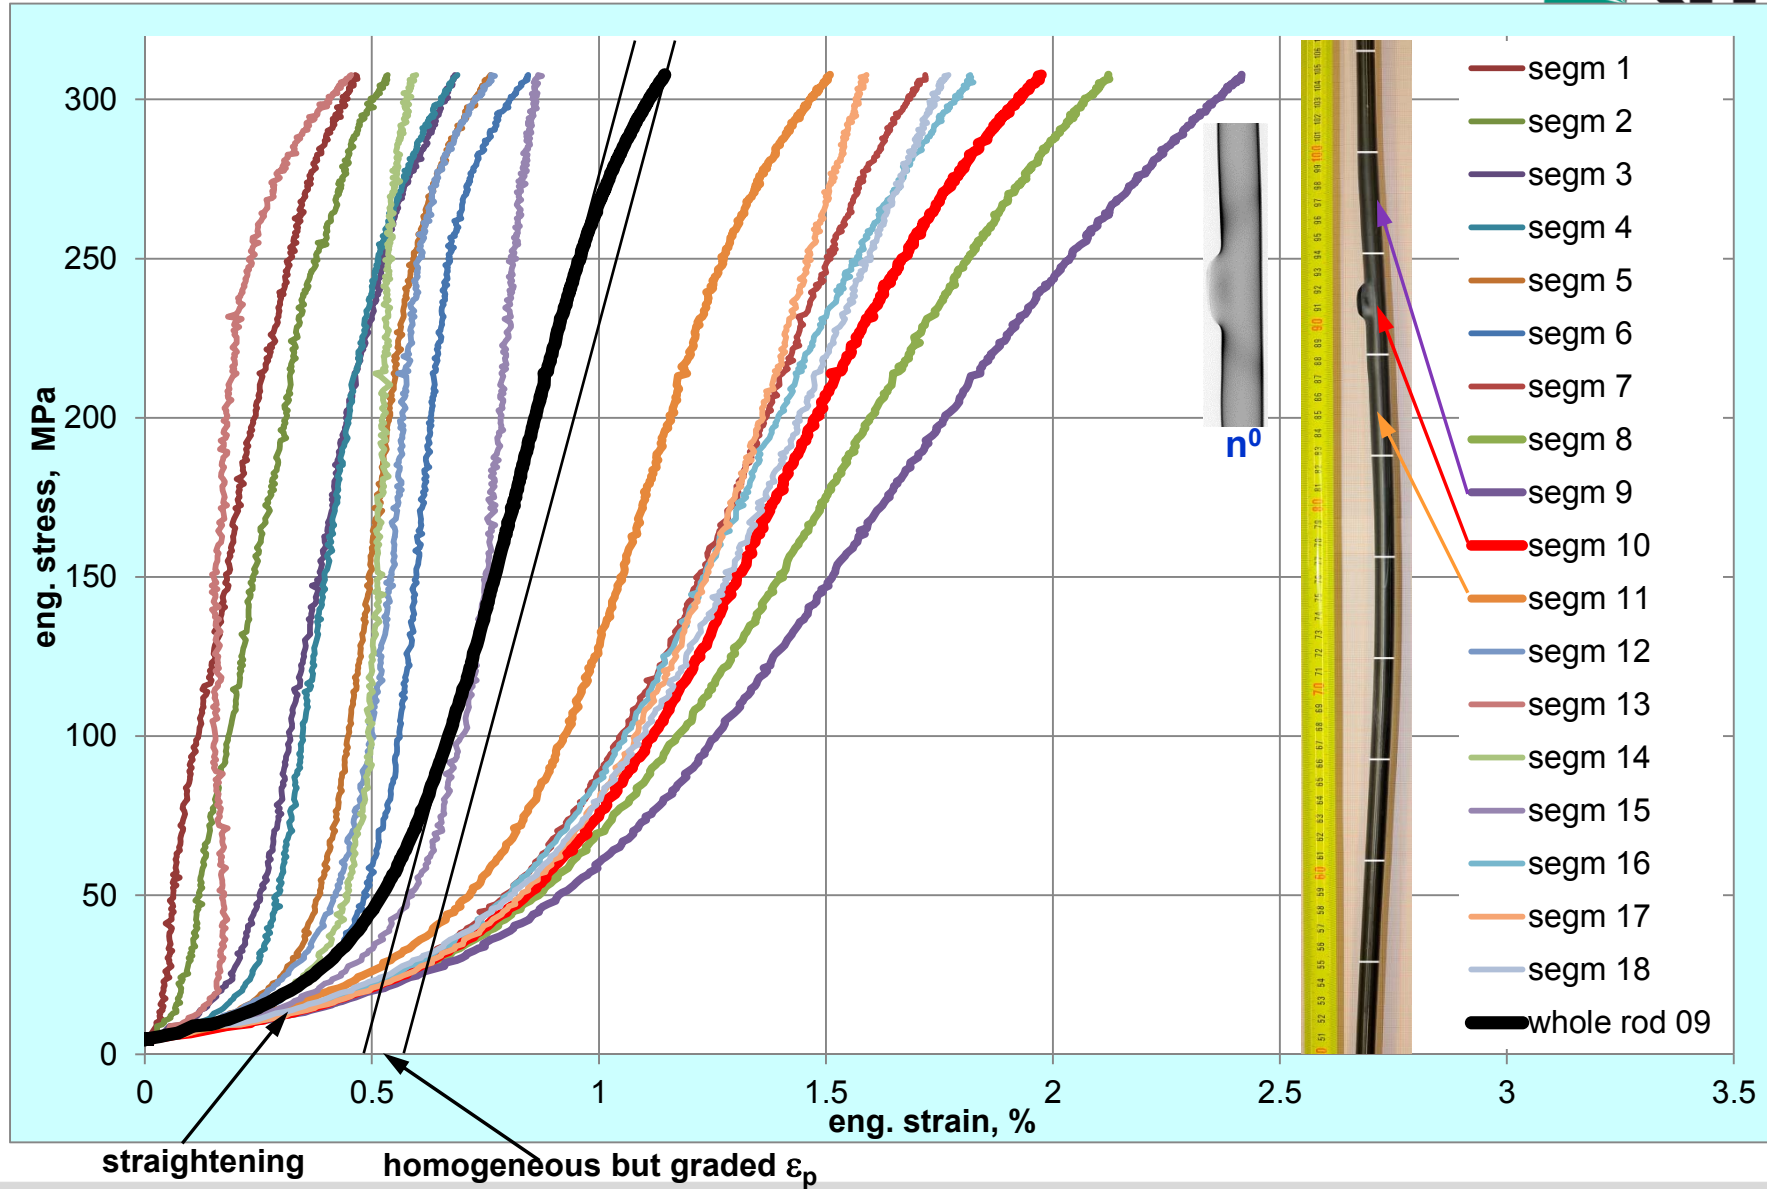
QL1: tensile test with bended rod #09 with detected secondary hydrogenation
