Results of the reference bundle test **QUENCH-L1** with Zircaloy-4 claddings and future planning of the **QUENCH- LOCA** program

QWS18, Karlsruhe 2012

Institute for Applied Materials; Program NUKLEAR

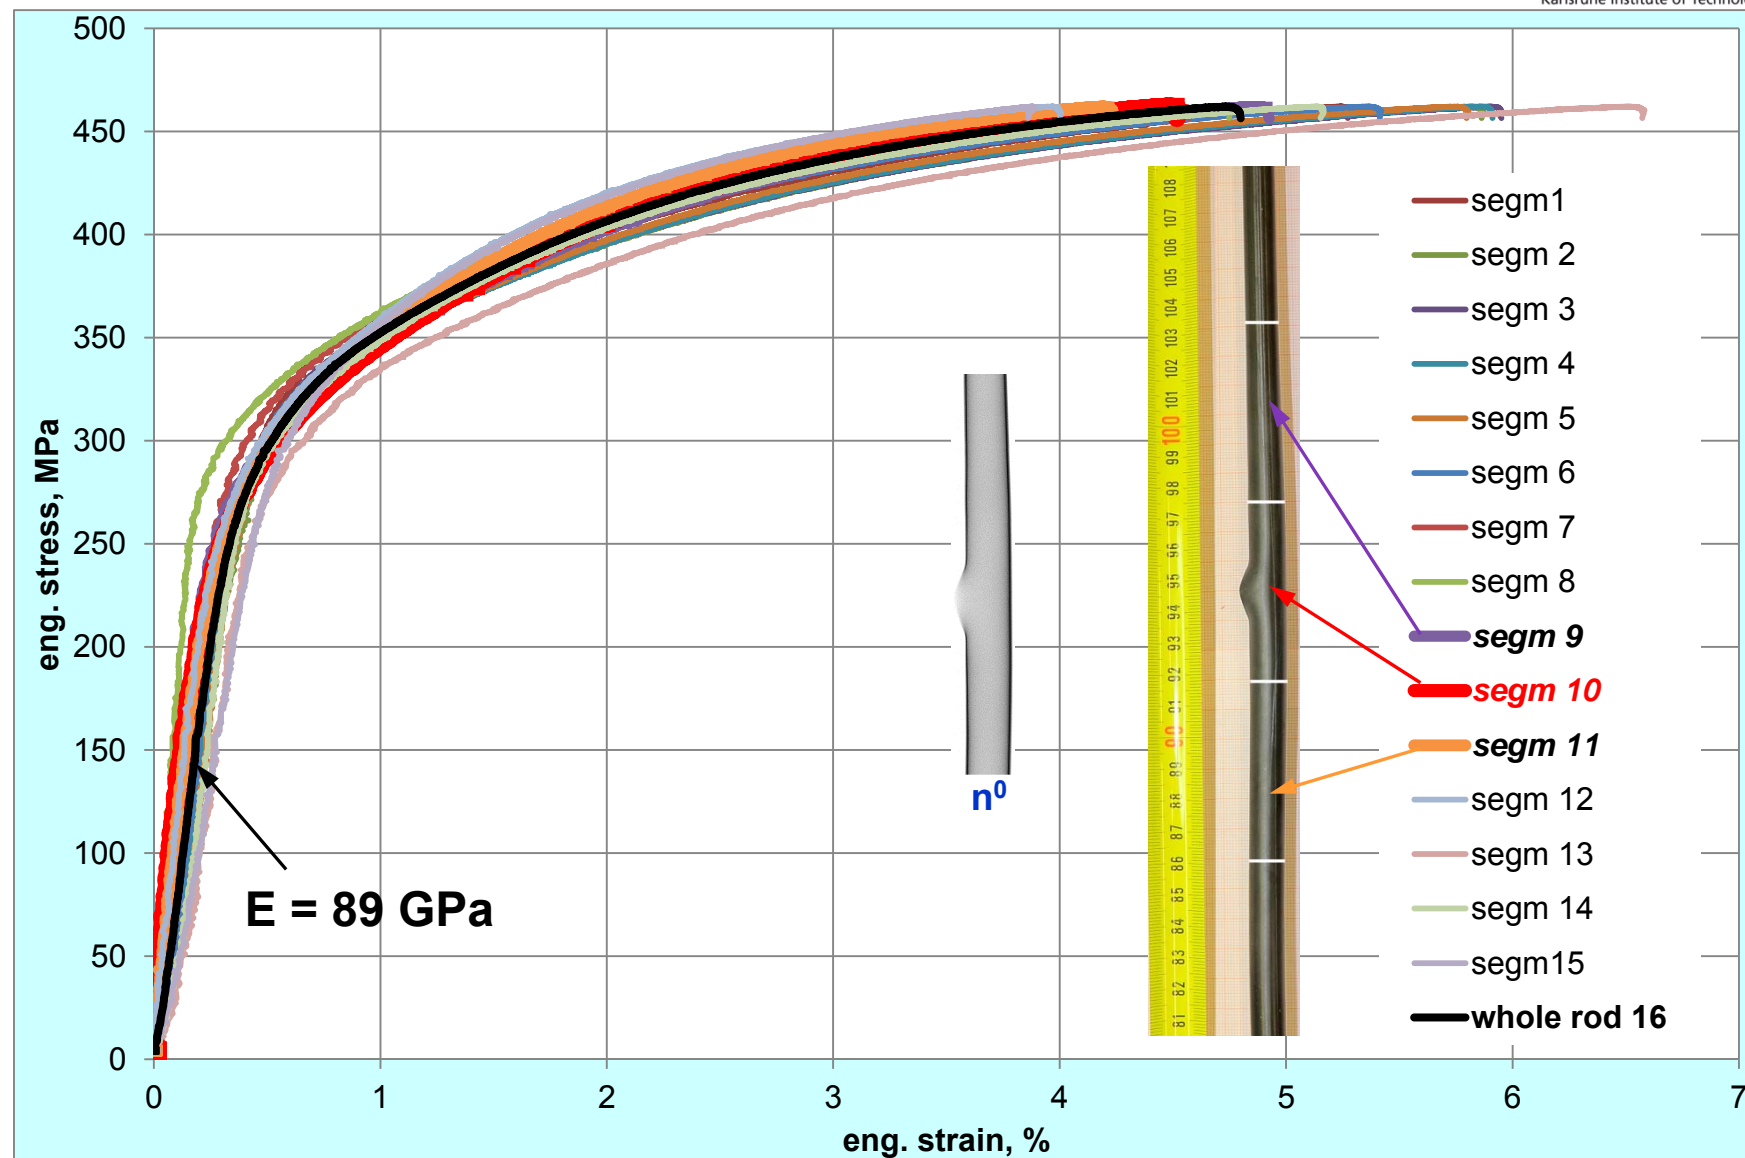
QL1: tensile test with not bended rod #16 without detected secondary hydrogenation

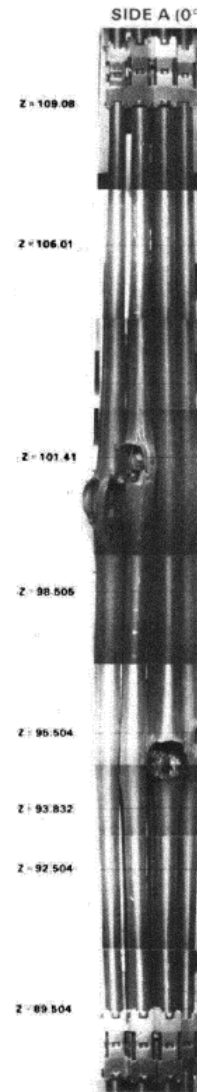
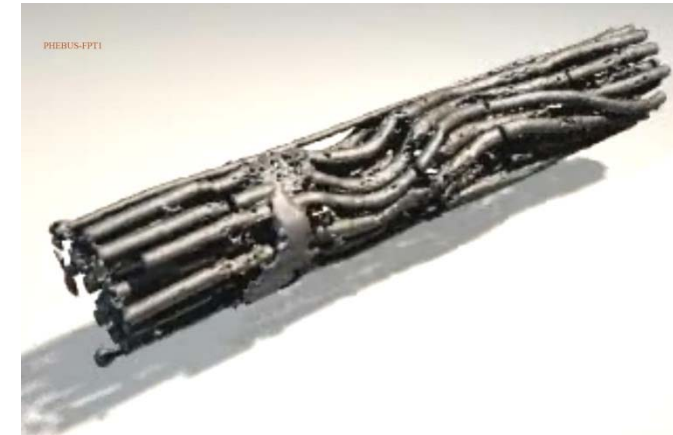
What is prototypical rod bending rate?

High temperature PHEBUS-FPT1 in-pile test

Results of the **FR2** in-pile single rod tests: out-of-pile results [Chung], showing significant bending below 840°C (α -Zr(O)) and negligible values above 840°C, **were not confirmed** by the in-pile tests. However, the orientation of the rod bend was consistent with out-of-pile results, i.e., the rupture was on the inside of the bend.

NRU MT-4 (1982) in-pile bundle test: no noticeable bending

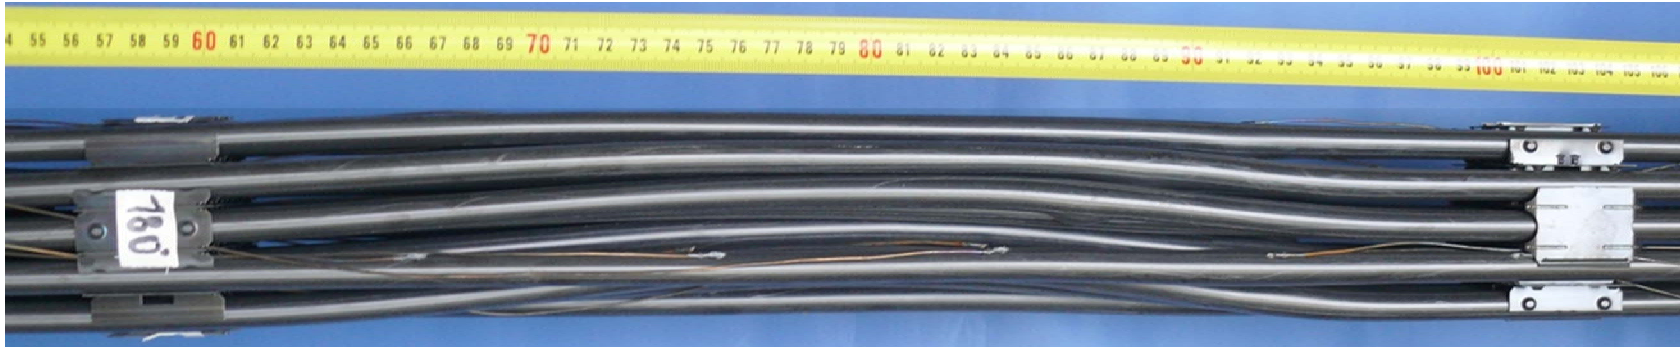
1. (prototypical) friction between oxidised grid spacers and ballooned claddings

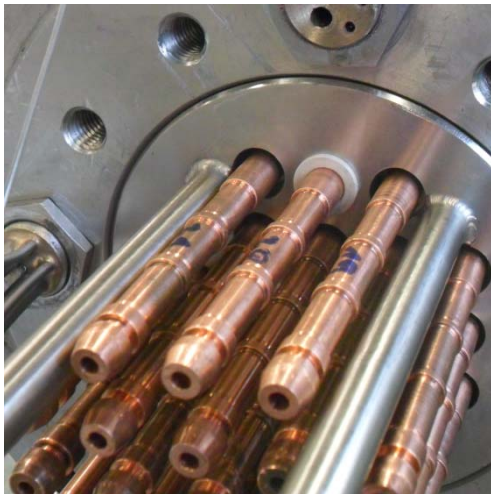
2. (not prototypical) friction inside the electrode group

Cu electrodes

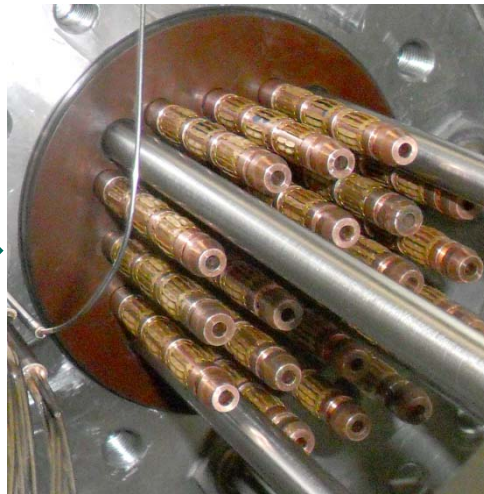
Cu electrodes with Au slide contacts

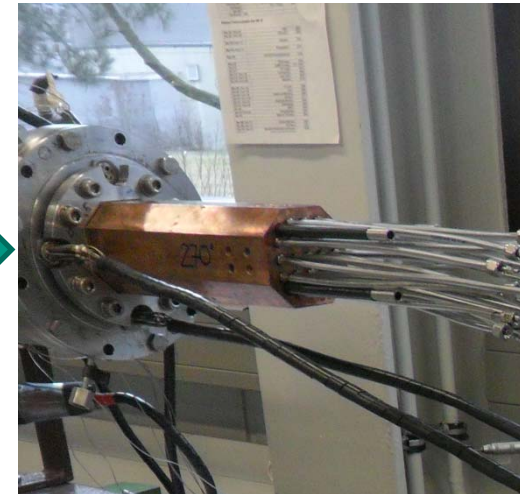
Cu block putted on electrodes
