First results of the bundle test QUENCH-L3 with optimized ZIRLO™ claddings

J. Stuckert, M. Große, J. Moch, C. Rössger, M. Steinbrück, M. Walter

QWS-21, Karlsruhe 2015

Institute for Applied Materials; Program NUKLEAR

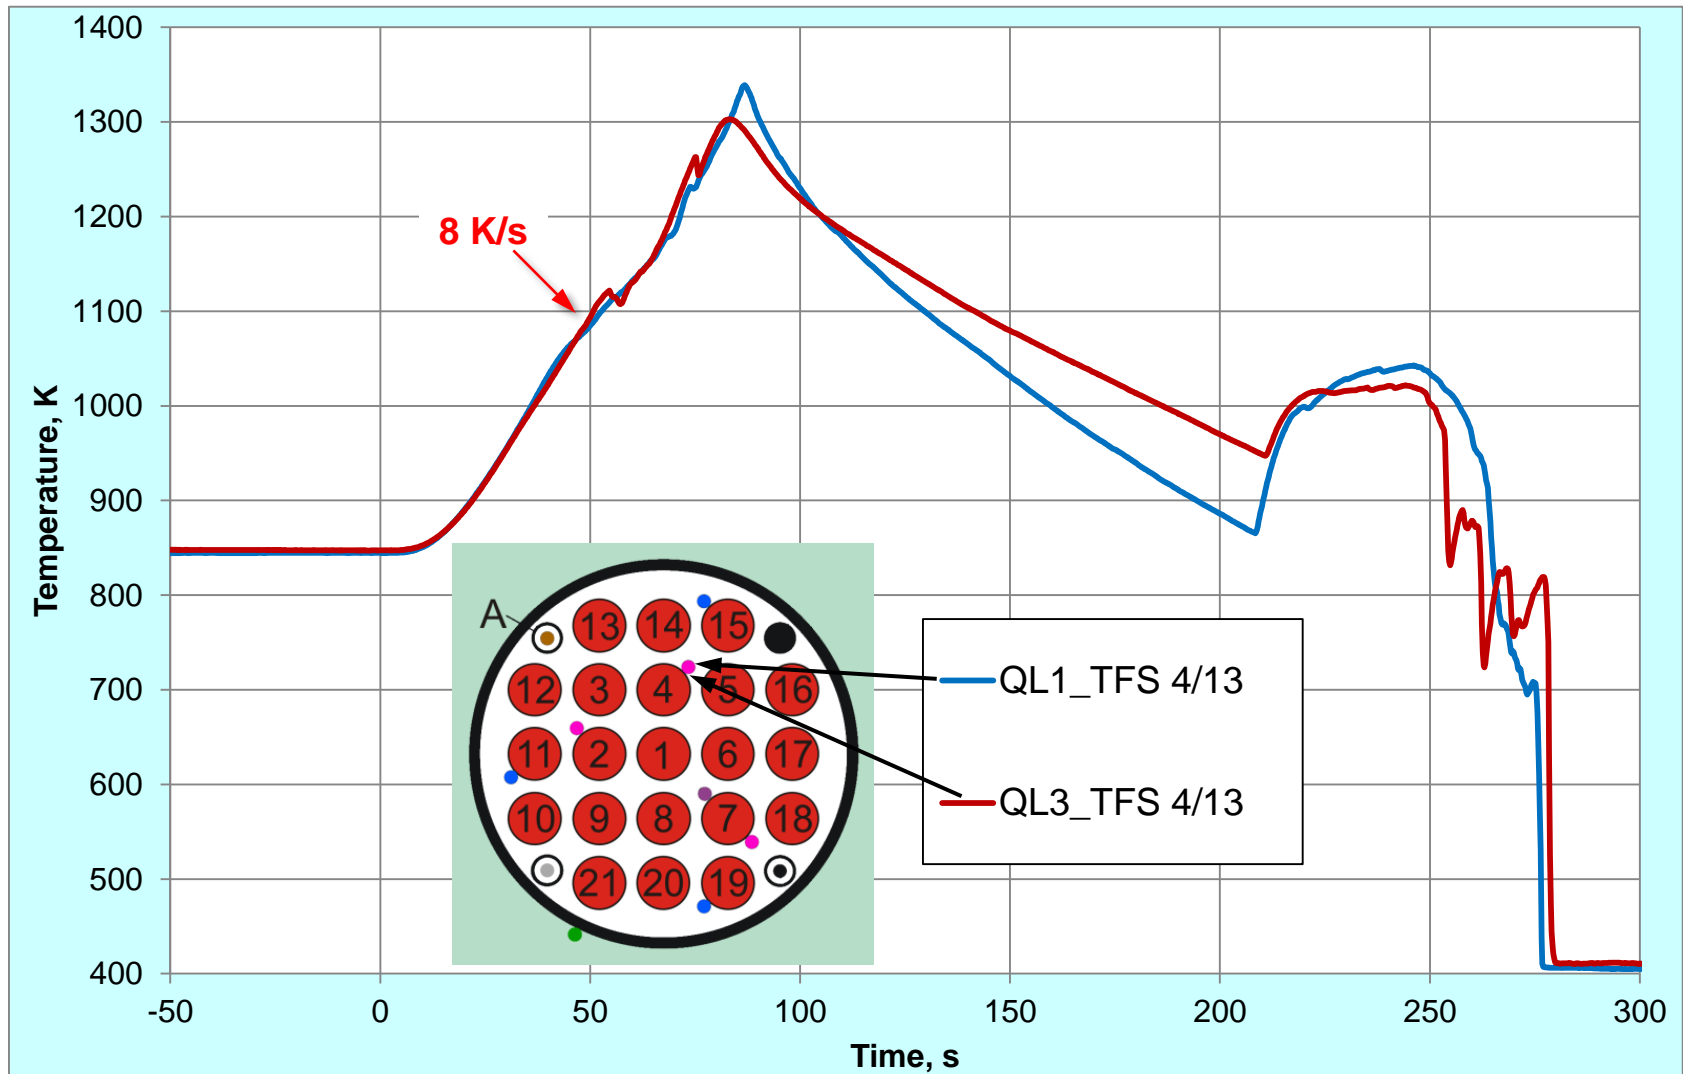
Maximal cladding temperatures of internal rods in hottest region of QUENCH-L1 (Zry-4, reference test) and -L3 bundles (elevation 950 mm)

- Similar to QUENCH-LOCA-1, the maximum temperature of 1350 K was reached on the end of the heat-up phase at elevation 950 mm. Circumferential temperature gradient across a rod was up to 70 K on the burst onset.

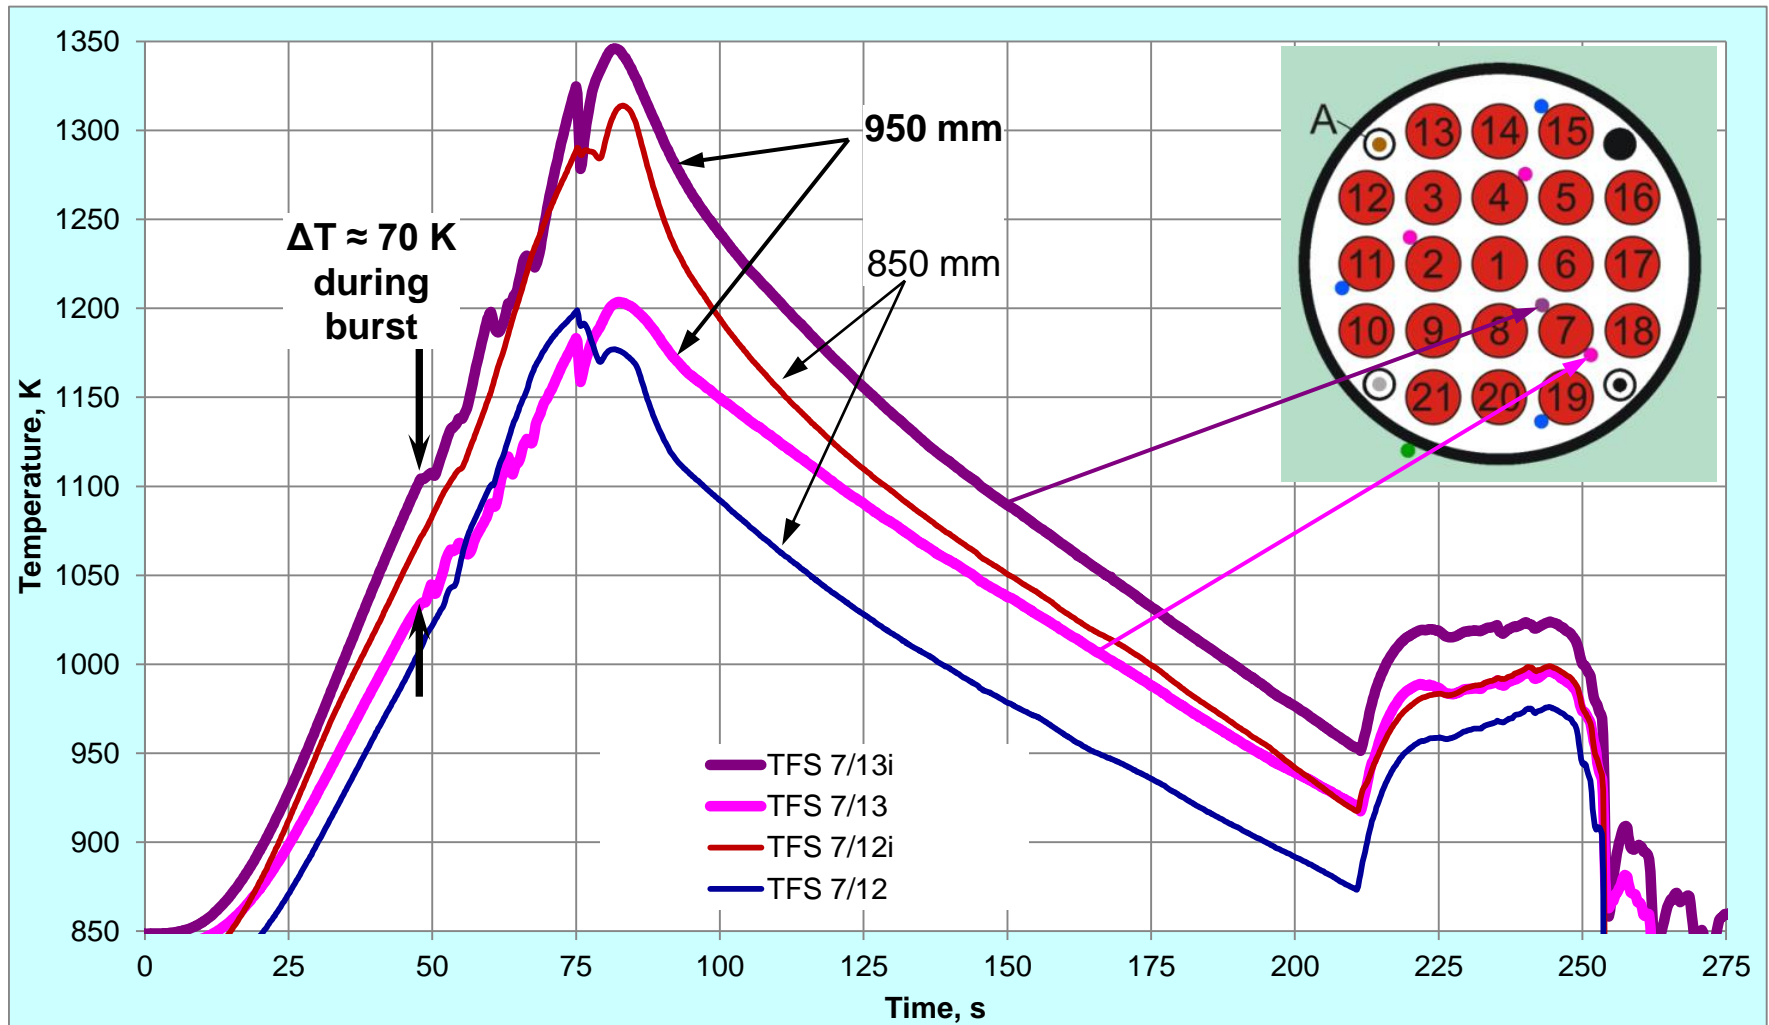
QUENCH-L3: radial temperature gradient ΔT for rod #7 at hottest elevations 850 mm (7/12) and 950 mm (7/13)

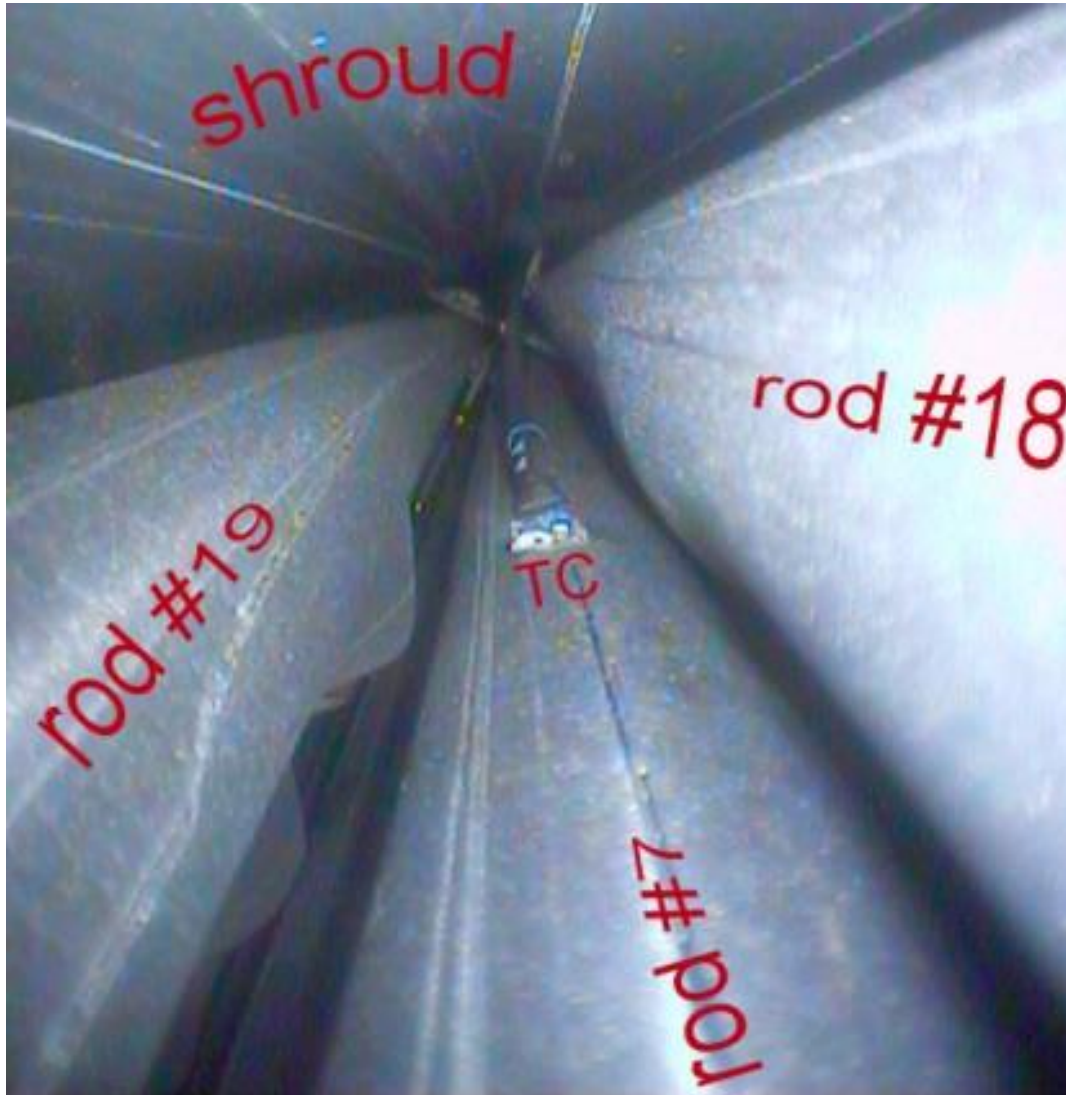
QUENCH-L3: Ballooning and burst of cladding tubes at elevation 950 mm (videoscope)

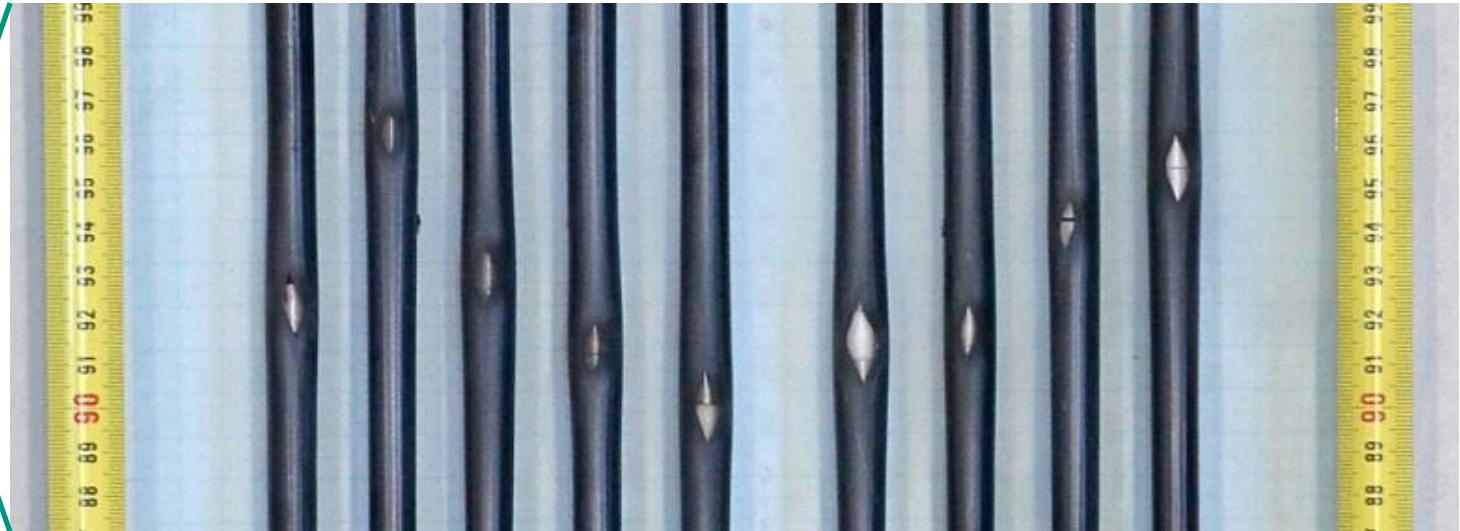
QUENCH-L3: 9 inner rods

#1 #2 #3 #4 #5 #6 #7 #8 #9

**average bending 1.1% oppositely to burst direction:
buckling due to simultaneous thermal expansion and friction at grid spacers**

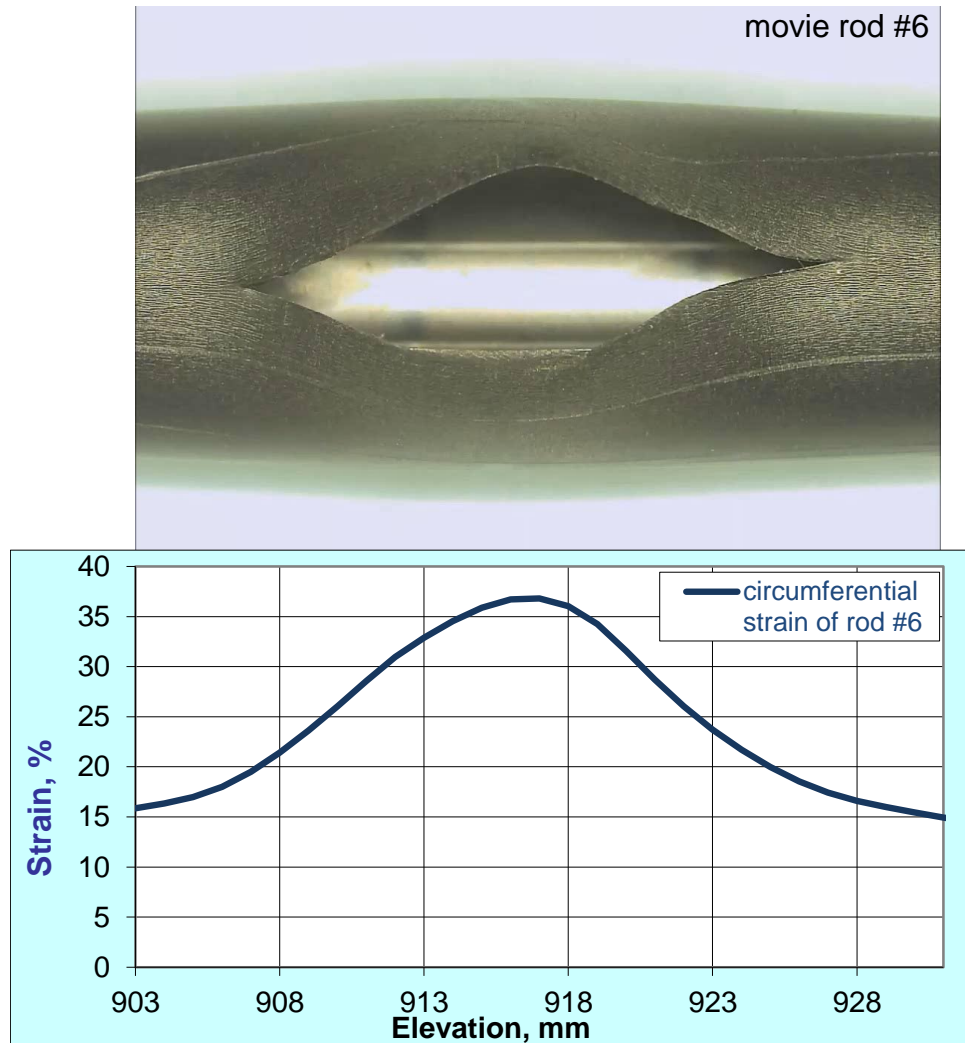
QUENCH-L3: Circumferential strain (laser scanner) and burst position overview
