Post-test investigations of the QUENCH-LOCA-4 bundle (hydrogenated M5[®] claddings)

QWS-21, Karlsruhe 2015

QUENCH-L4: test with hydrogenated claddings

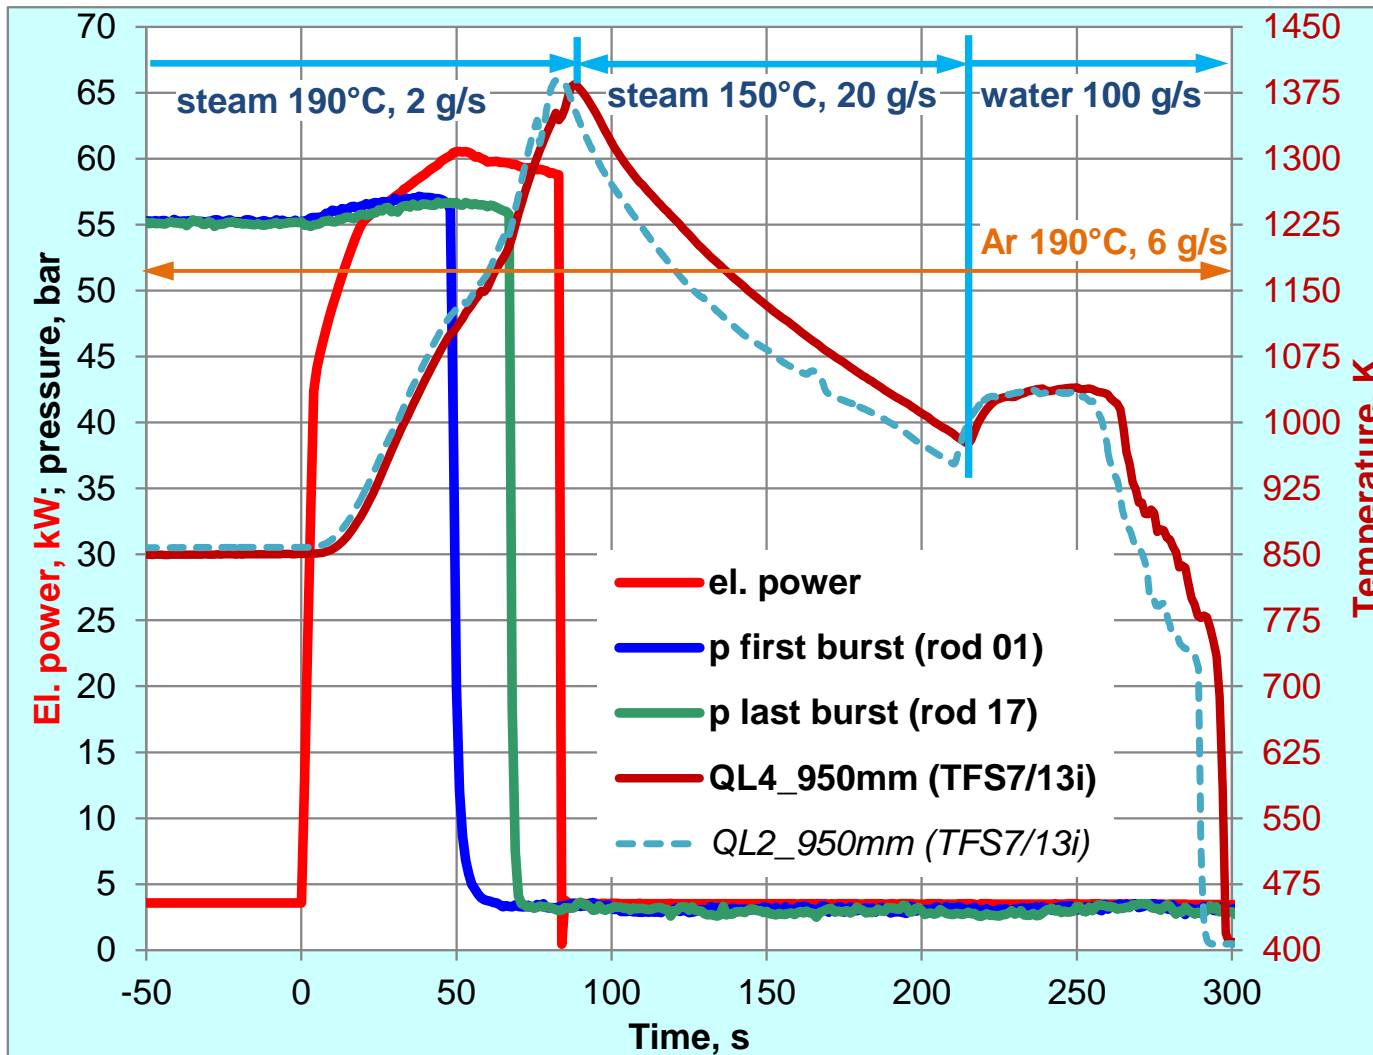
QUENCH-L4: test progress.

Comparison with QUENCH-L2 temperature.

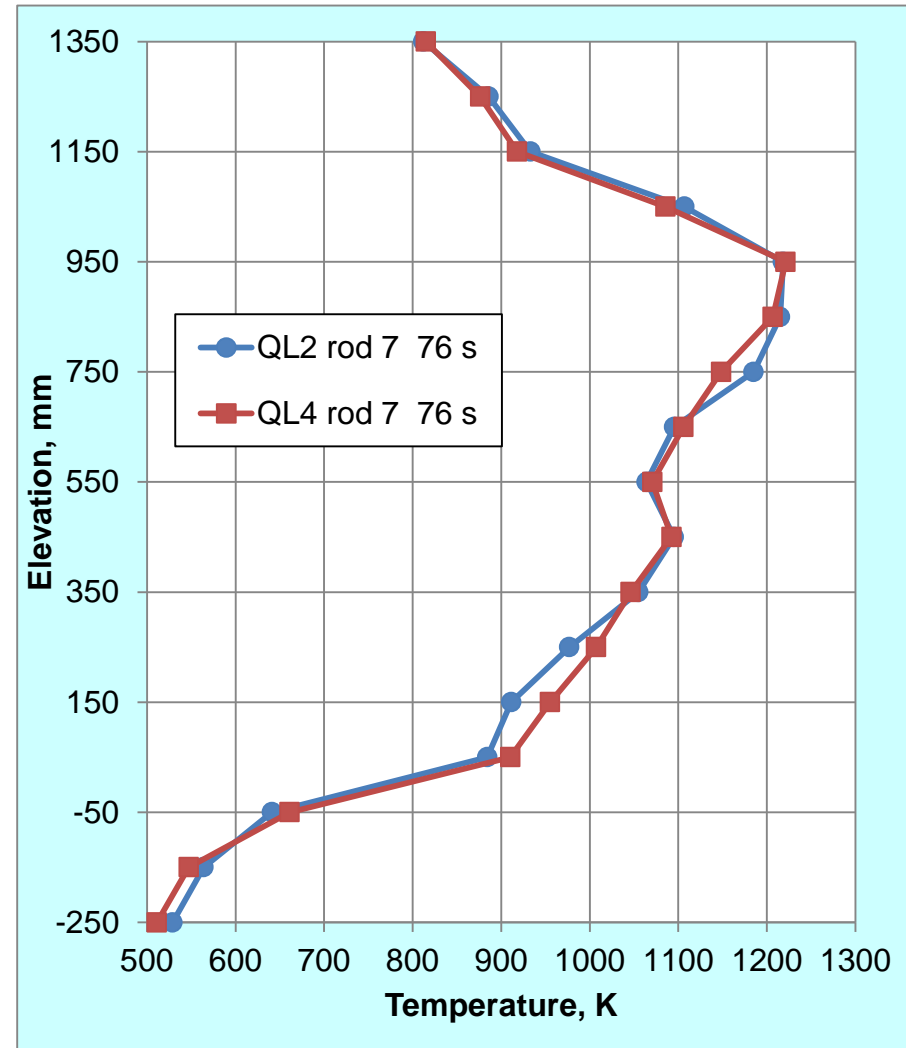
QL2 and QL4: similar axial temperature distribution for inner rod

on first cladding burst (t = 48 s)

on the end of transition (power reduction at t = 76 s)

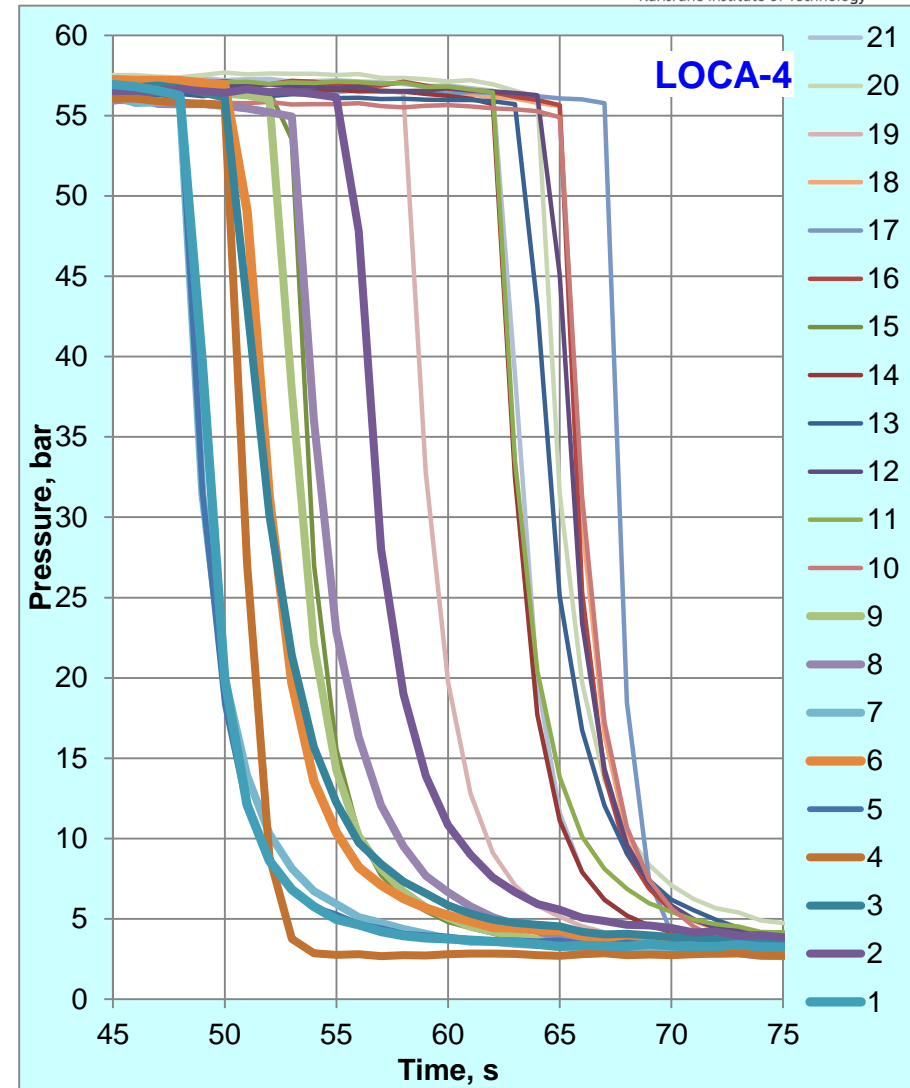
Rod pressure evolution during heating phase for QUENCH-L2 and -L4: burst time indication

duration of decrease of the inner pressure to the system pressure: $\tau_0 \approx 30$ s

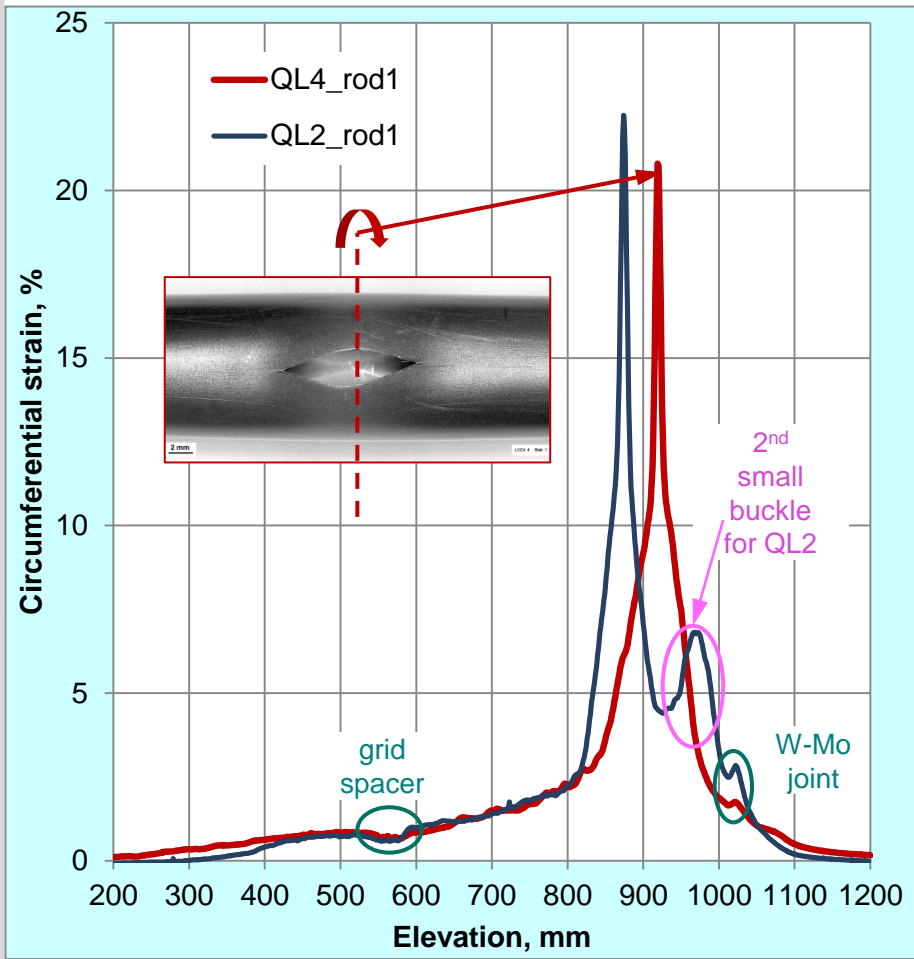
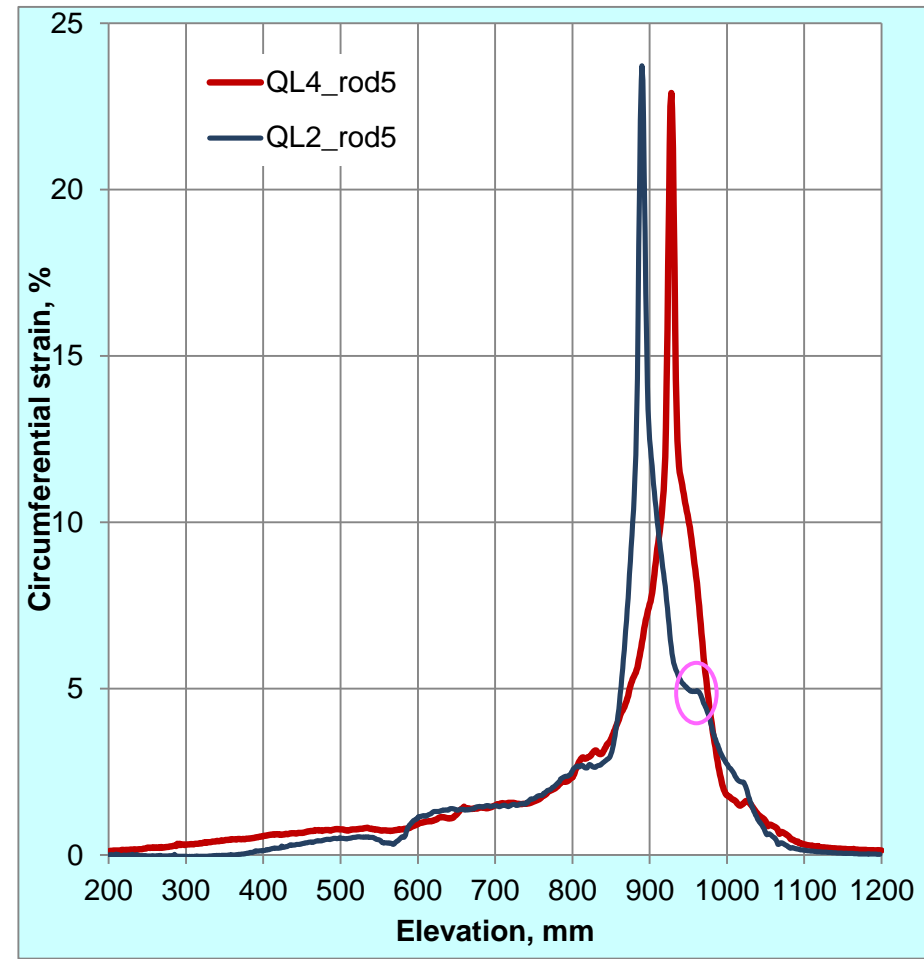
Circumferential strain for QUENCH-L2 and -L4 rods due to cladding ballooning: similar profiles, however 2 buckles for QL2

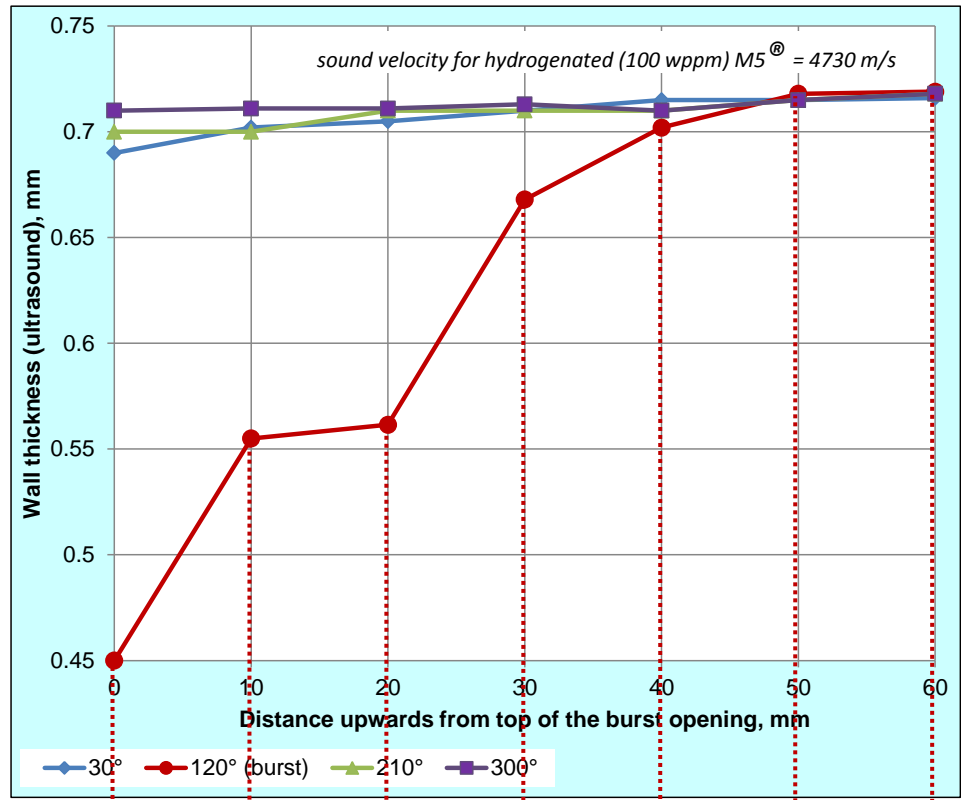
QUENCH-L4: cladding wall thinning at the burst opening side due to ballooning /ultrasound measurement of wall thickness for rod #1/

neutron radiography above burst opening: localization of hydrogen band (dark)

- The cladding wall thinning from 725 μm to 450 μm due to ballooning was observed at the burst side along 50 mm below and above burst opening (ultrasound measurement).

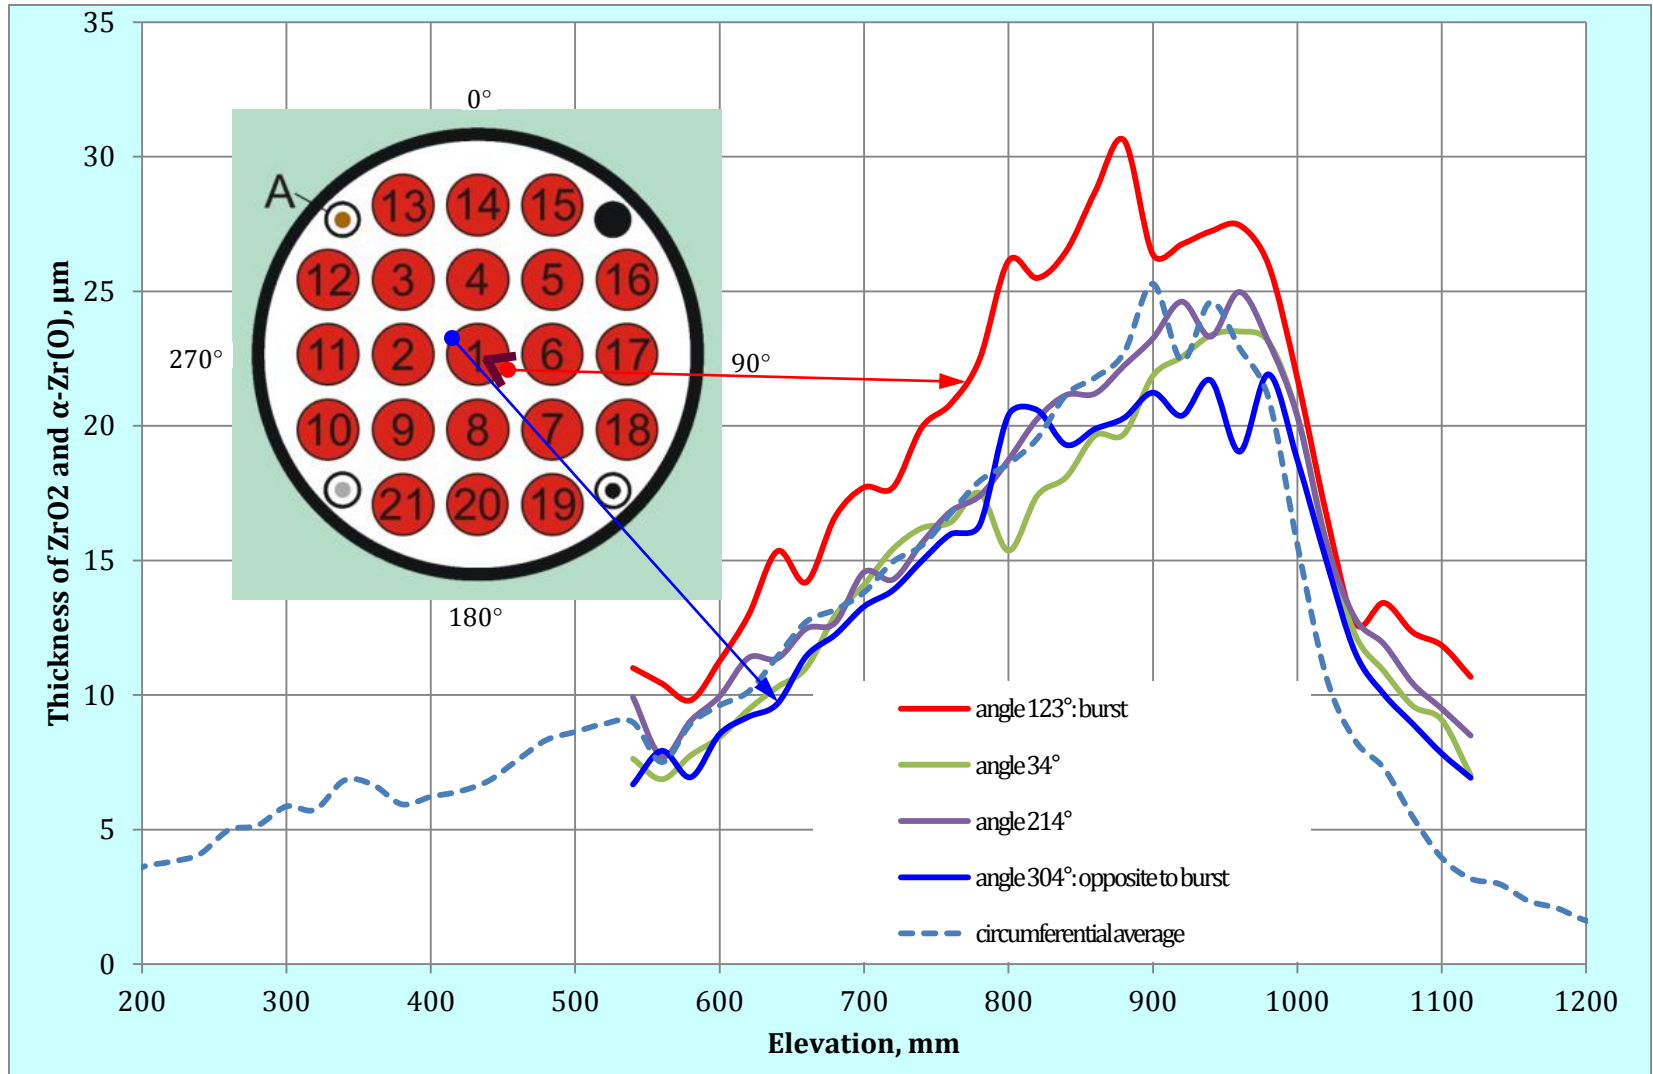
Oxidation of clad external surface: eddy current data for rod #1

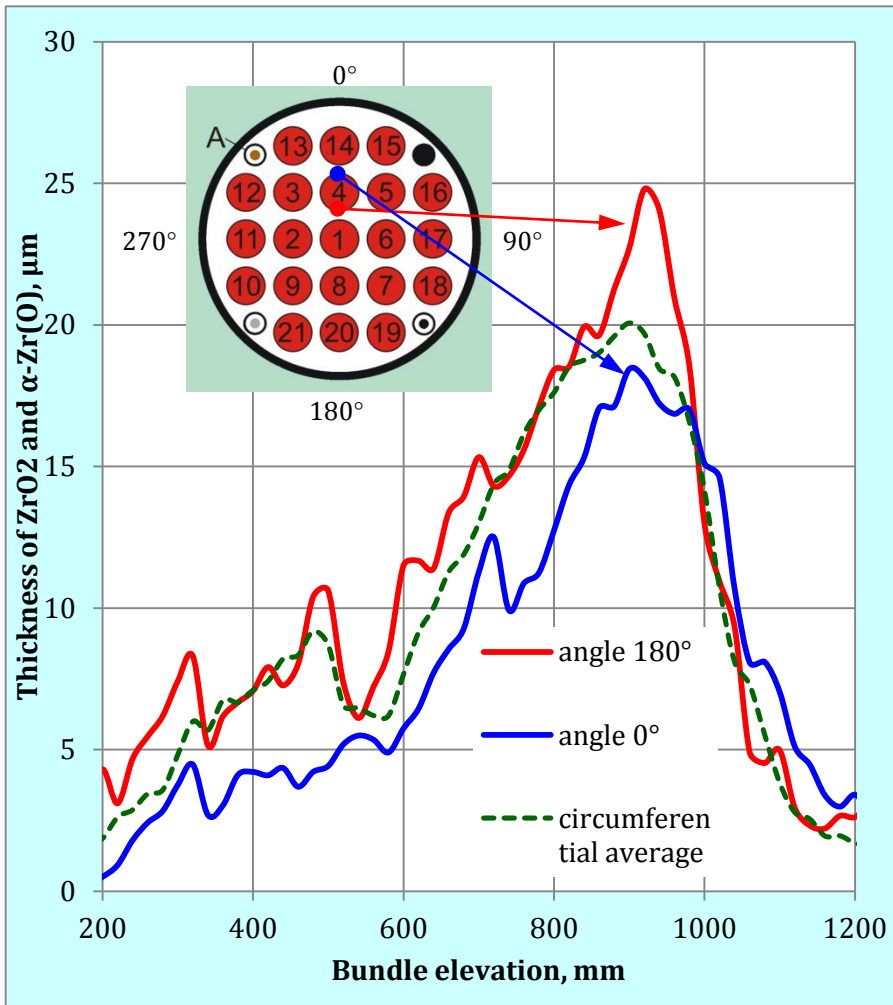
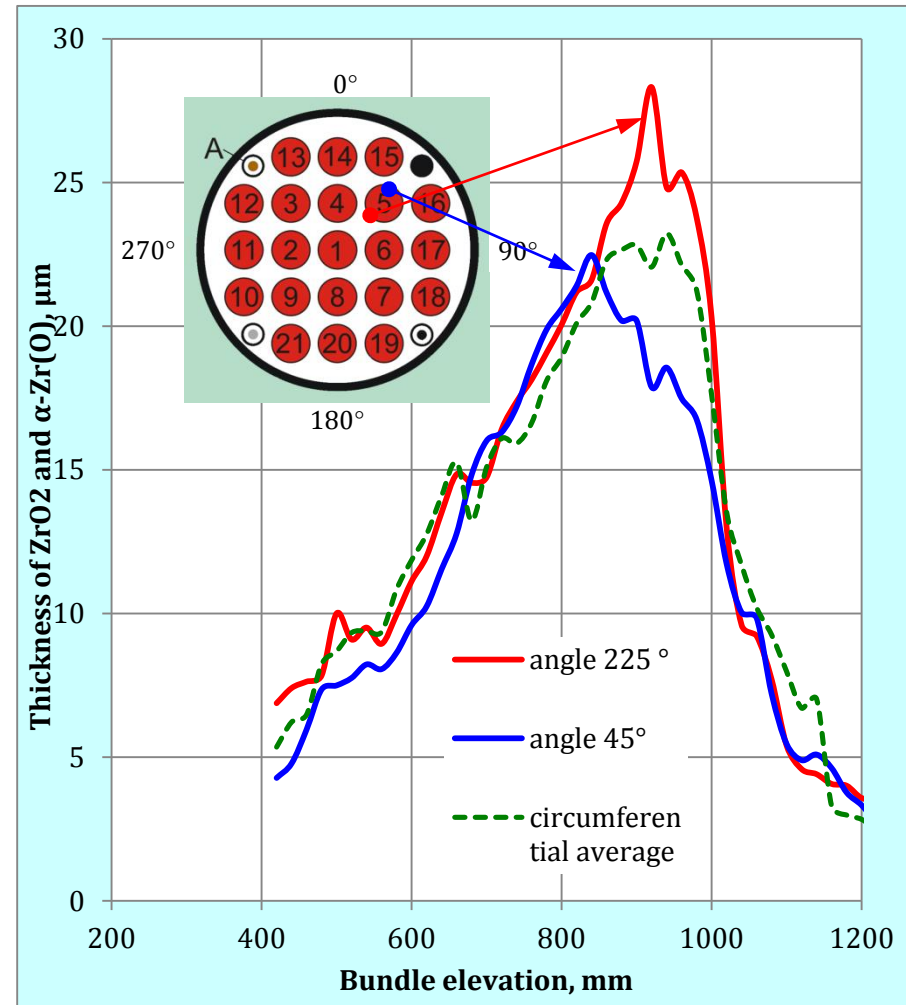
Oxidation of clad external surface: eddy current data for rods #4 and #5

rod #4

rod #5

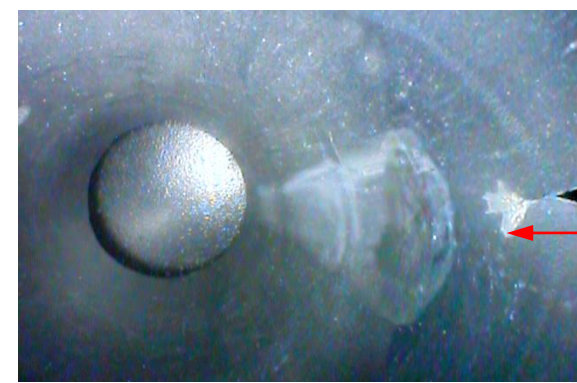
QUENCH-L4: videoscope observations of cladding inner surface

QL4, inner surface of clad #18

QL4, inner surface of clad #6, top view

QL4, inner surface of clad #1

similar structure of inner clad surface for QL2, rod #8

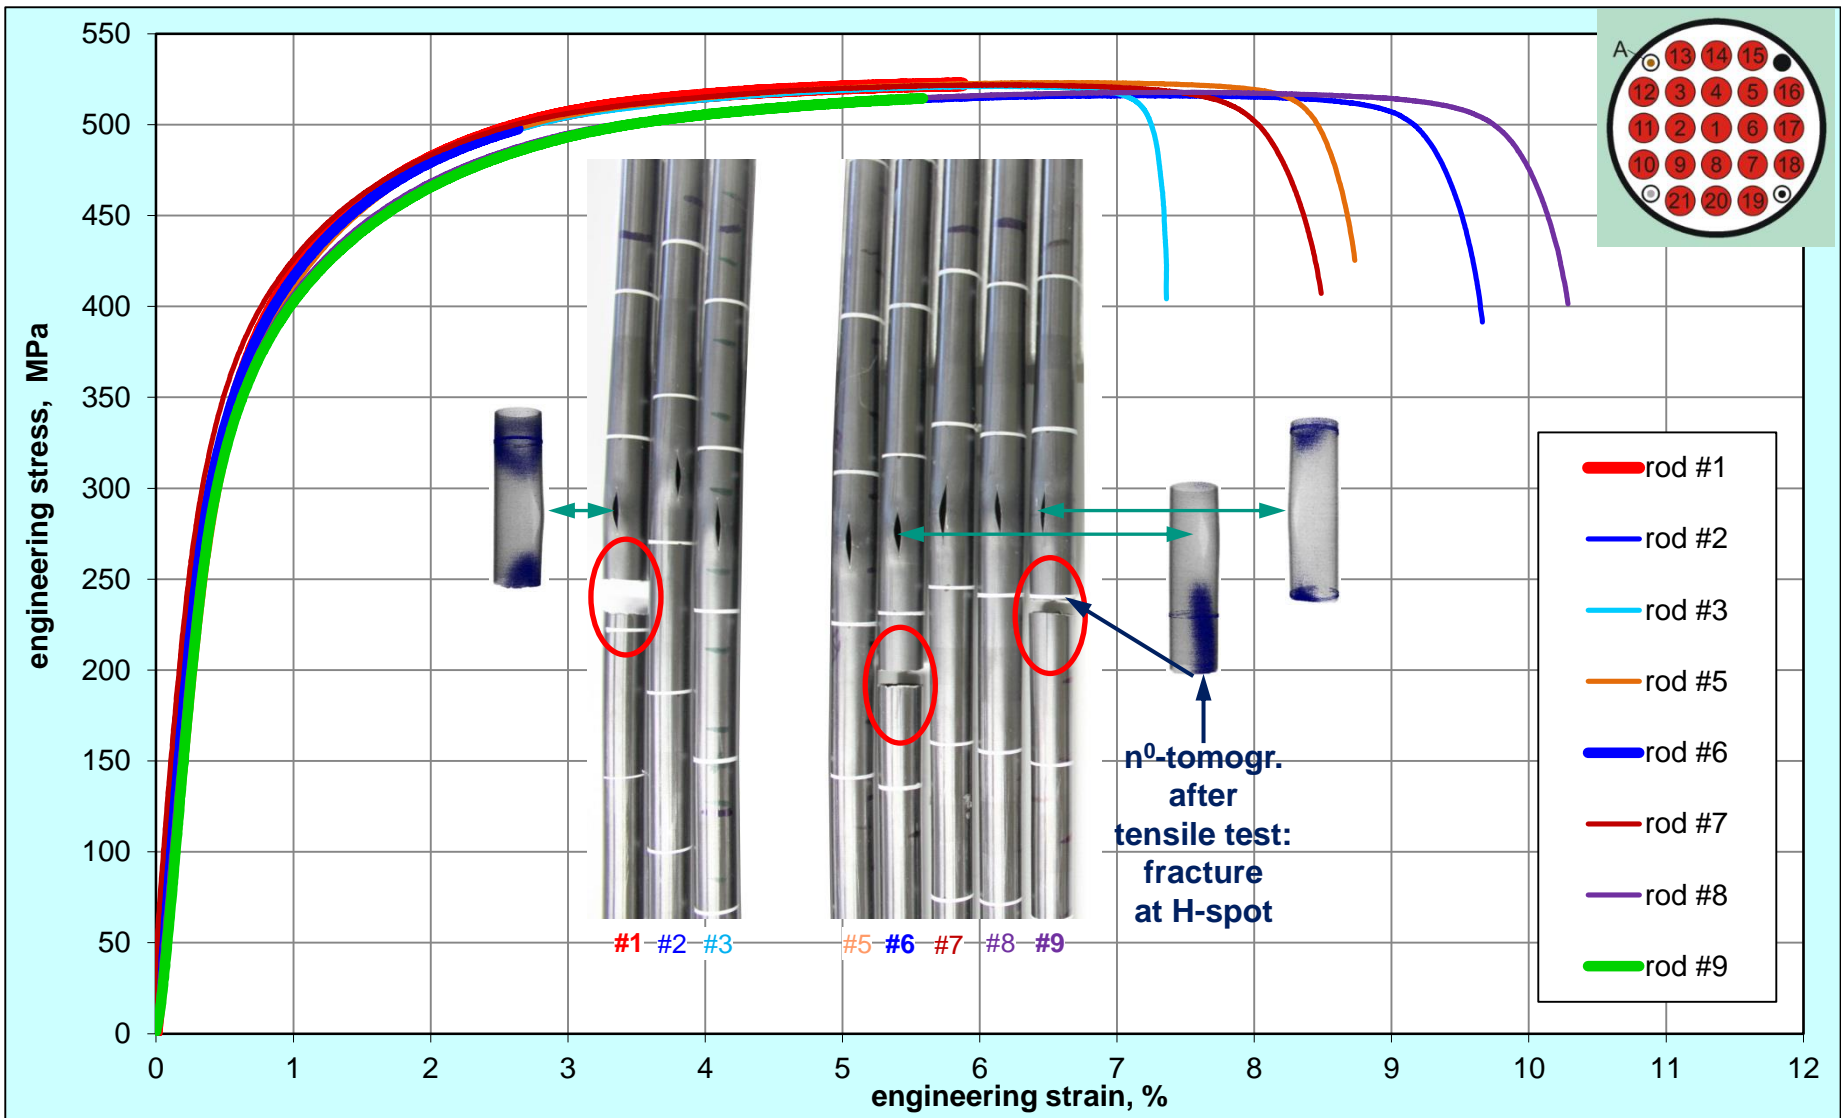
QUENCH-L4: tensile tests at RT with inner rods, fractures at hydrogen-bands (3 rods) and due to necking (5 rods)

Tensile tests evidenced fracture at hydrogen bands (similar to the QUENCH-LOCA-0 commissioning test with Zry-4 claddings): three inner rods were fractured due to this embrittlement. Eight peripheral rods were fractured due to stress concentration at burst opening edges (similar to ten claddings of QUENCH-LOCA-2 test with not pre-hydrogenated M5[®] claddings). All other tensile tested claddings failed after necking far away from the burst region.

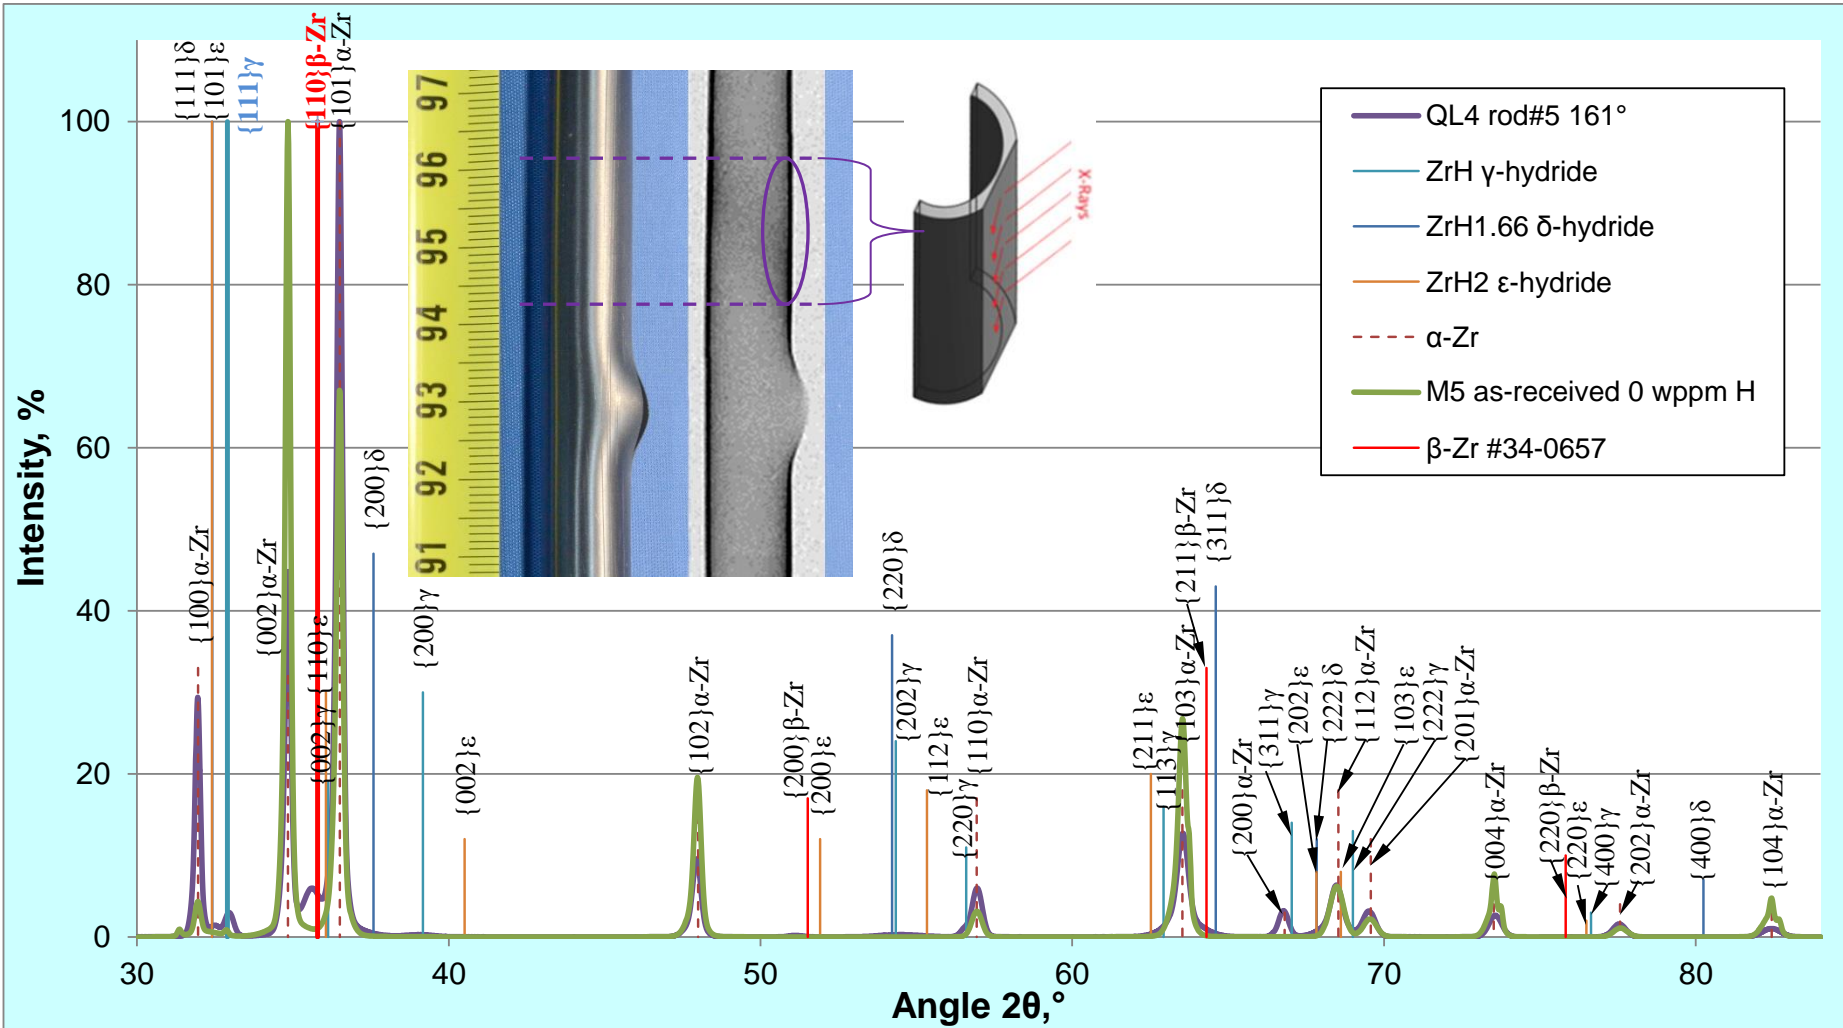
QUENCH-L4, rod 5; XRD analysis

XRD analysis detected hydrides inside hydrogen bands. Elaborated EBSD analysis showed that 1) the hydrides have μm -sizes and distributed in matrix intra- as well inter-granularly; 2) areas with secondary hydrogenation have a strong distorted lattice.
