# First Results of the QUENCH-13 Bundle Experiment with a Silver-Indium-Cadmium Control Rod

*Institute for Materials Research  
Forschungszentrum Karlsruhe*

## Objectives of the QUENCH-13 test

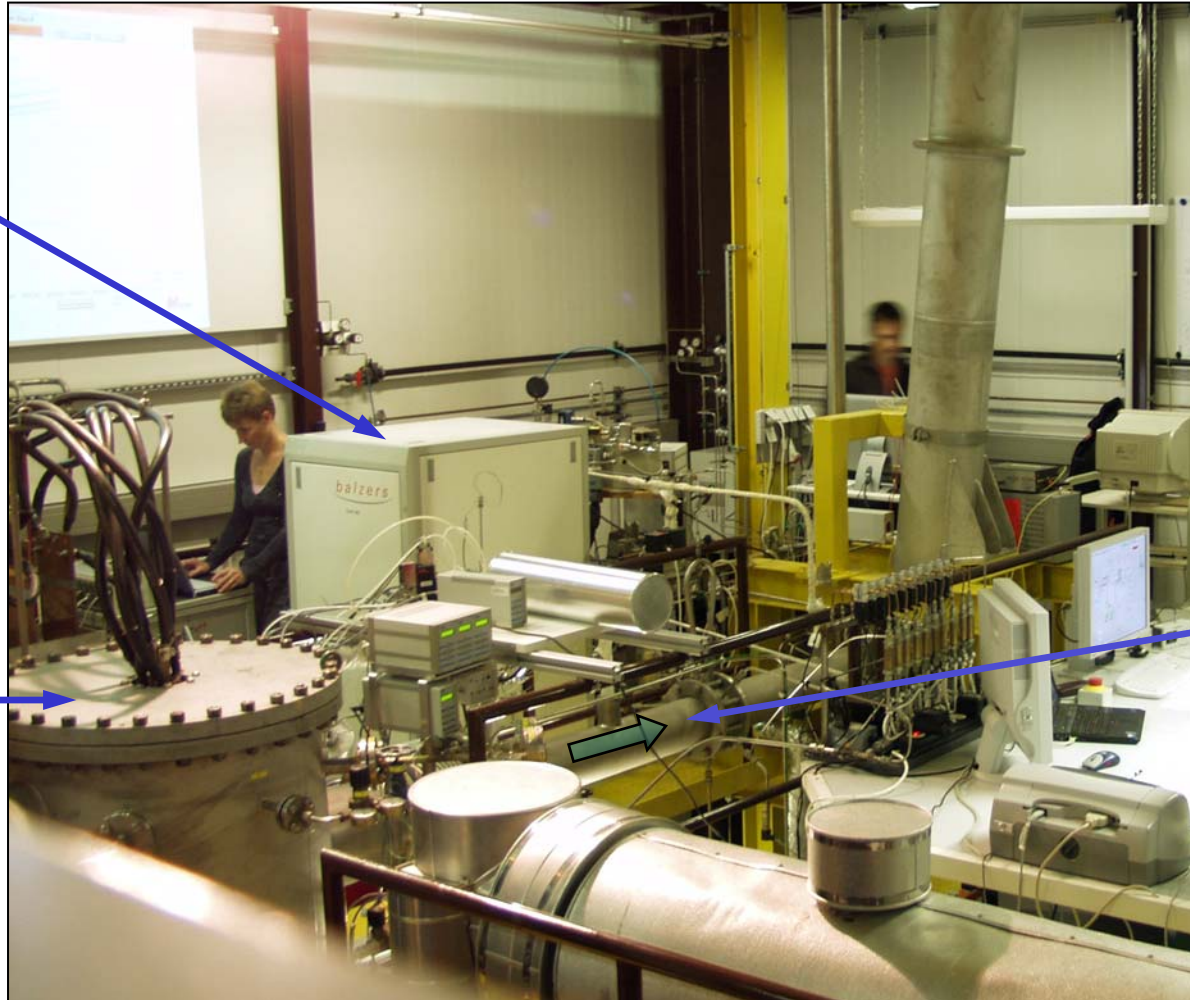
# Components of the QUENCH facility

mass spectrometer

containment with electrically heated bundle

off-gas pipe

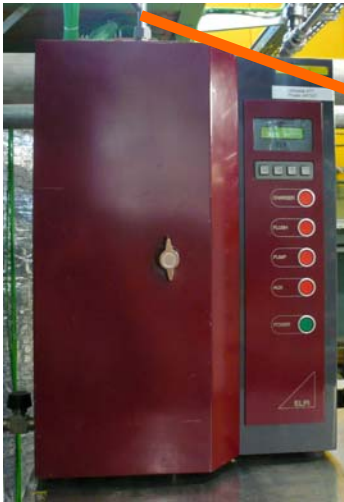
**ELPI  
online measurement**

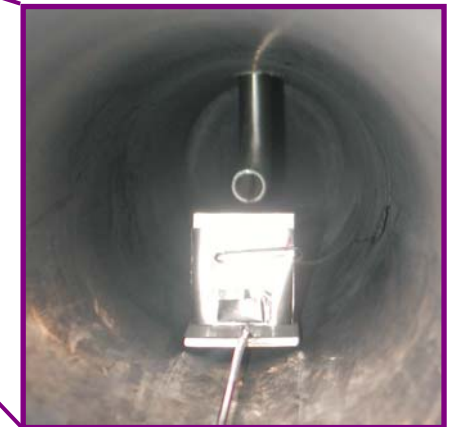
**Ni-plate with pocket  
installed inside off-gas pipe  
under sampling tube**

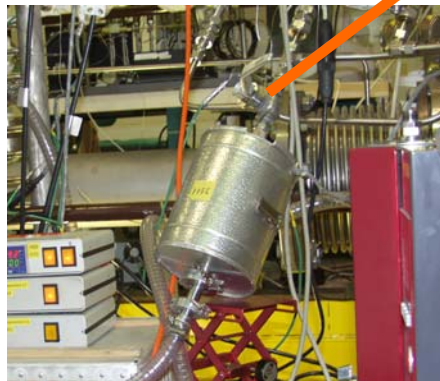
**BLPI, 3 time exchanged during the test**

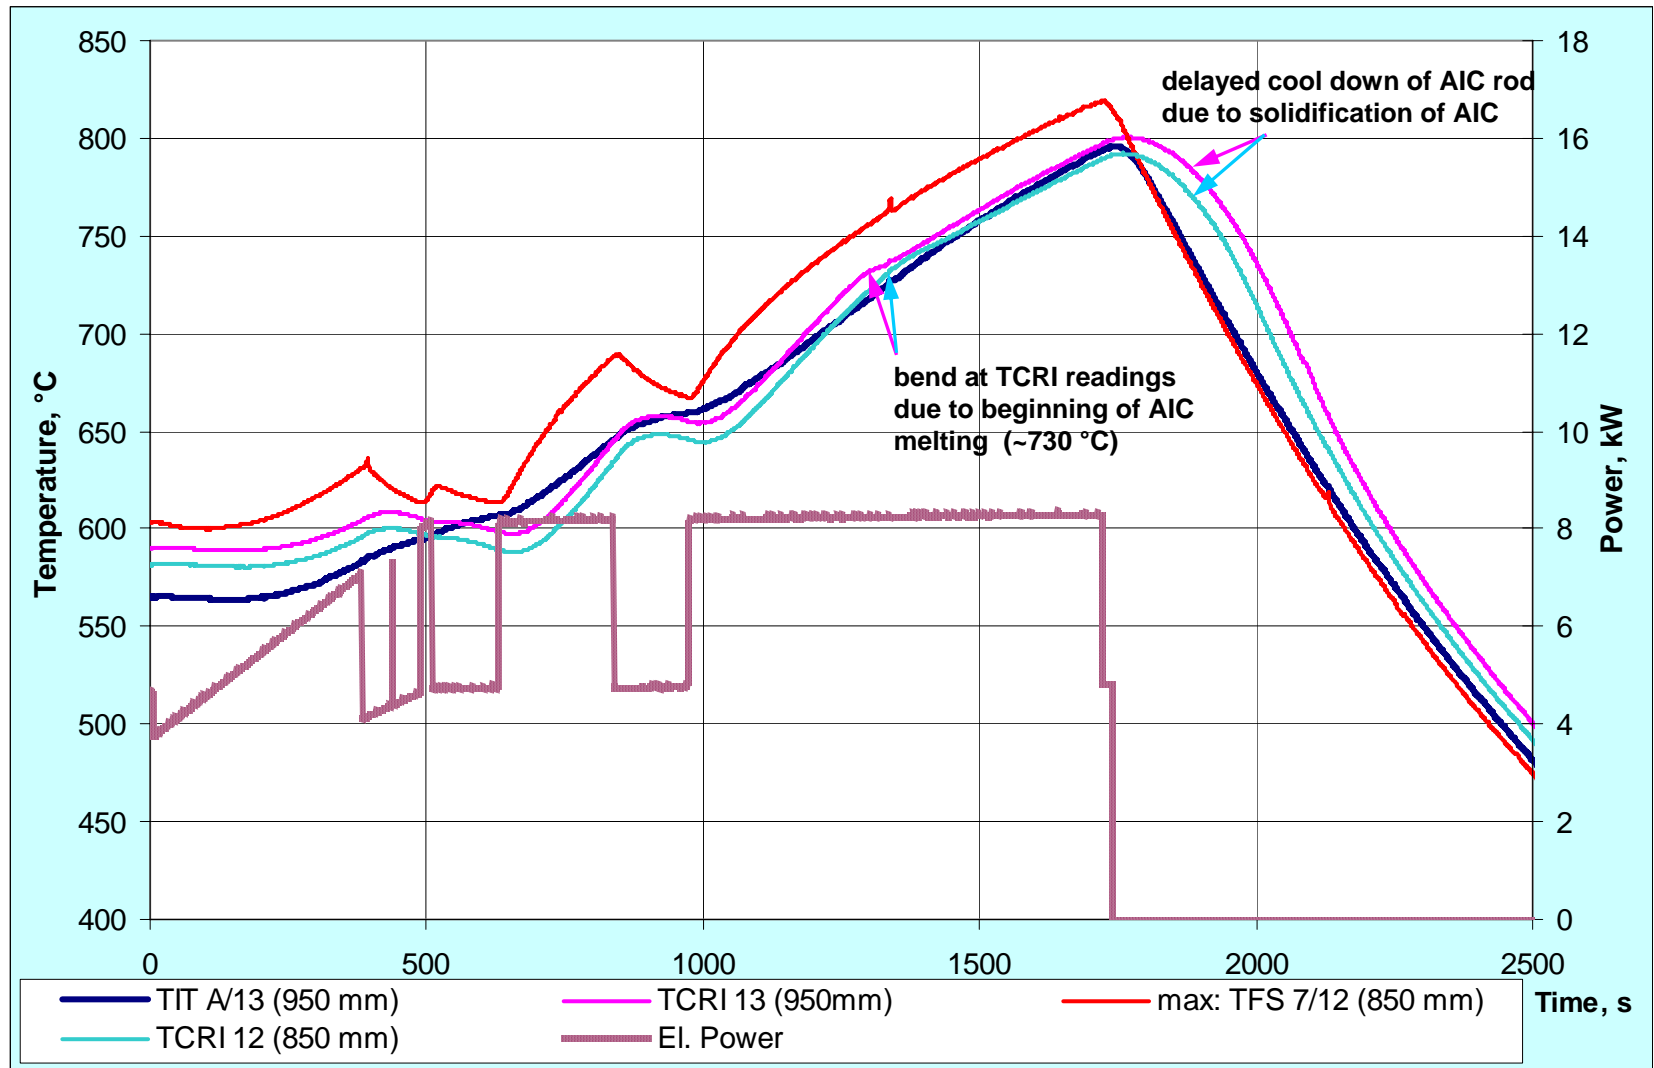
## Preliminary test to investigation of the bundle behaviour and testing of the aerosol measurement equipment.

**TC between control rod claddings (TCRI) shows initiation of AIC melting at 850 mm and 950 mm.**

- The preliminary test at the maximum temperature 800°C was performed. Melting of absorber material was shown by changes in heat-up rate at temperatures of about 1000 K (solidus).

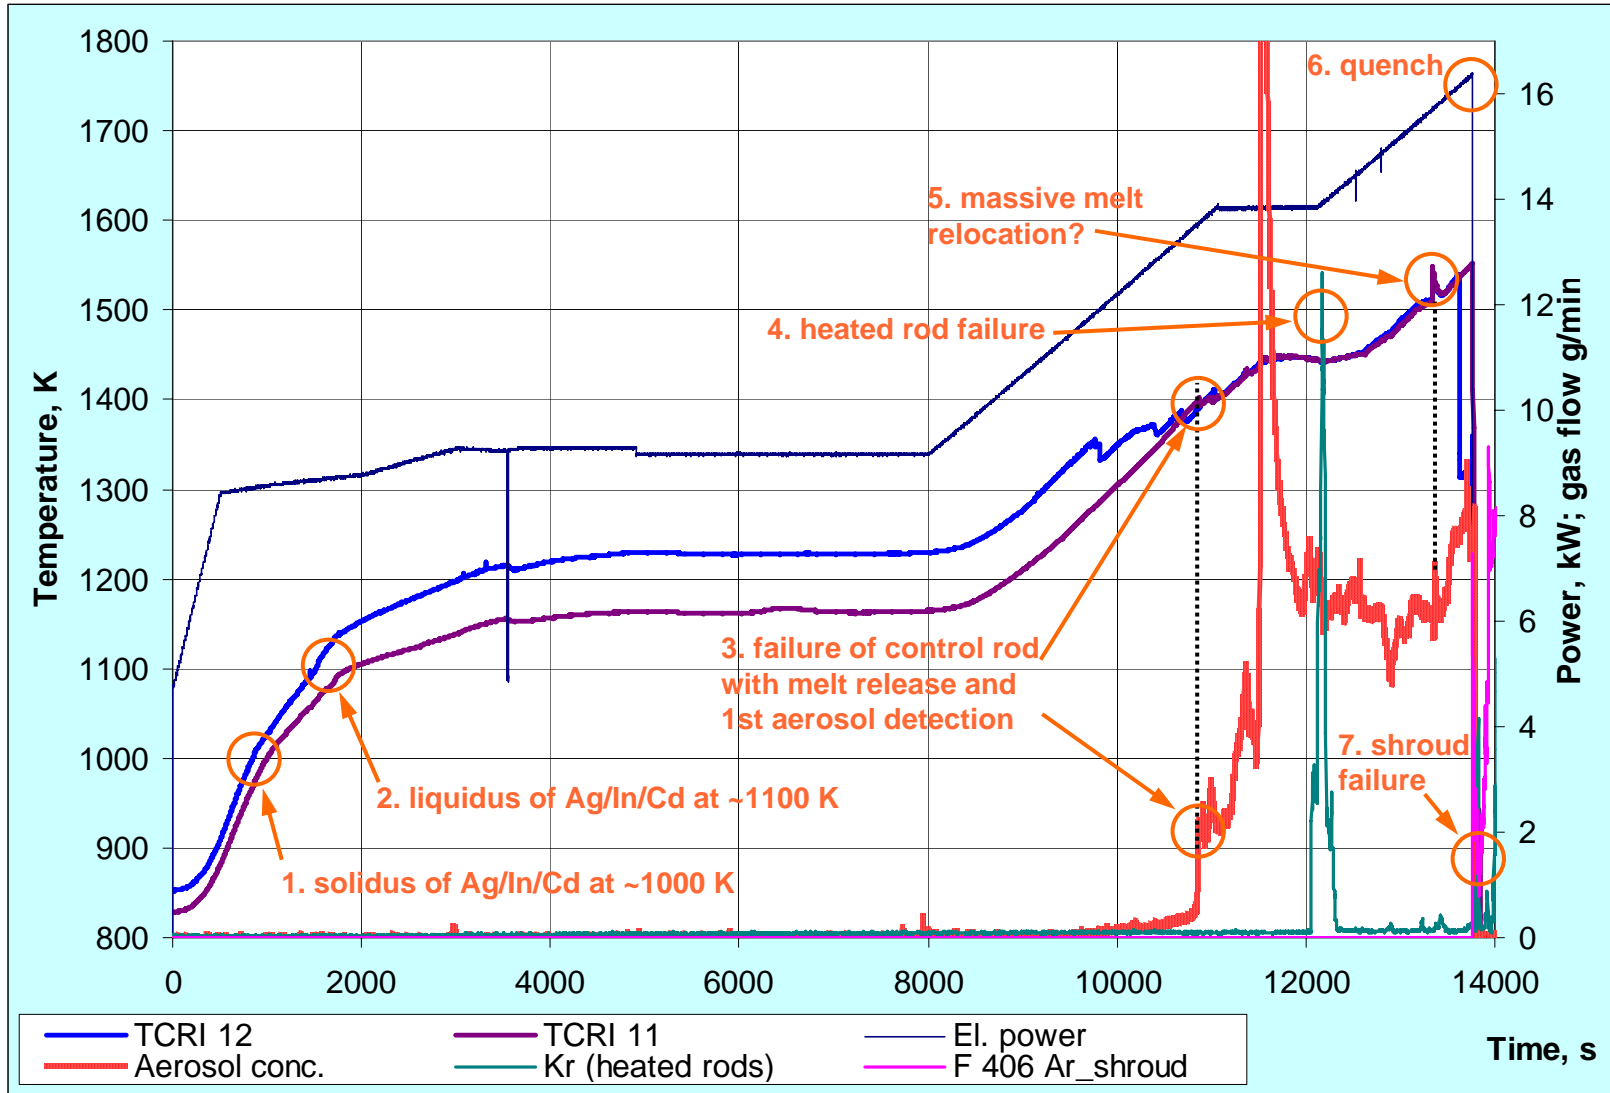
# QUENCH-13: sequence of events

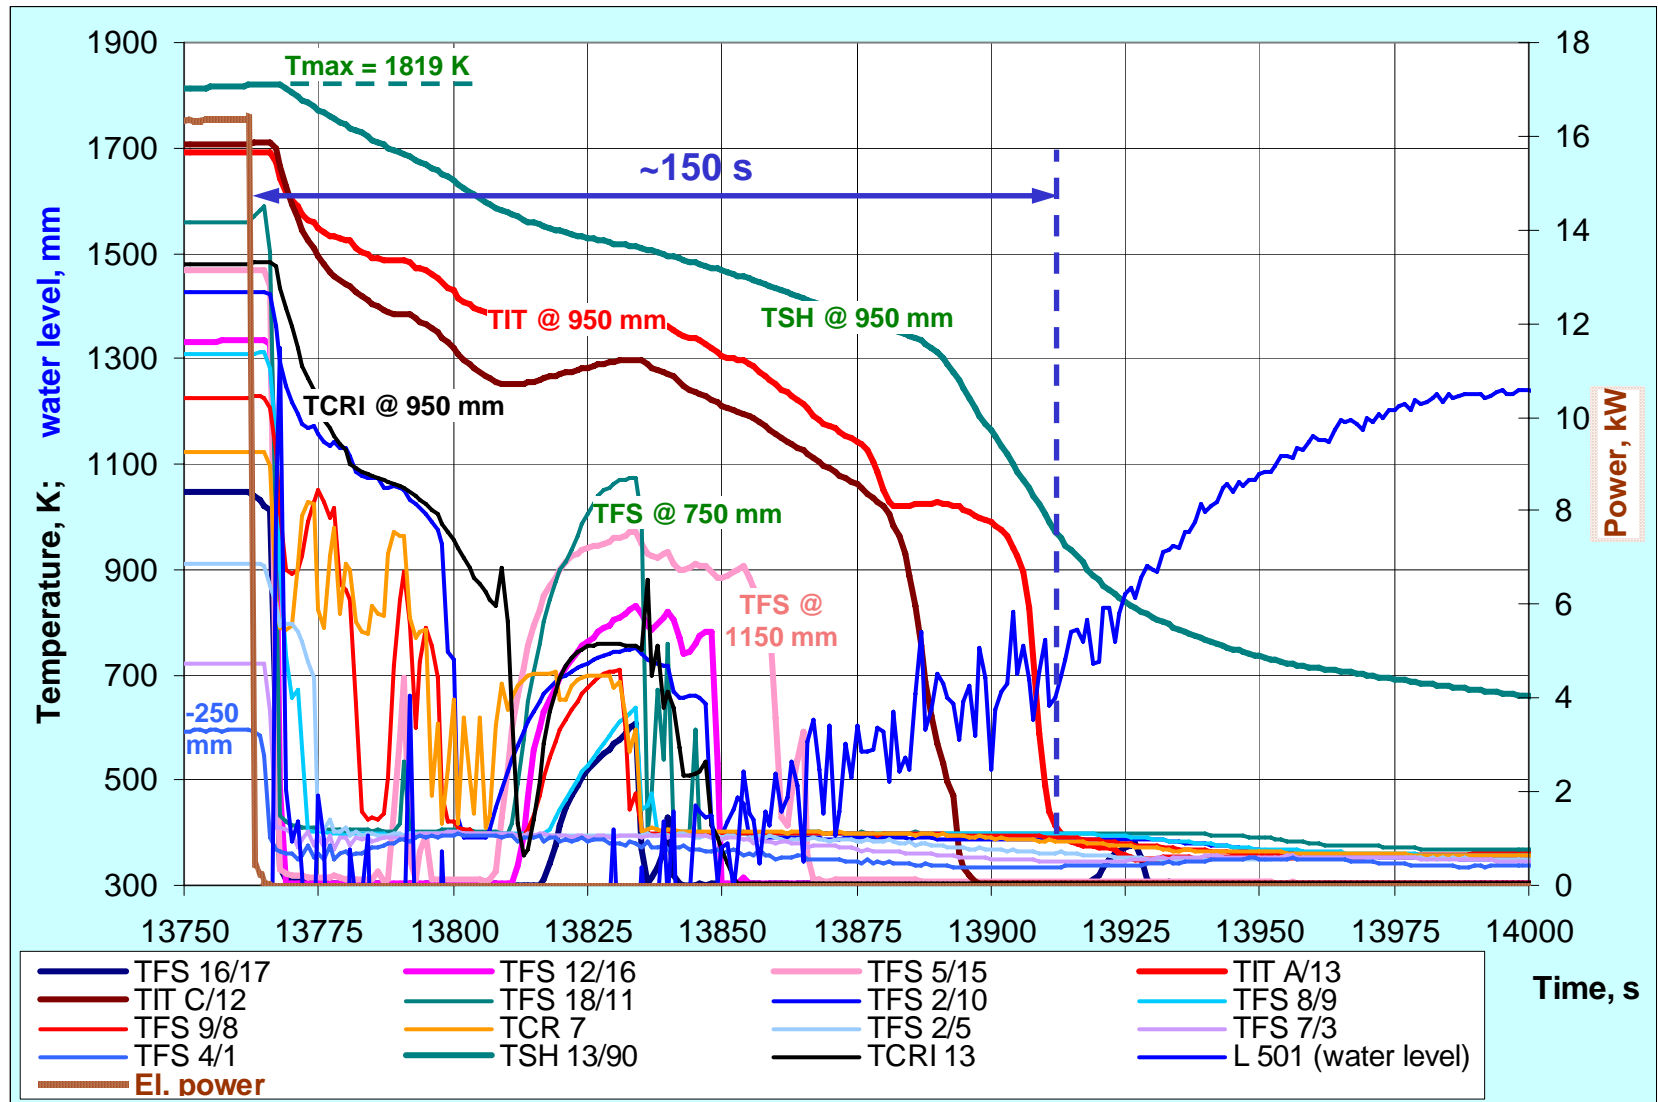
## QUENCH-13, quench phase: bundle cooling during ~150 s

- The test was terminated at  $T_{\max} = 1813$  K, by reflood with cold water at 52 g/s, and switching off the electrical power. The total hydrogen production was ~42 g. Only negligible mass of hydrogen (~0.5 g) was released during the reflood.
- Some failure of heated rods occurred during a second part of the transient phase (after the power plateau), while shroud failure was observed just after the initiation of reflood.
- EDX analysis of aerosols collected after control rod failure shows significant content of Cd (42 wt%) and In (41 wt%) with minor parts of Ag and W. The content of Ag and W increased during the following transient.
- The post-test videoscope investigations of the bundle were performed at positions of three withdrawn corner rods. The relocated Ag/In/Cd melt was detected between third (550 mm) and first (-150 mm) spacer grids.

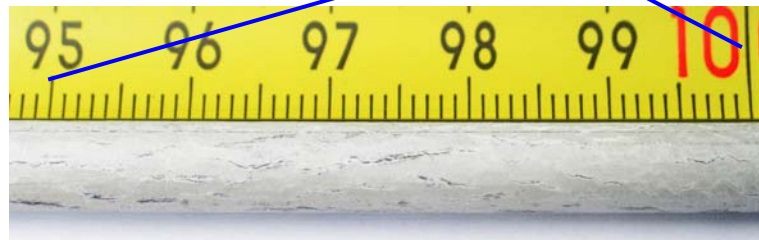
# QUENCH-13: withdrawn corner rods, breakaway oxidation between 850 and 1000 mm

corner rods B, D:

B – withdrawn at 12538 s after corner rod failure (beginning at ~10850 s) ,  
D – withdrawn after test.

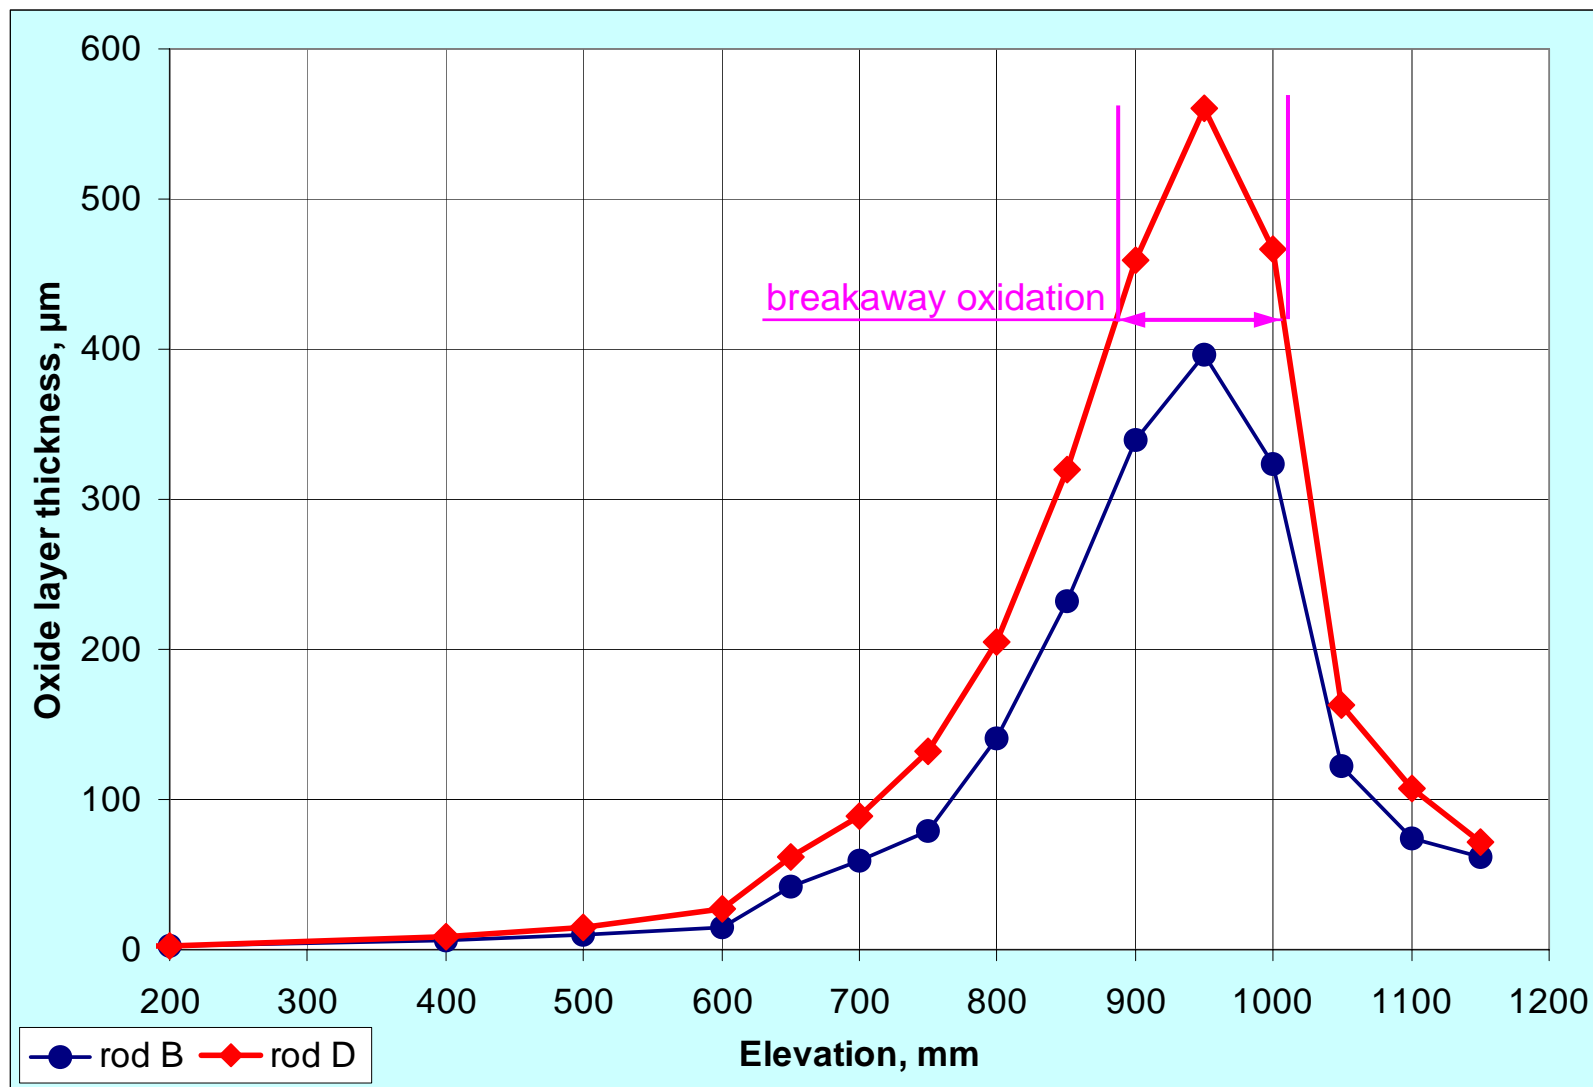
## QUENCH-13: axial oxide layer thickness distribution measured with eddy current

- A first corner rod was withdrawn following the control rod failure. A maximum oxide layer thickness of ~400 µm was reached at elevation 950 mm. A second and a third corner rods, which were withdrawn after the test, have a maximum oxide layer thickness of ~550 µm and evident development of cracks inside the oxide layer. Axial distribution of accumulated hydrogen shows 3 peaks with maximum of 16%.

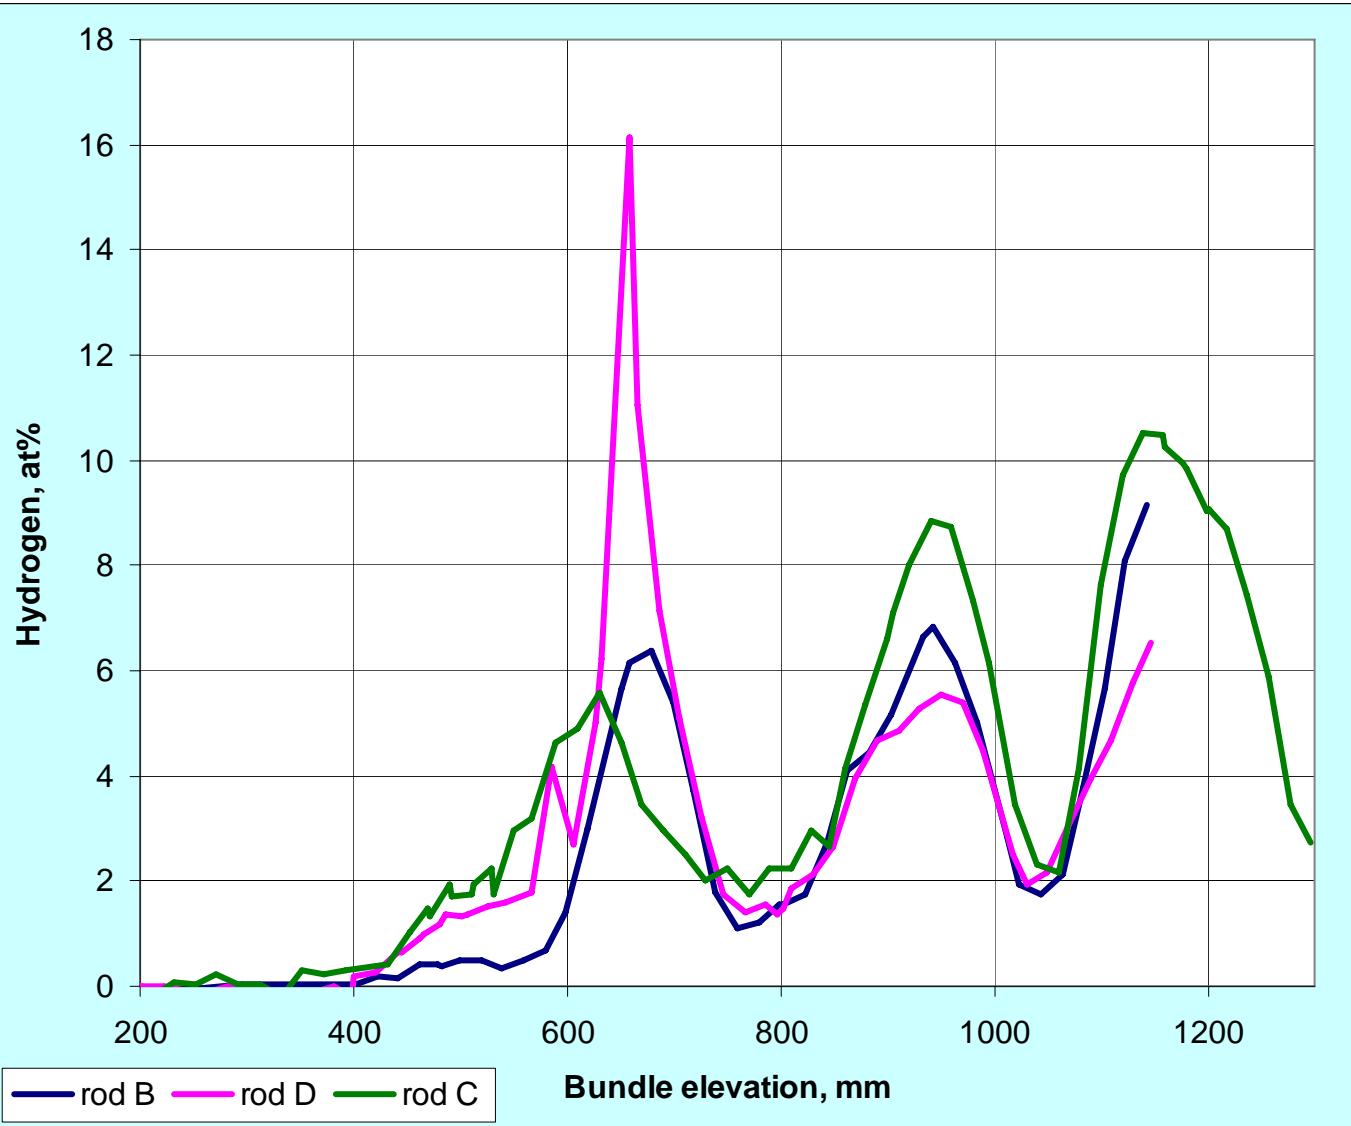
# QUENCH-13: hydrogen uptake by corner rods /results of neutron radiography by PSI (M. Große)/

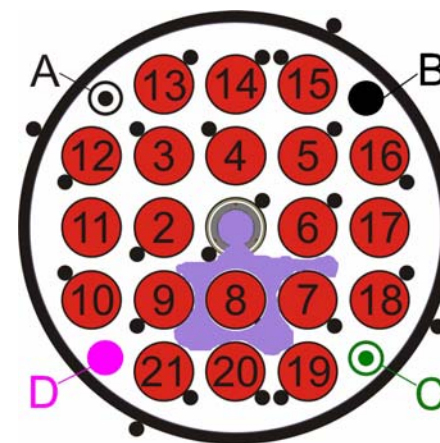
probable  
Ag/In/Cd melt  
distribution  
(axial: between 3<sup>rd</sup> and 1<sup>st</sup>  
spacer grids):

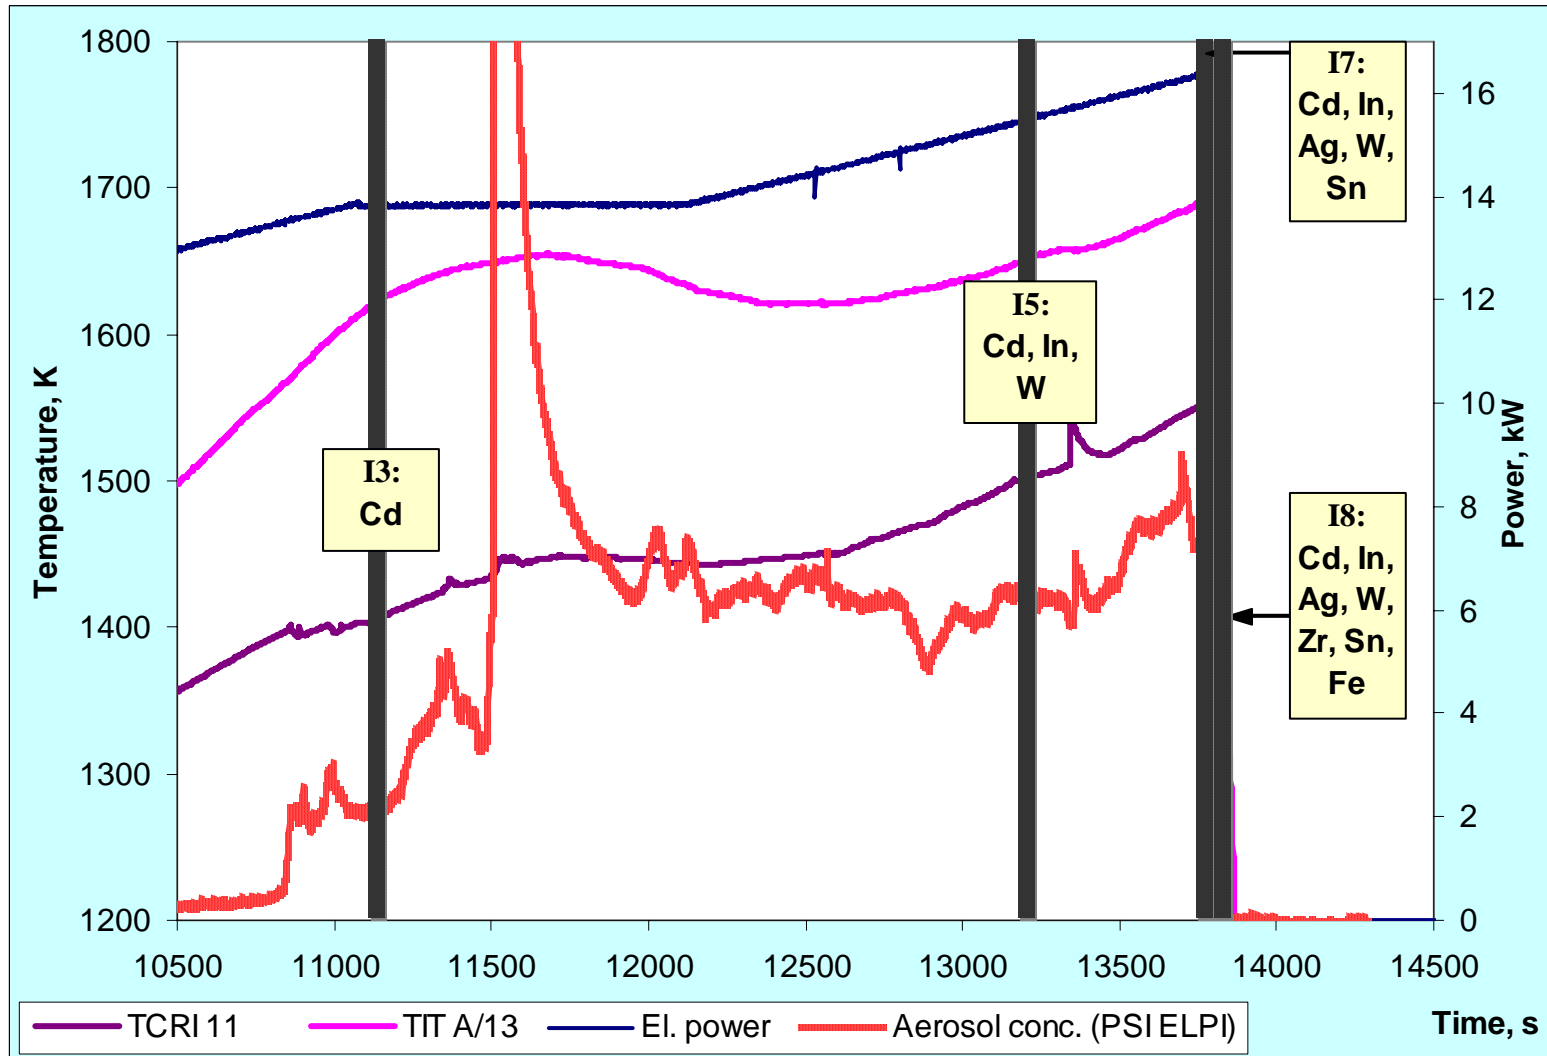
# QUENCH-13: AEKI aerosol measurement at bundle outlet. Analysis of impactors content.

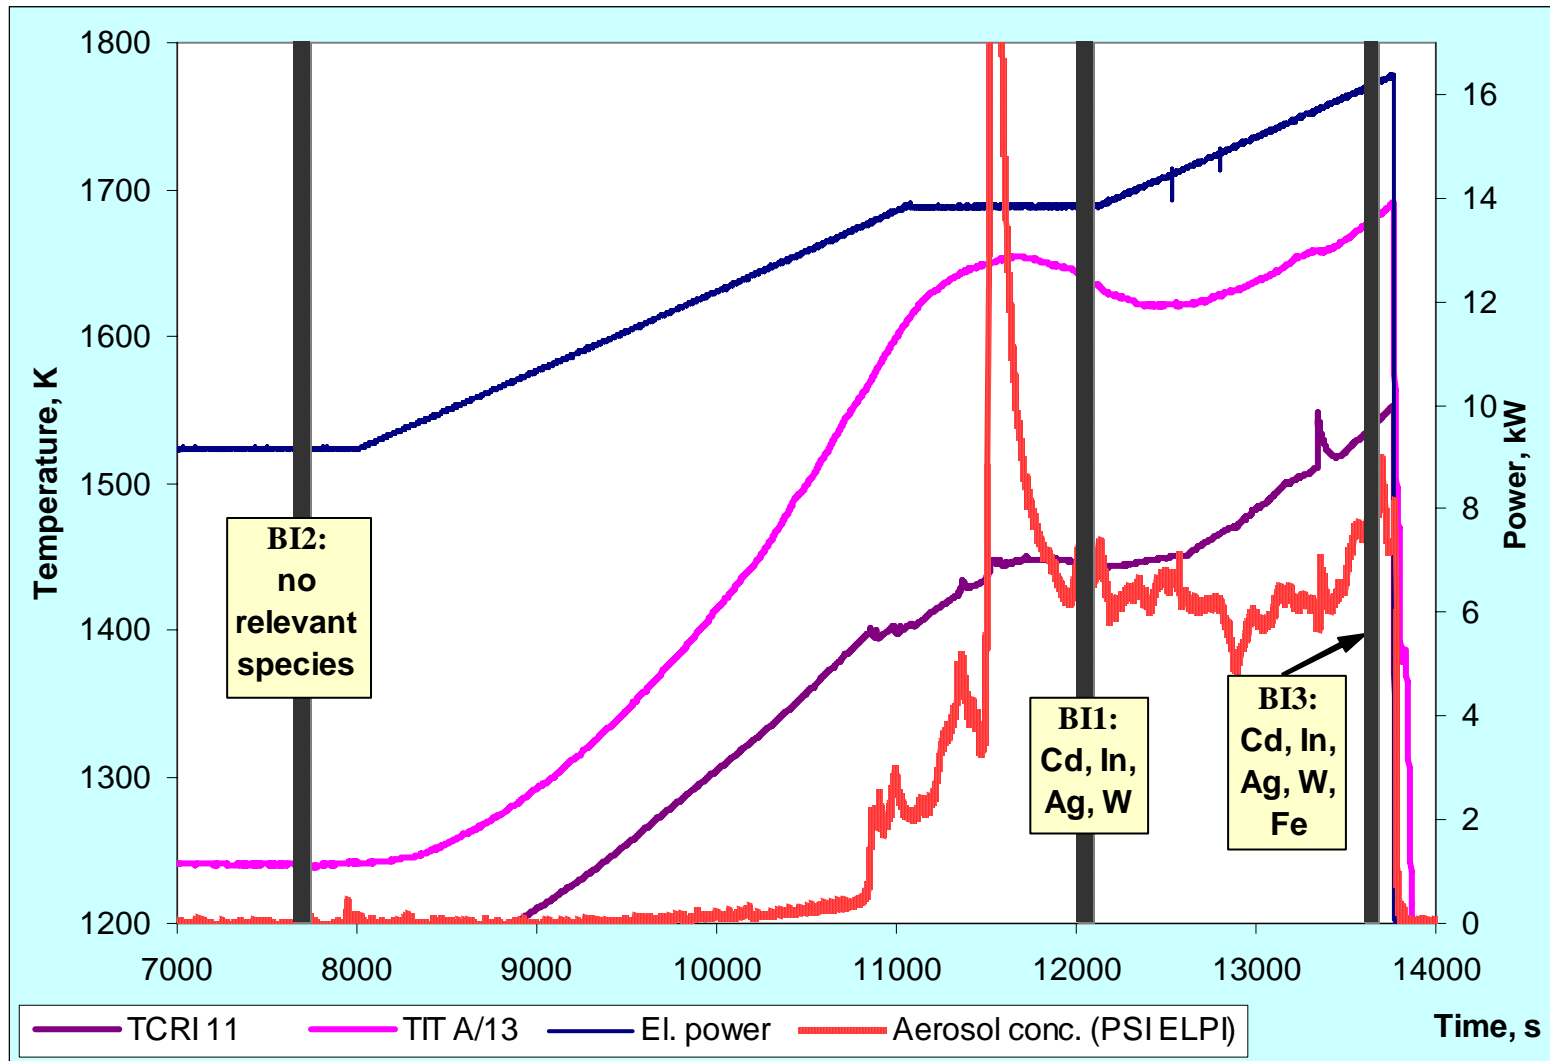
# QUENCH-13: PSI aerosol measurement at bundle outlet. Analysis of BLPI impactors content.

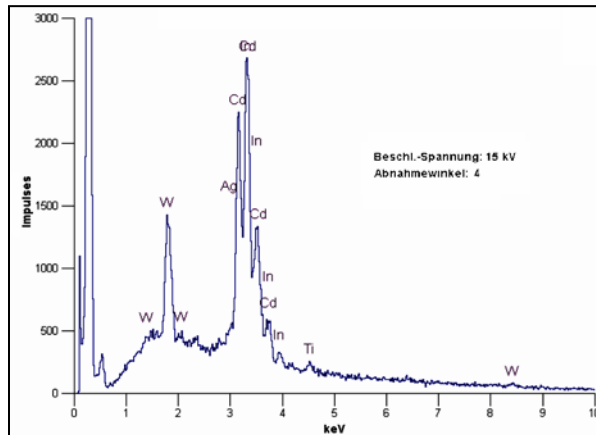
**Sample BI1: collected after control rod failure**

Cd	In	Ag	W
wt%	42	41	2.5	14.5
