Experimental results of the QUENCH-16 bundle tests on air ingress, performed within the framework of the LACOMEKO project

17th QUENCH Workshop, Karlsruhe

Institute for Applied Materials, IAM-WPT; Program NUKLEAR

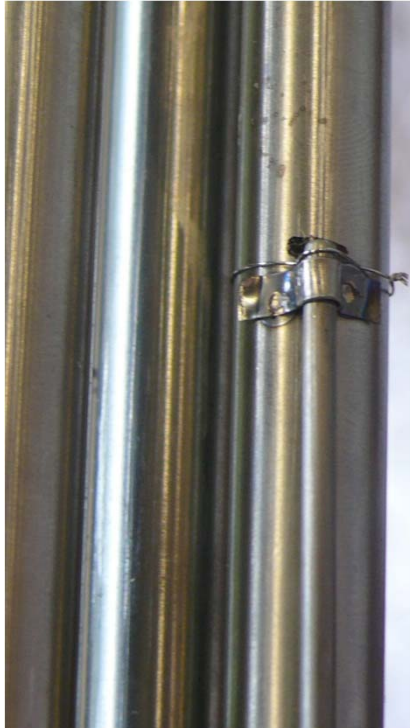
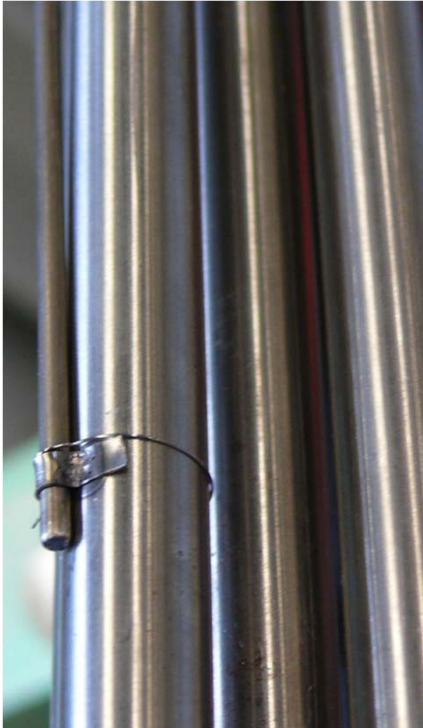
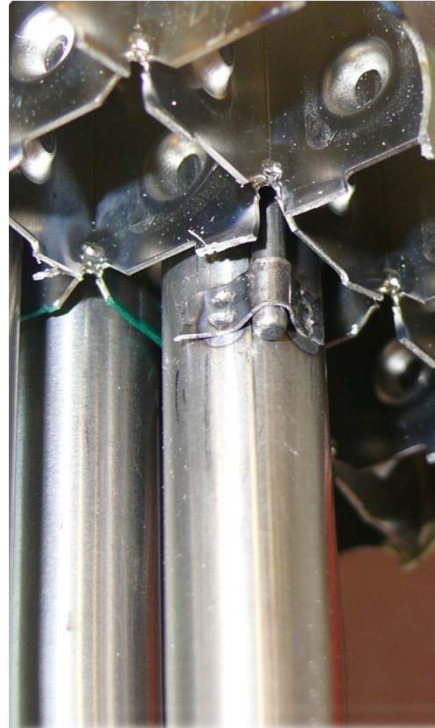
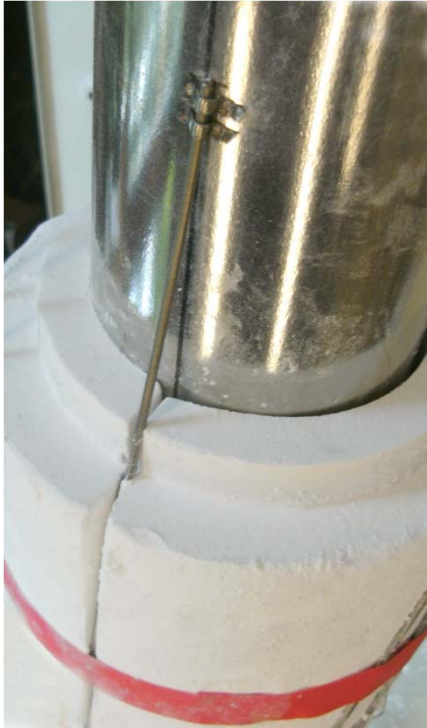
Mounting of high temperature thermocouples

<p>TC inserted from bundle bottom up to 850 mm</p>	<p>TC inserted from bundle top above 850 mm</p>	<p>TC inserted from bundle top under GS4 (1150 mm)</p>	<p>TC installed at shroud</p>
<p>Cladding surface thermocouples TFS</p>			<p>Shroud thermocouples TSH</p>

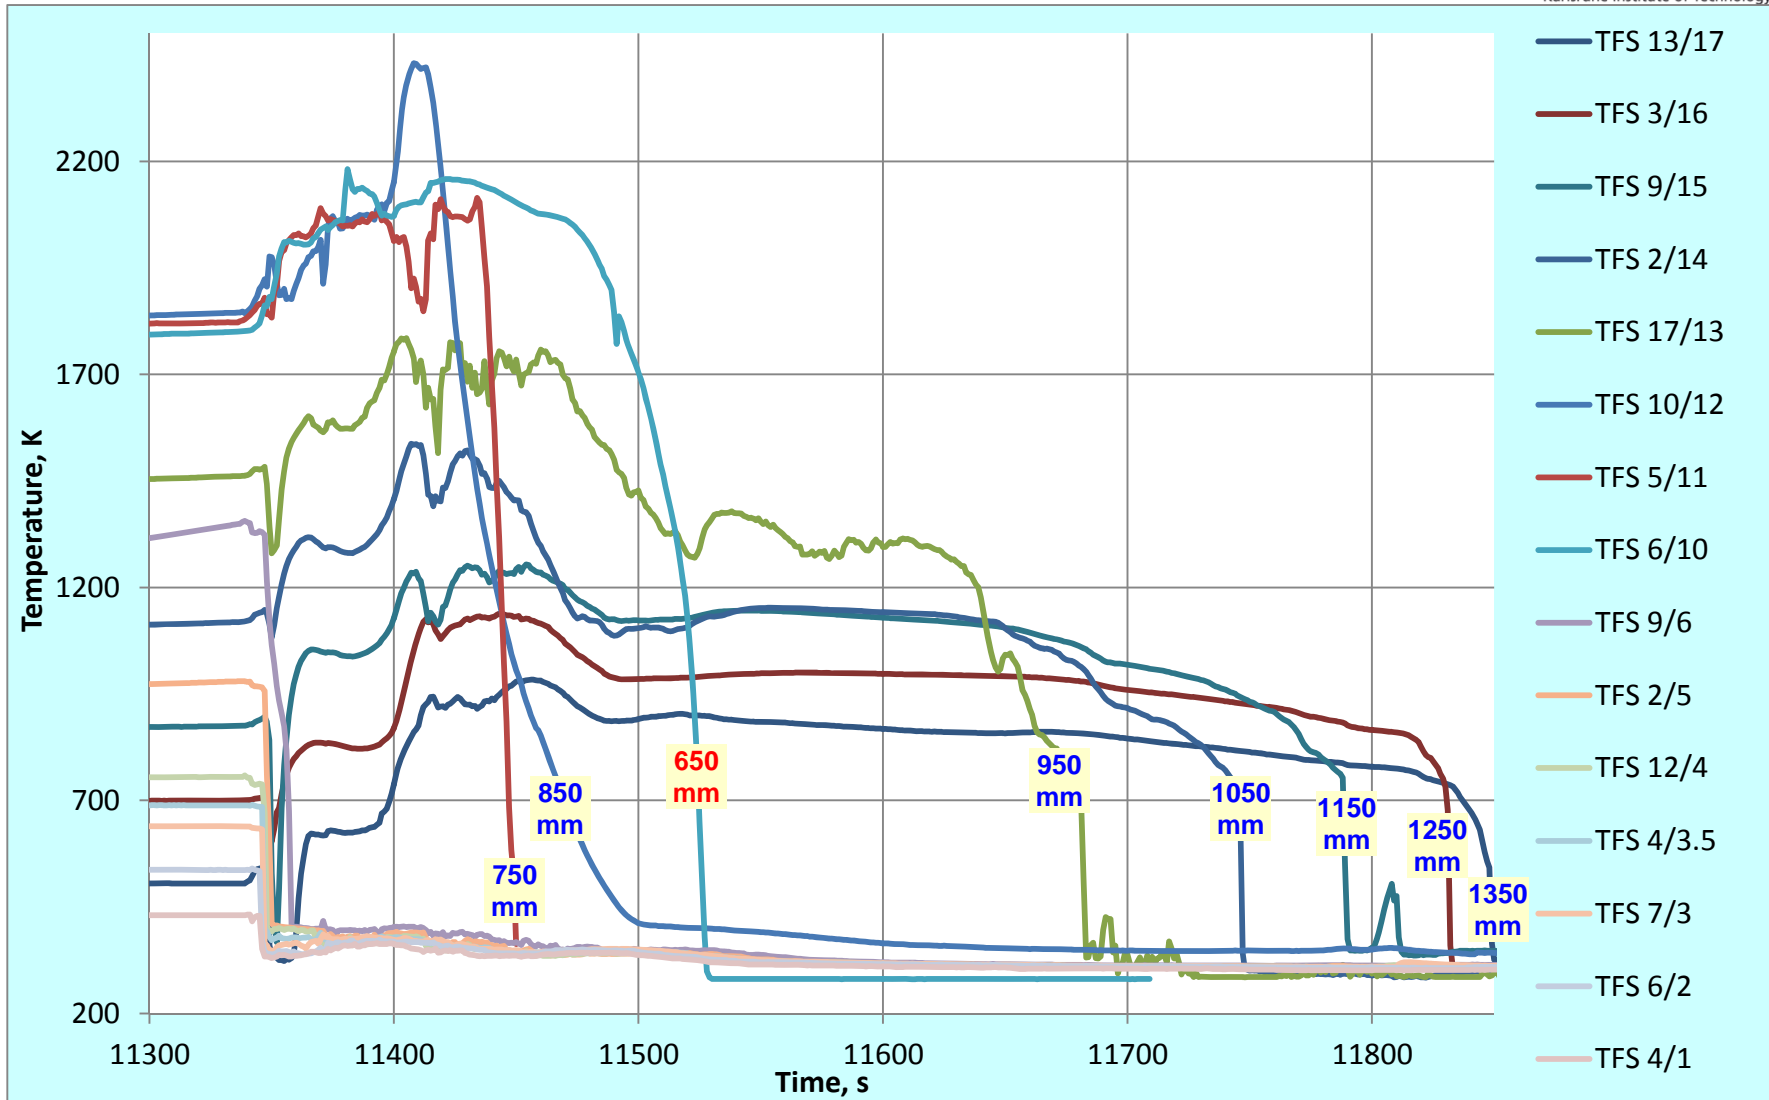
Temperature escalation and cooldown during reflow

Durations: escalation 100 s cooldown 400 s

- Immediate temperature escalation on reflood initiation, leading to maximum measured temperatures of about 2420 K. The cooling phase to the final quench lasted ca. 500 s after achievement of peak temperature.

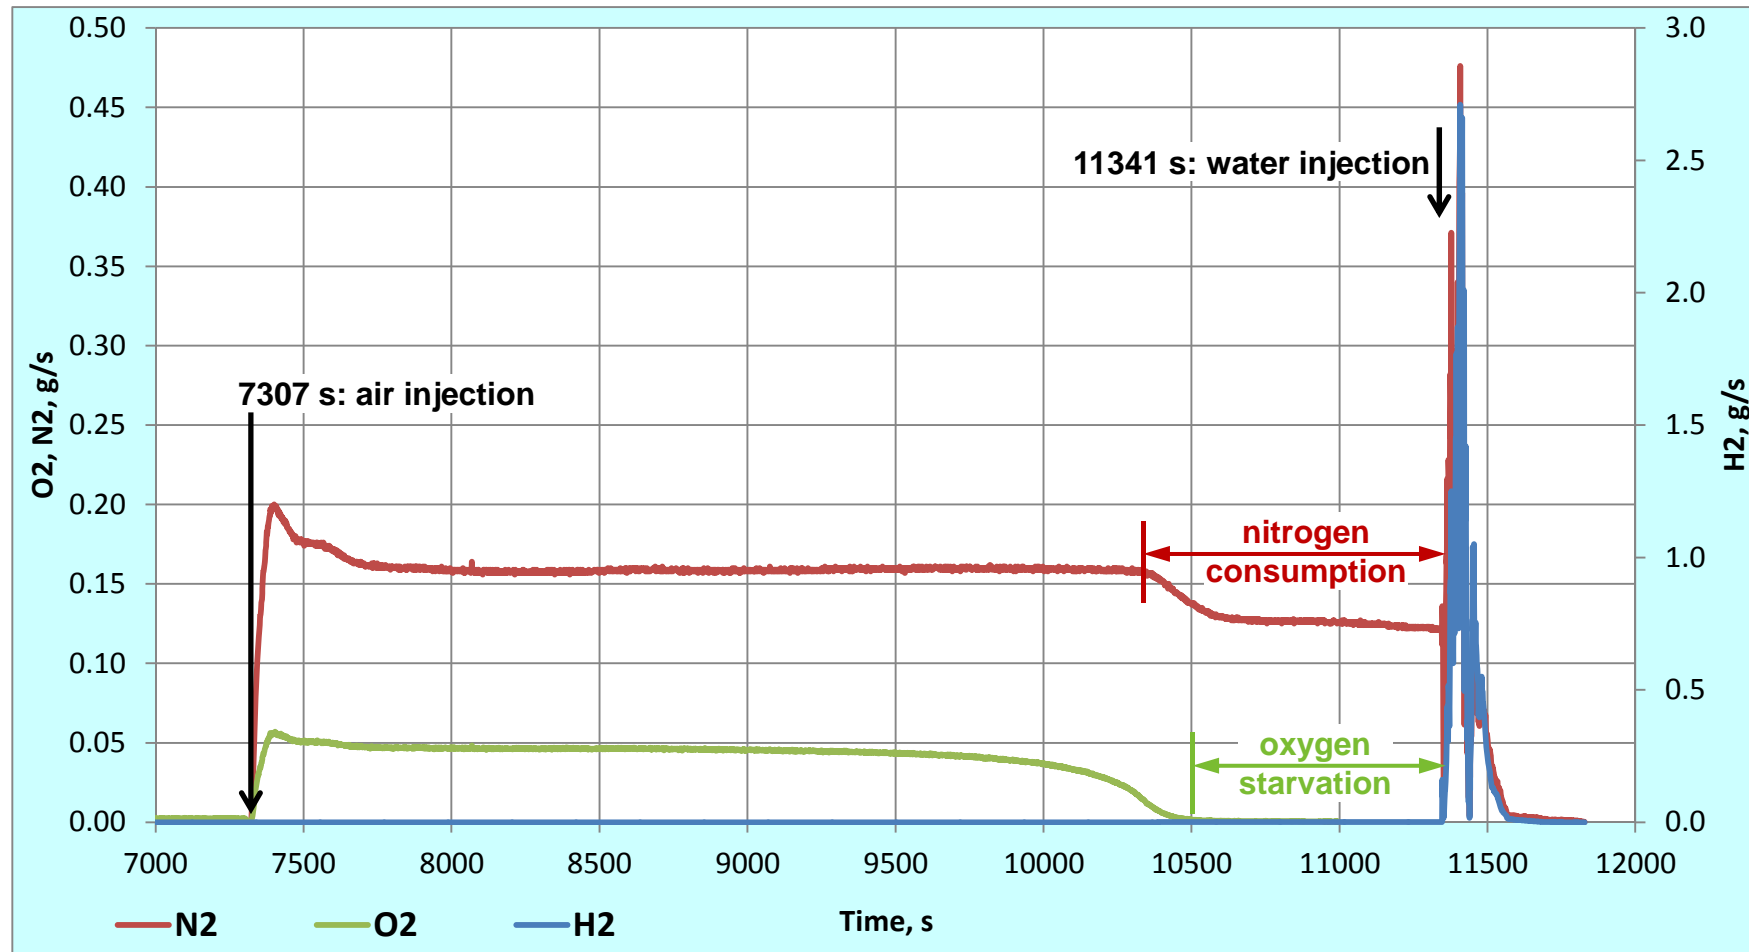
Consumption of nitrogen and oxygen during air ingress phase: data of mass spectrometer

oxygen uptake: 58 g

nitrogen uptake: 29 g

- Maximal oxide thickness before air ingress 130 μm (measured on withdrawn corner rod).
- The last 835 s of air ingress phase correspond oxygen starvation and partially consumption of nitrogen and accompanied by acceleration of the temperature increase at mid bundle elevations.

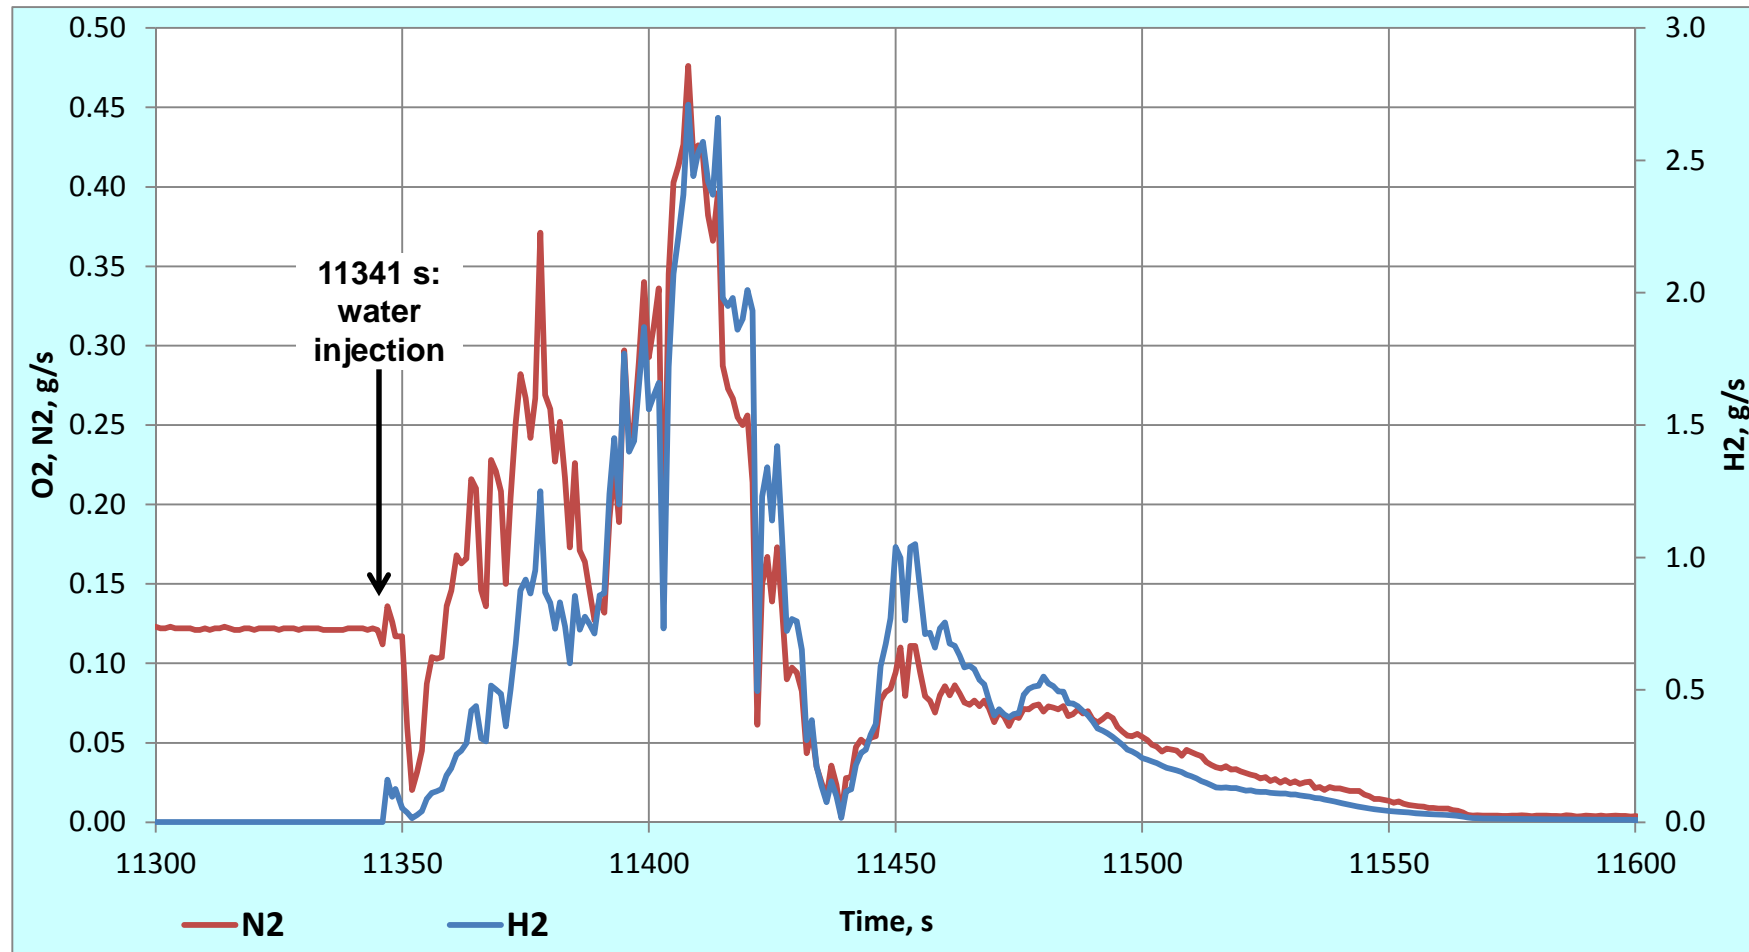
Release of hydrogen and nitrogen during quench phase: data of mass spectrometer

hydrogen release: 128 g. Two main sources: 1) melt oxidation; 2) re-oxidation of Zr-nitrides

nitrogen release: 24 g from consumed 29 g -> severe nitrides leftover and should be observed

- 24 g nitrogen from 29 g, consumed during oxygen starvation period, were released during the quench phase
- Significant quantity of hydrogen was generated during the reflood (128 g).

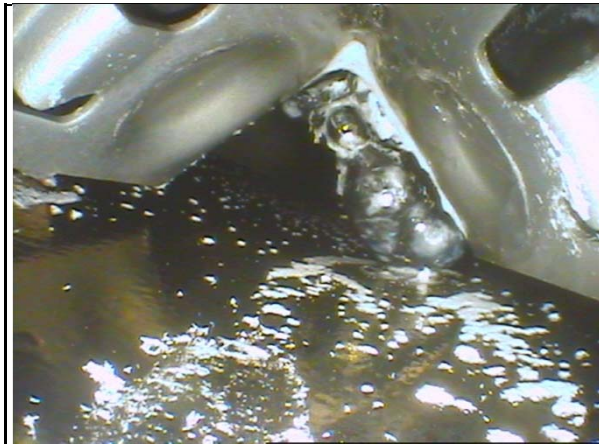
Grid spacer #1 at -60 mm: frozen melt relocated from upper elevations

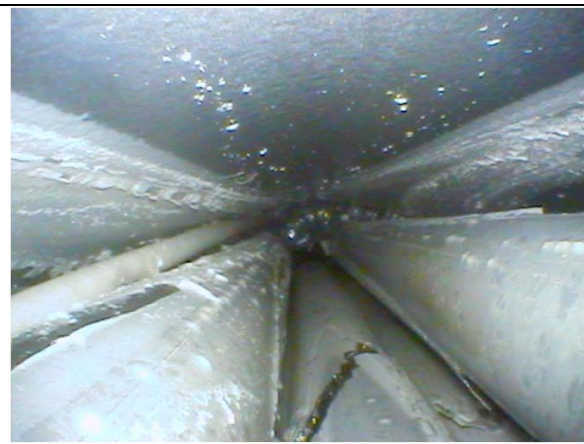
350 mm: oxide cracks; between rods – melt relocated from upper elevations

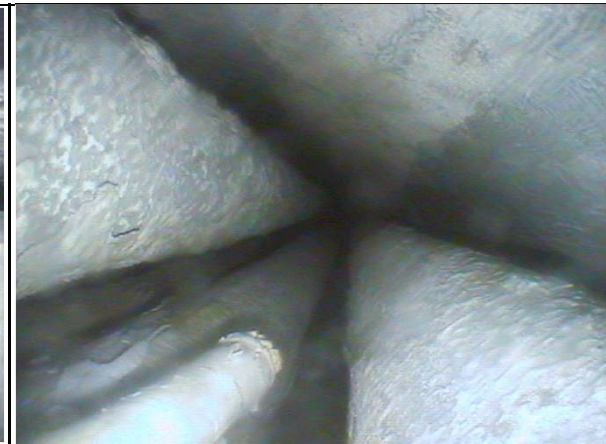
650 mm: absence of upper spalled oxide scales

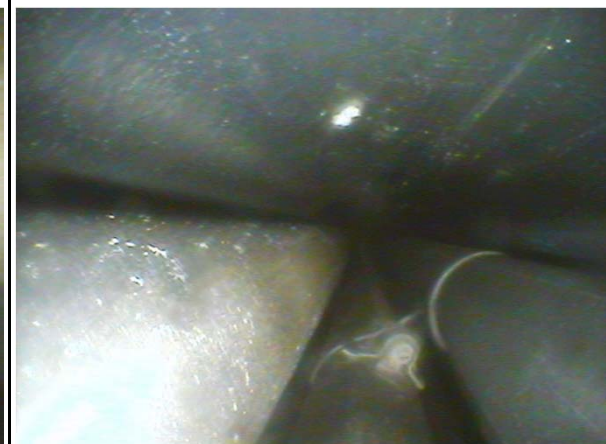
1150 mm: intact dark oxidised surface of claddings

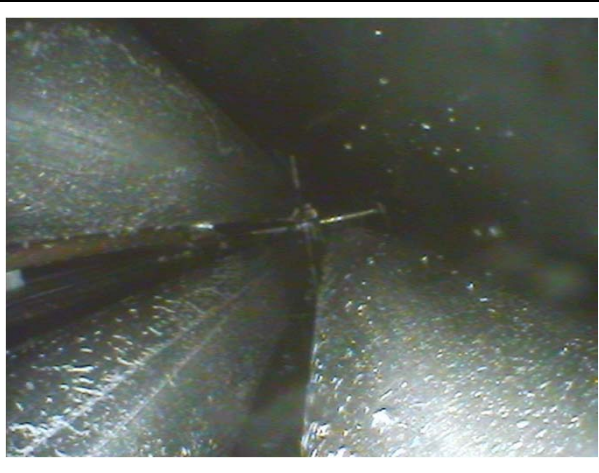
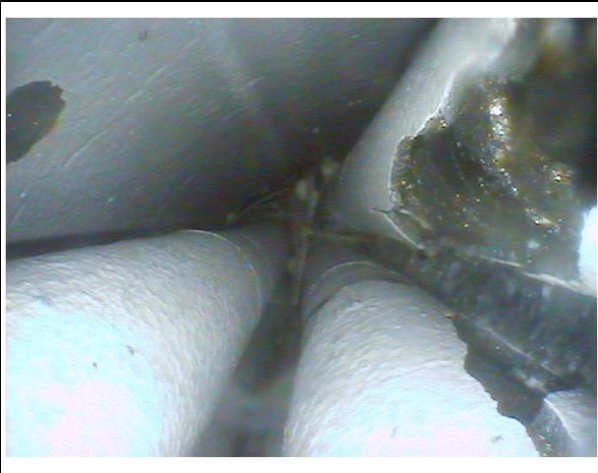
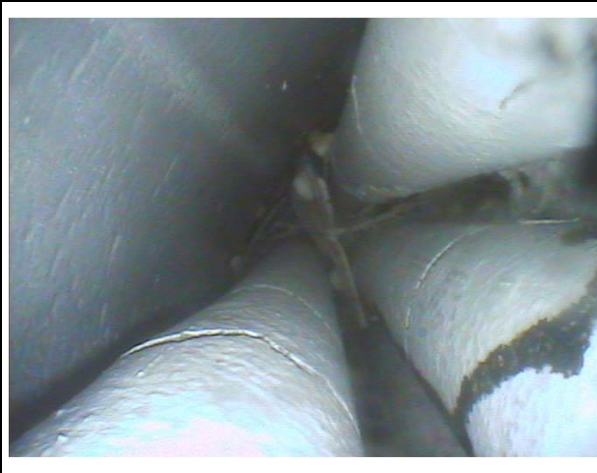
Post-test visual investigations by endoscope introduced at the position of the corner rod D: front view

<p>0 mm: relocated small oxidised debris adhered to surface of lightly oxidised claddings</p>	<p>400 mm: breakup of cladding pieces</p>	<p>450 mm: cracks going through the oxidised cladding; piece of relocated oxidised GS#3</p>

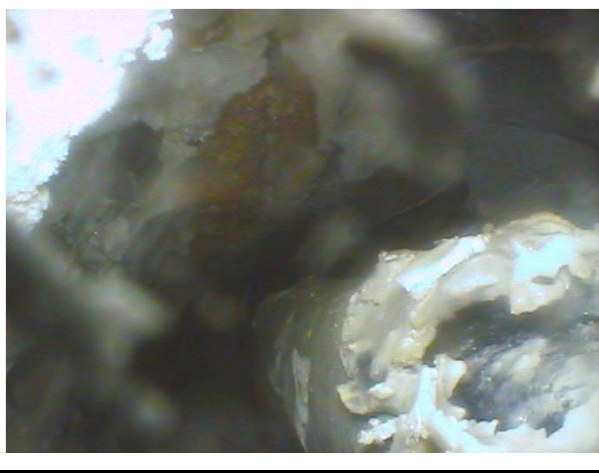
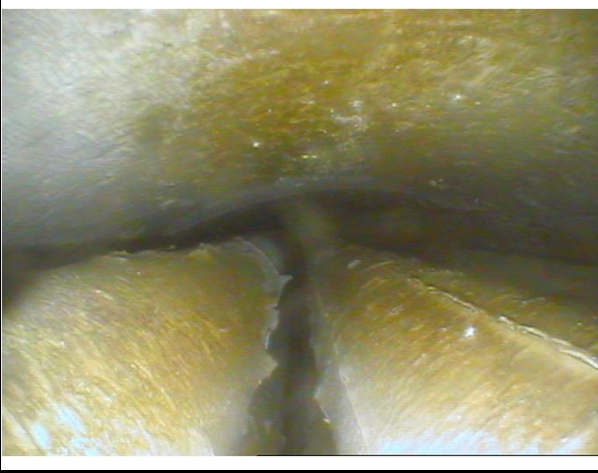
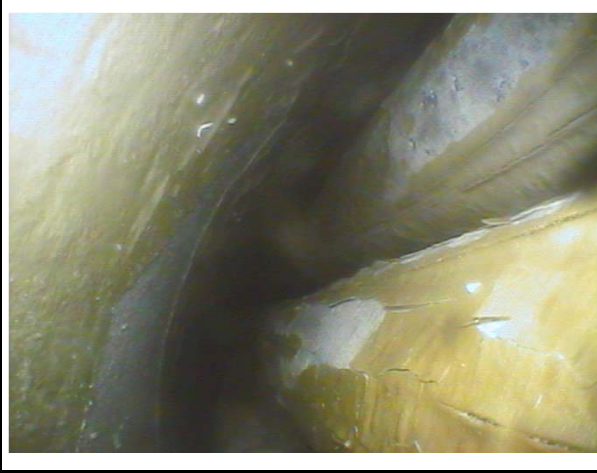
<p>600 mm: cladding melted through</p>	<p>700 mm: spalling of yellowed ZrO₂ scales from oxide layer</p>	<p>1000 mm: spalling of yellowed ZrO₂ scales from oxide layer</p>

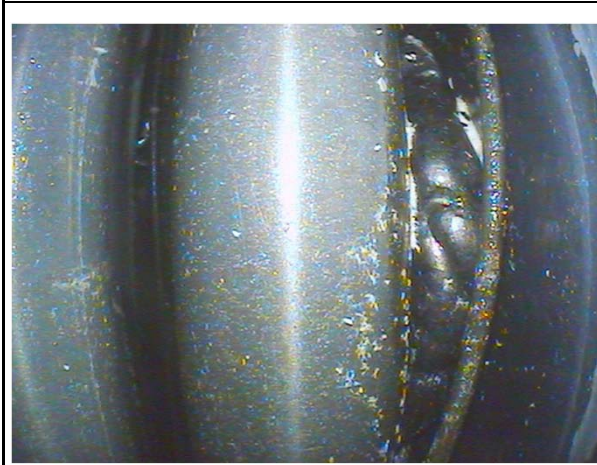
215 mm: frozen melt relocated from upper elevations

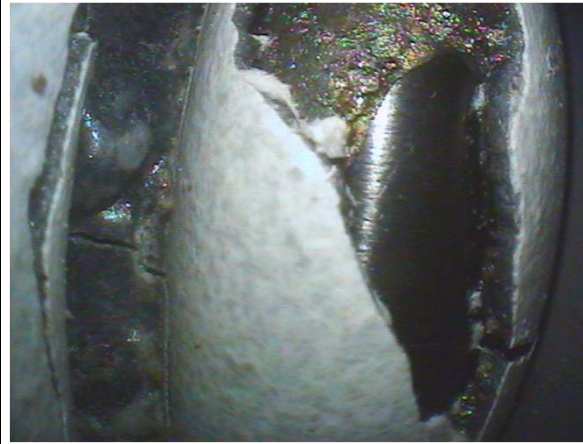
400 mm: frozen melt between rods

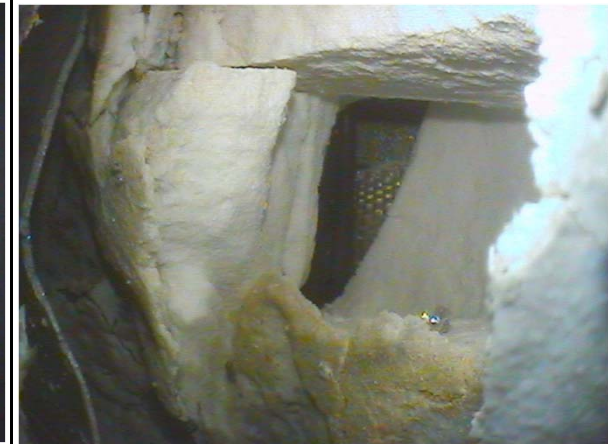
550 mm: ZrO₂ insulation damage under failed shroud

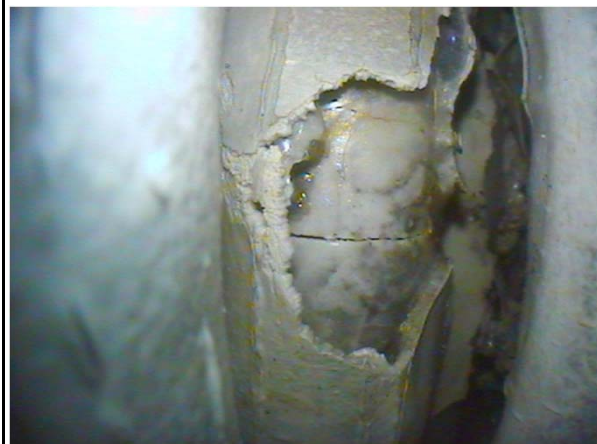
600 mm: damaging of cladding due to influence of melt

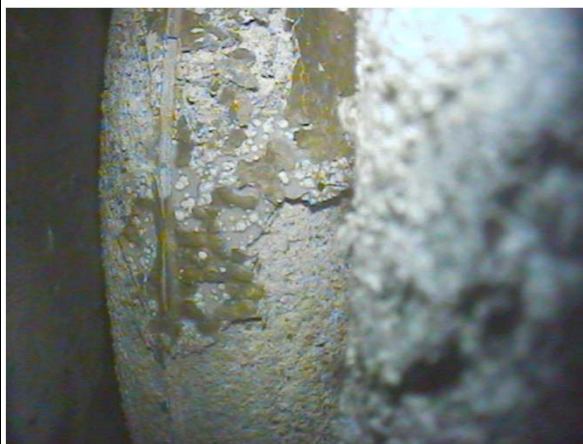
775 mm: spalling of outer oxide scales

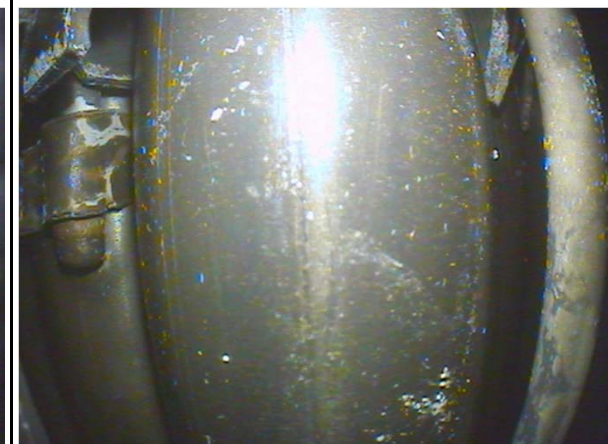
1050 mm: dark oxide of claddings, intact Grid Spacer #4

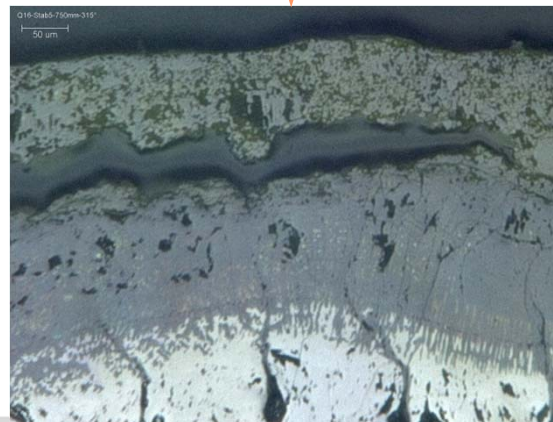
Spalling of re-oxidised scales at elevation 750 mm

prior nitrated scale
re-oxidised during quench
and spalled from internal ZrO₂ layer
growing during quench

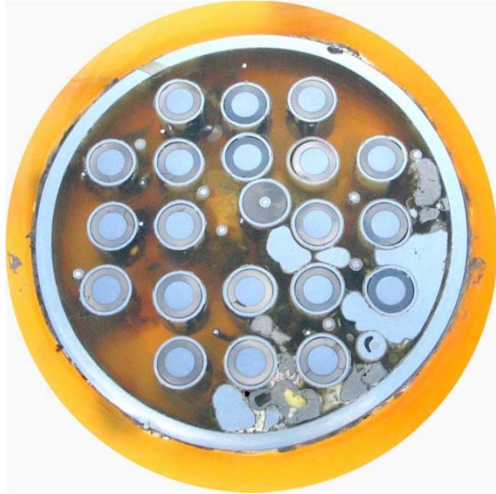
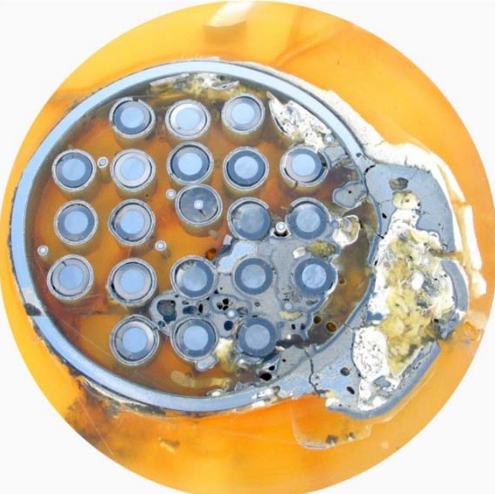
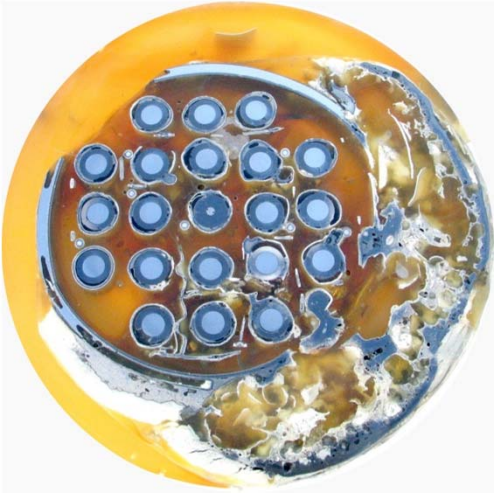
Bundle cross sections

<p>350 mm: metallic and oxidised melt pools</p>	<p>450 mm: mostly oxidised melt pools</p>	<p>550 mm: downwards relocated cladding metal</p>

- Metallographic investigation of cross sections between 300 and 500 mm showed frozen partially oxidised melt, relocated from upper elevations 500 – 800 mm. The melt oxidation could have been the main source of hydrogen during reflood.

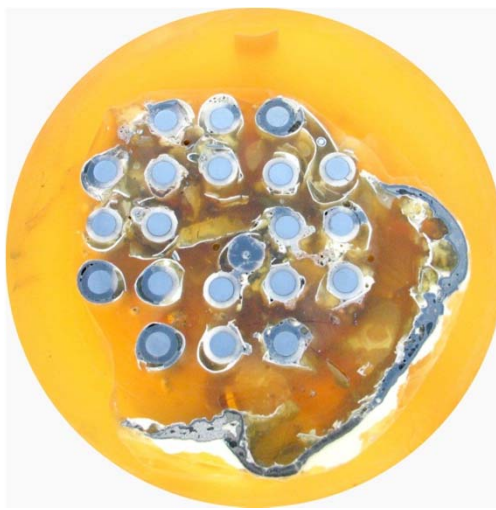
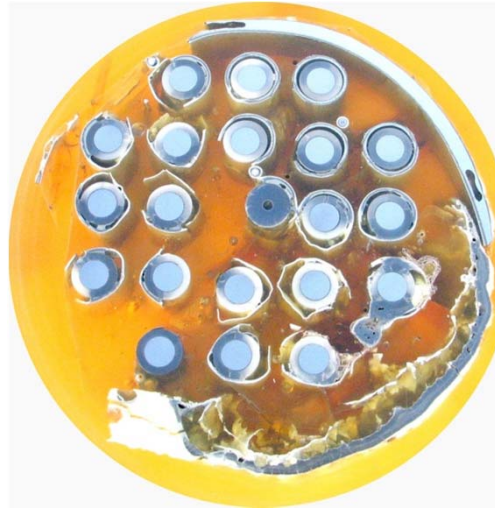
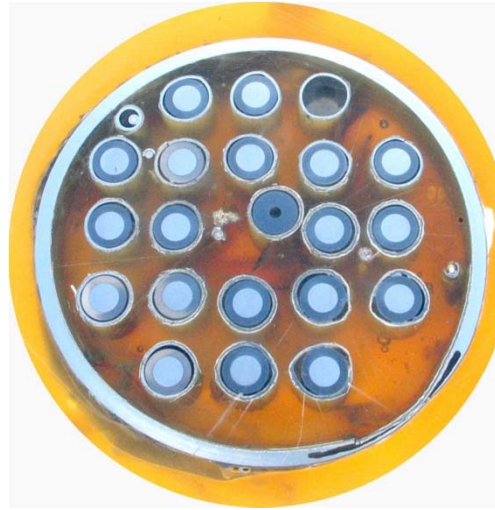
<p>650 mm: downwards relocated cladding metal</p>	<p>750 mm: downwards relocated cladding metal</p>	<p>850 mm: outer oxide layer not failed</p>
