KfK 3346  
März 1983

# **LWR Fuel Rod Behavior in the FR2 In-pile Tests Simulating the Heatup Phase of a LOCA**

**Final Report**

**E. H. Karb, M. Prüßmann, L. Sepold, P. Hofmann, G. Schanz**  
Hauptabteilung Ingenieurtechnik  
Institut für Material- und Festkörperforschung  
Projekt Nukleare Sicherheit

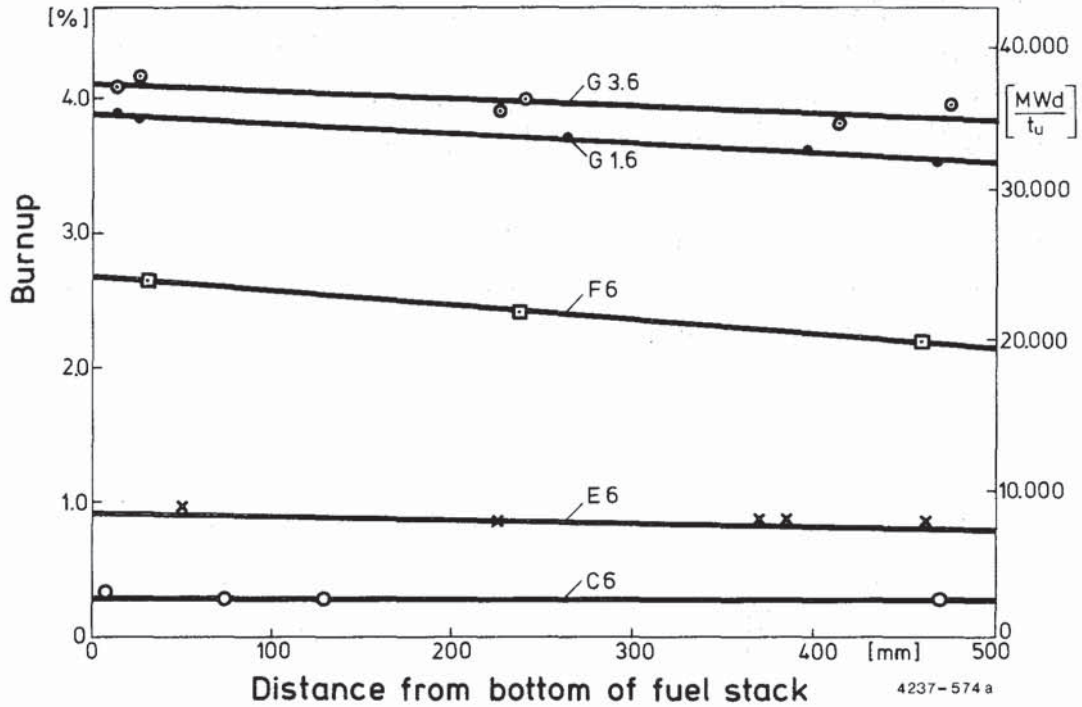
Figure 9: Axial burnup profiles of the preirradiated rods

The axial burnup profiles determined from the radiochemical samples of test series C, E, F, G1, and G2/3 are given in Fig. 9, the average data are listed in Table 4 for both methods of burnup determination.

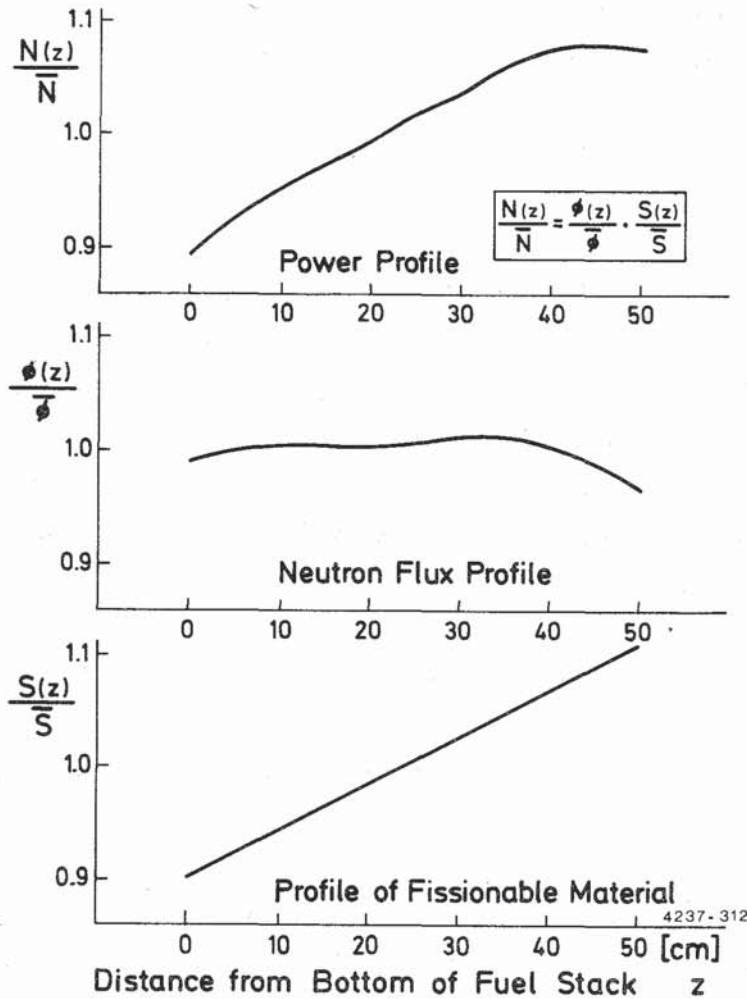
Figure 12: Procedure for the evaluation of the axial power profile of preirradiated rods (normalized), Test F4 as example.

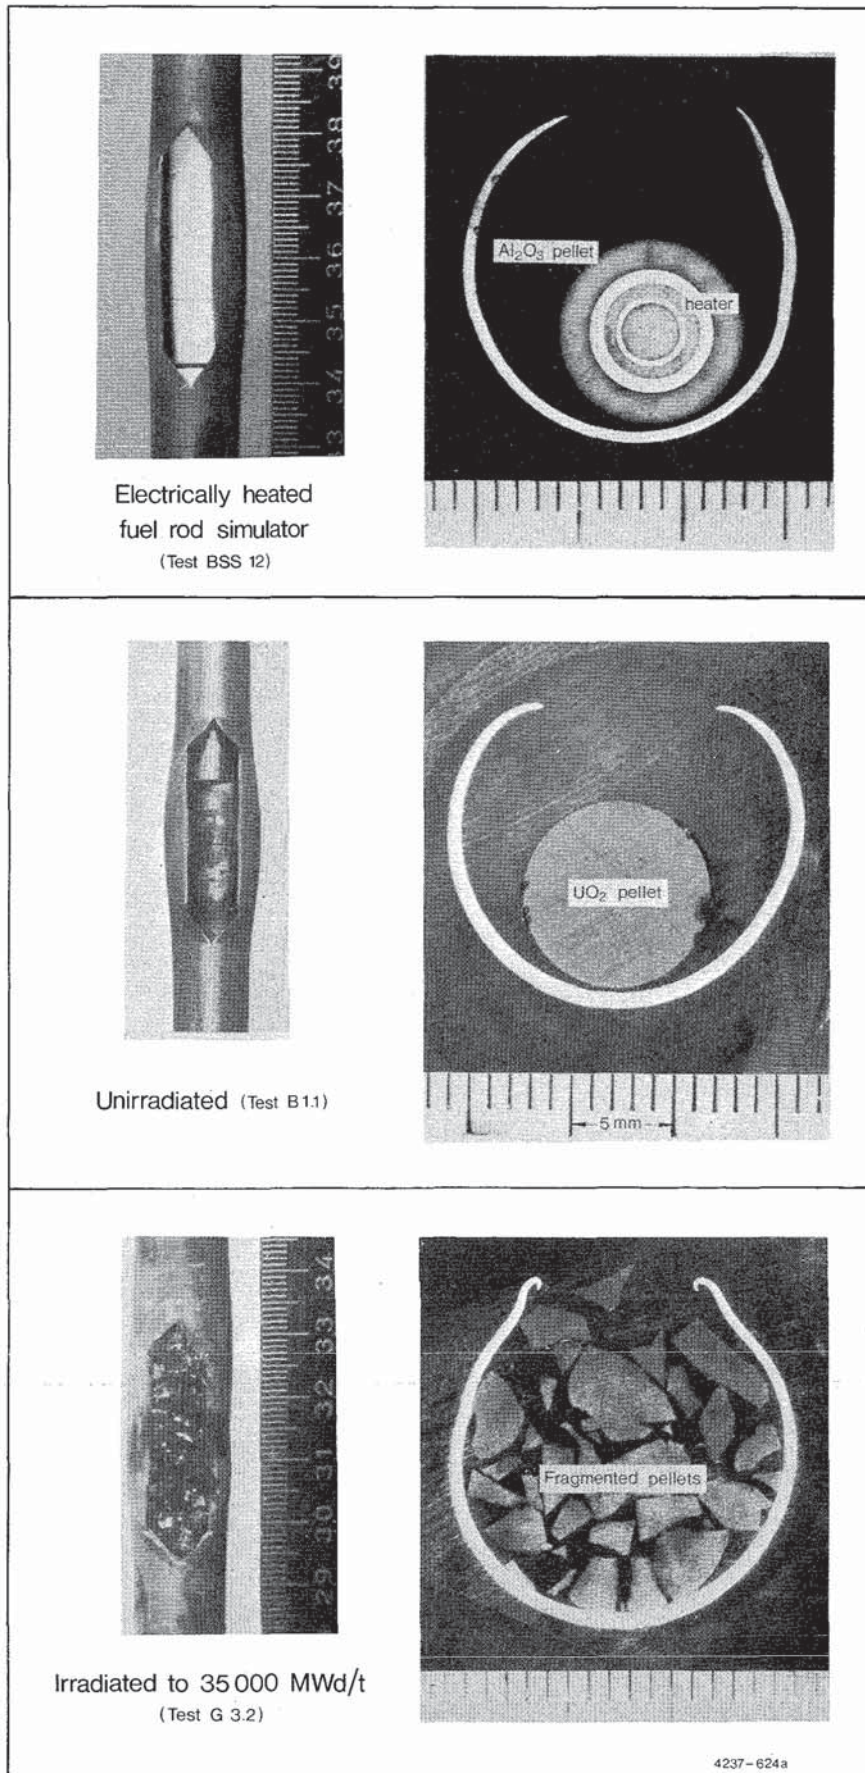
Figure 13: Views and cross sections of rupture regions of fuel rods and rod simulators.

During the heatup phase, the pressurized rods suffered deformation over the entire heated length, ballooned locally, and ruptured within the ballooned section /12, 15-20/. With two exceptions all rods burst at the location of maximum strain. The ruptured regions of an unirradiated rod, an irradiated rod, and a rod simulator are presented in Fig. 13. The burst shapes of the three types of rods are similar, and the cross sections of the burst locations do not indicate an influence of irradiation. The only apparent difference is the fragmentation of the irradiated fuel, which is described in Section 5.

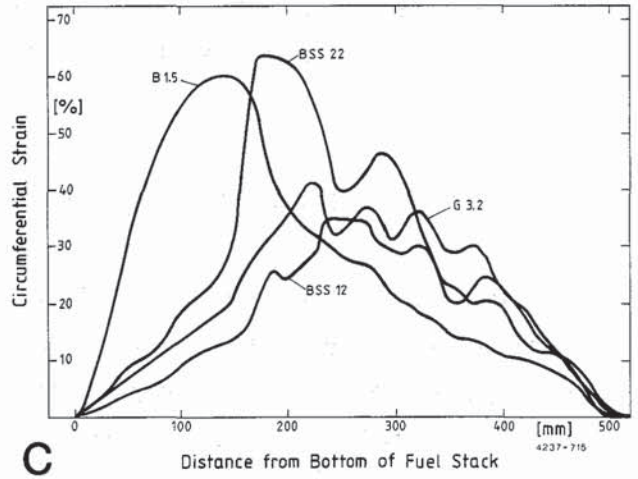
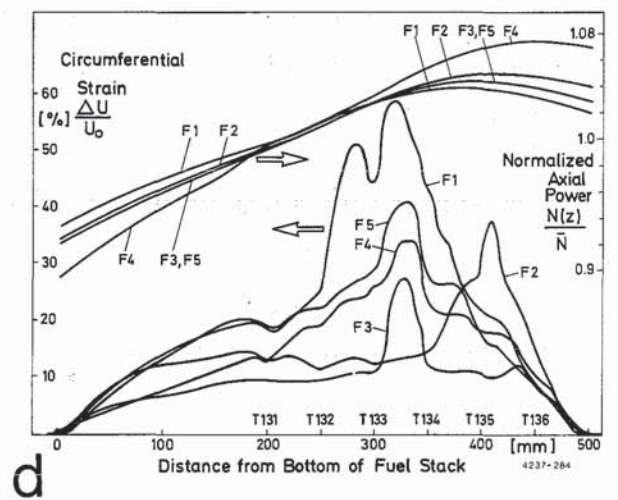
Figure 24: Relative increase of total void volume versus maximum circumferential elongation (24a) and deformation profiles for tests below the average (24b), above the average (24c), and tests F1 through F5 representing the average (24d).

The position of ballooning and maximum strain was usually at or close to the position of maximum rod power (see Fig. 24d).

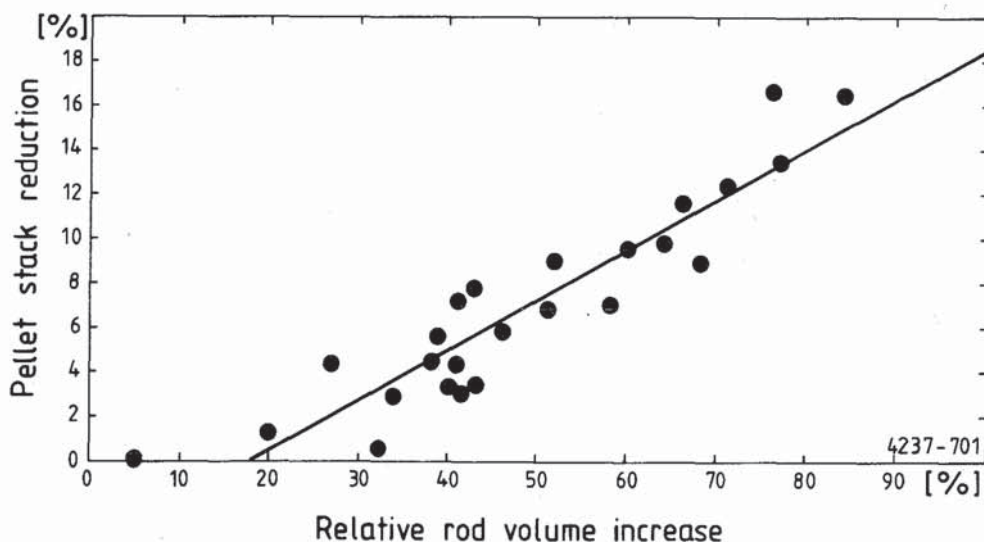
Figure 32: Pellet stack reduction vs. rod volume increase for the preirradiated rods.

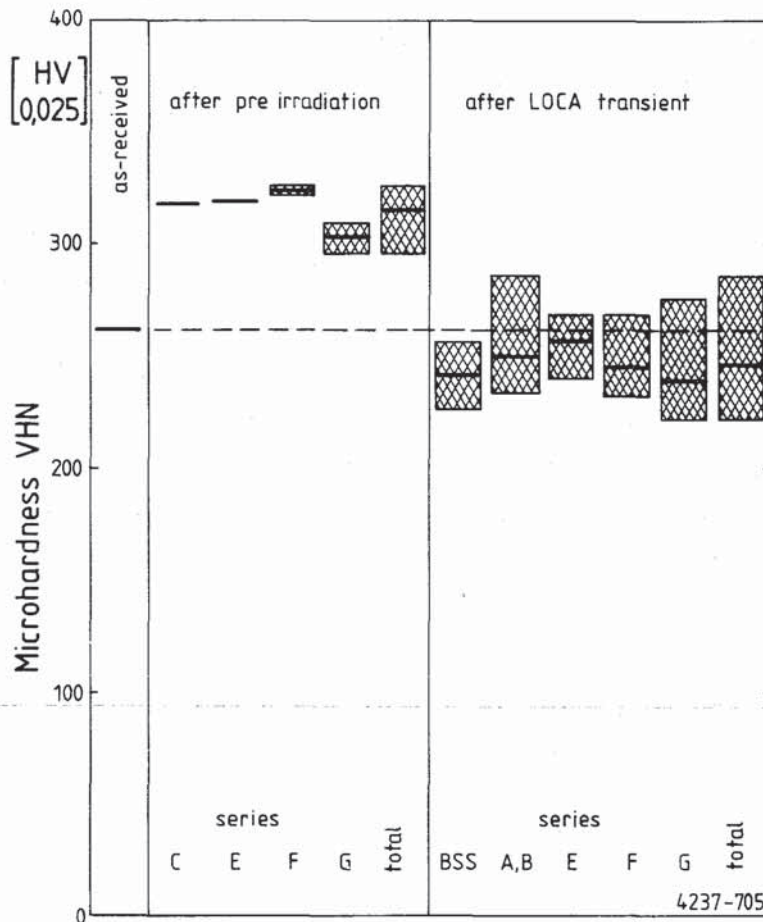
Figure 39: Cladding microhardness VHN for as-received, unirradiated, transient tested (BSS, A, B), and preirradiated and transient tested specimens (E, F, G)

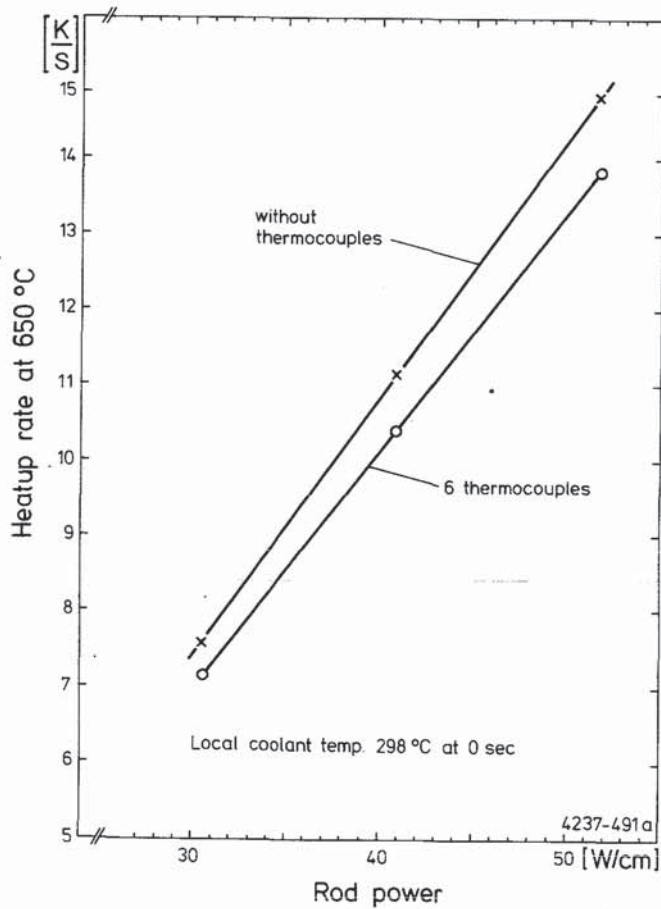
Figure 41: Influence of thermocouple leads on the heatup rate of the cladding, STATI 3 calculation
